PENNSYLVANIA CAPITOL PRESERVATION COMMITTEE
2010-11 ANNUAL REPORT

HISTORIC SOUTH CAPITOL PARK PROJECT PHASE II & III

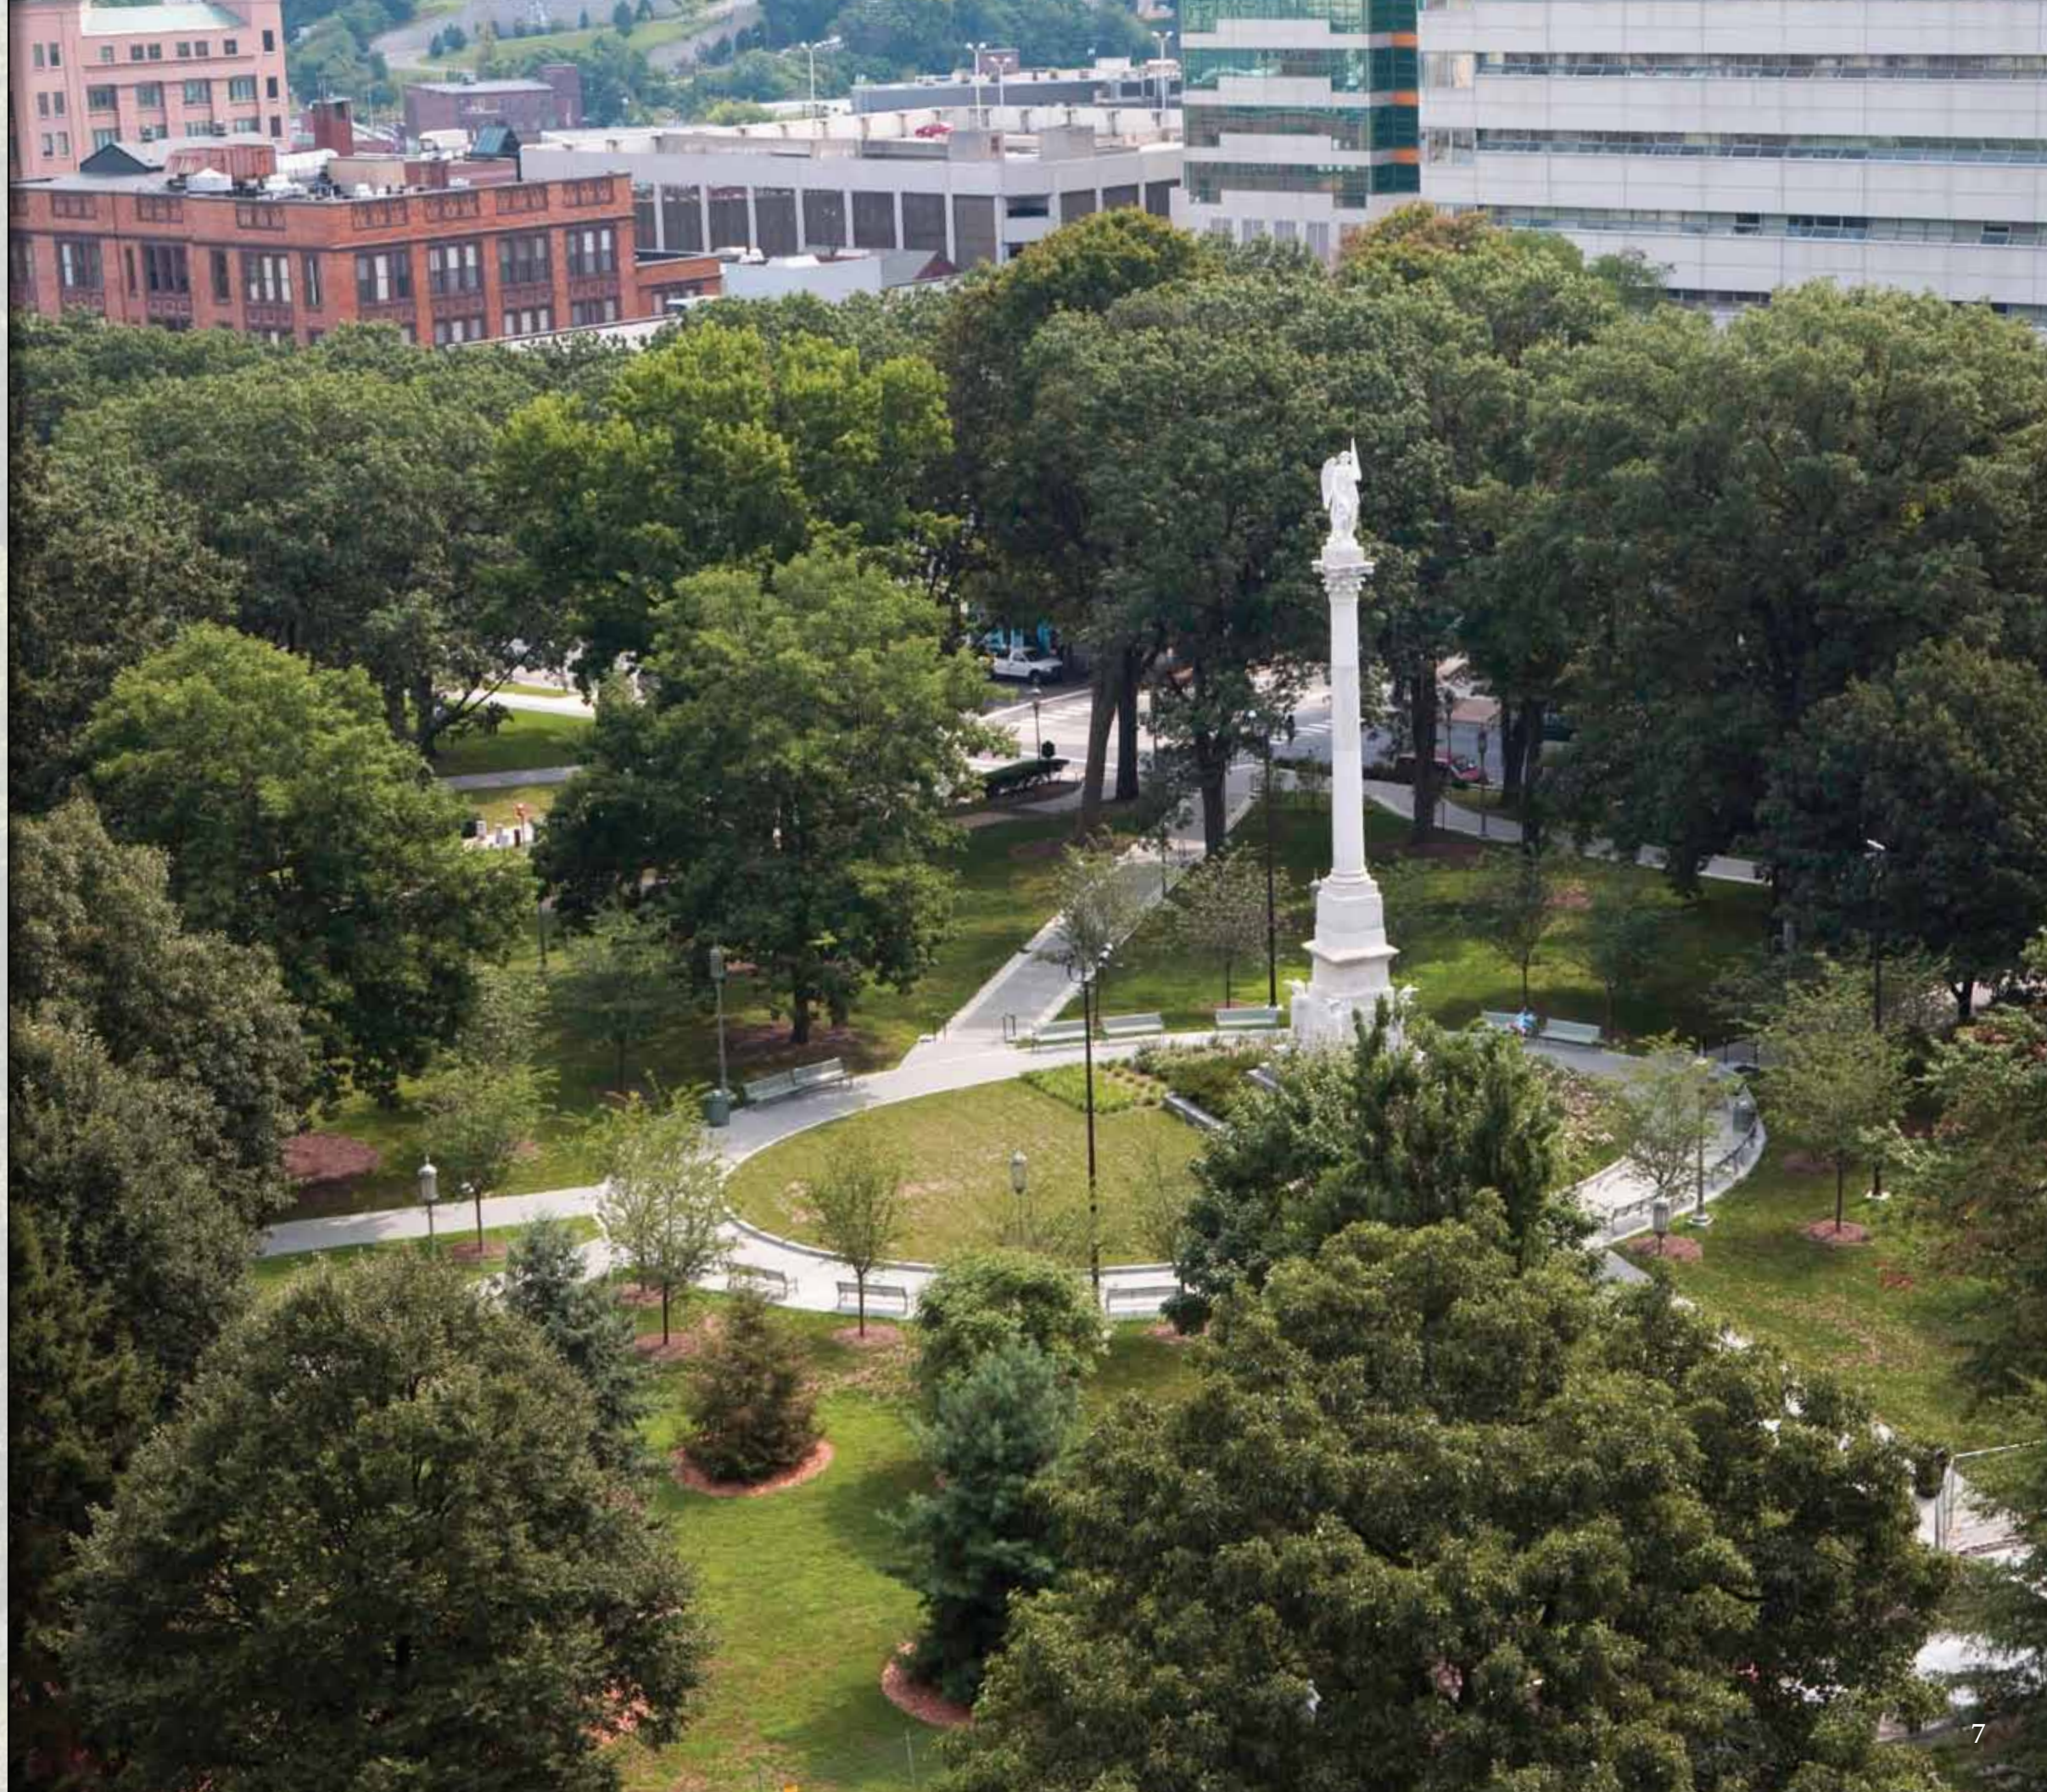
TREE PROTECTION

Before any work began in the park, tree protection areas were identified and temporary fencing was installed around the perimeter of the construction area. Many trees required protection and help to control stress reduction around impacted trees. Tree protection fences were installed before any site work began. The fence remained until all of the site work was completed. On the inside of the fence, both Supersonic Air Tool (SSAT) excavation and root pruning occurred. SSAT excavation took place in areas where excavation for utilities was required but tree roots were present. Once the utility was installed, the protective material was removed and the area was backfilled with clean topsoil.

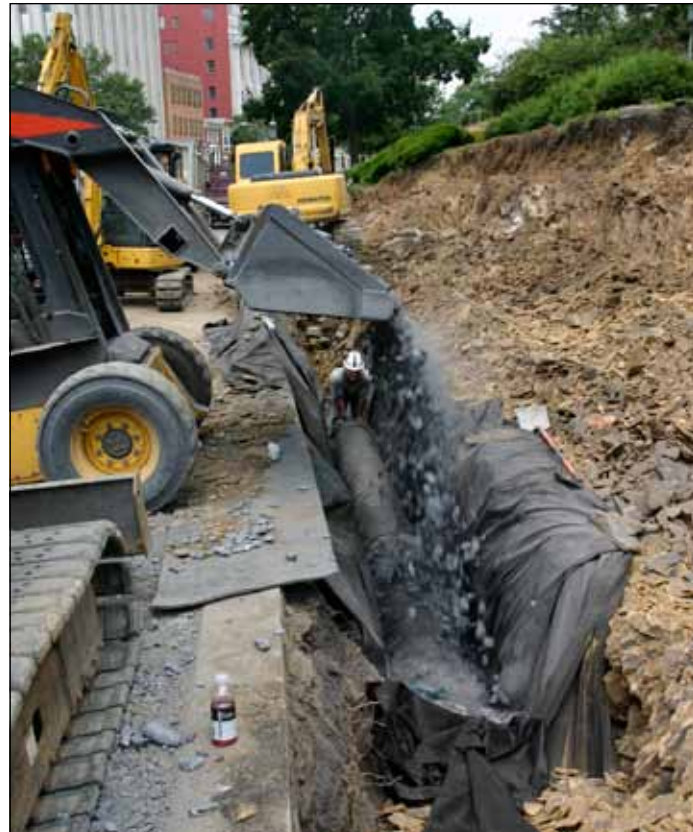
15" pipe on Third Street wrapped in geotextile fabric, back-filled with stone and wrapped in fabric again

The design of the new stormwater drainage system now not only allows it to convey water but to also act as a storage system promoting subsurface drainage, sediment control and avoiding the possible overburdening of the existing city storm water system. The initial step in the renovation of the water drainage and management system was in excavating the area parallel to the interior park path as well as partially excavating along Third Street and trenching for the conduit to the street. When excavation was complete, the installation of the new system – consisting of catch basins, storm pipe and concrete manholes connected by 15" perforated pipe – was begun. In this process, hydraulic jack hammering was required on the northern end of Third Street to break up the shale, and a backhoe cleared the cut stone and soil from the newly excavated area. To this end, a trench was dug and a new section of 15" perforated storm pipe was then laid and fitted into the previously installed section of pipe. The top of the pipe was then wrapped in geotextile fabric to prevent the perforated holes from becoming clogged with sediment. On top of the fabric a layer of stone was then installed and then filled with a layer of the broken-up shale. The Beehive grates were also installed at this time with the addition of filter fabric at the inlet to prevent soils from washing into the structure in the event of large rainstorms. The fabric was removed once the soil and plantings became established. The entire system was then tied into the existing system installed in Phase I and prepped for tie in into Phase 3 at the north end of the interior park path.

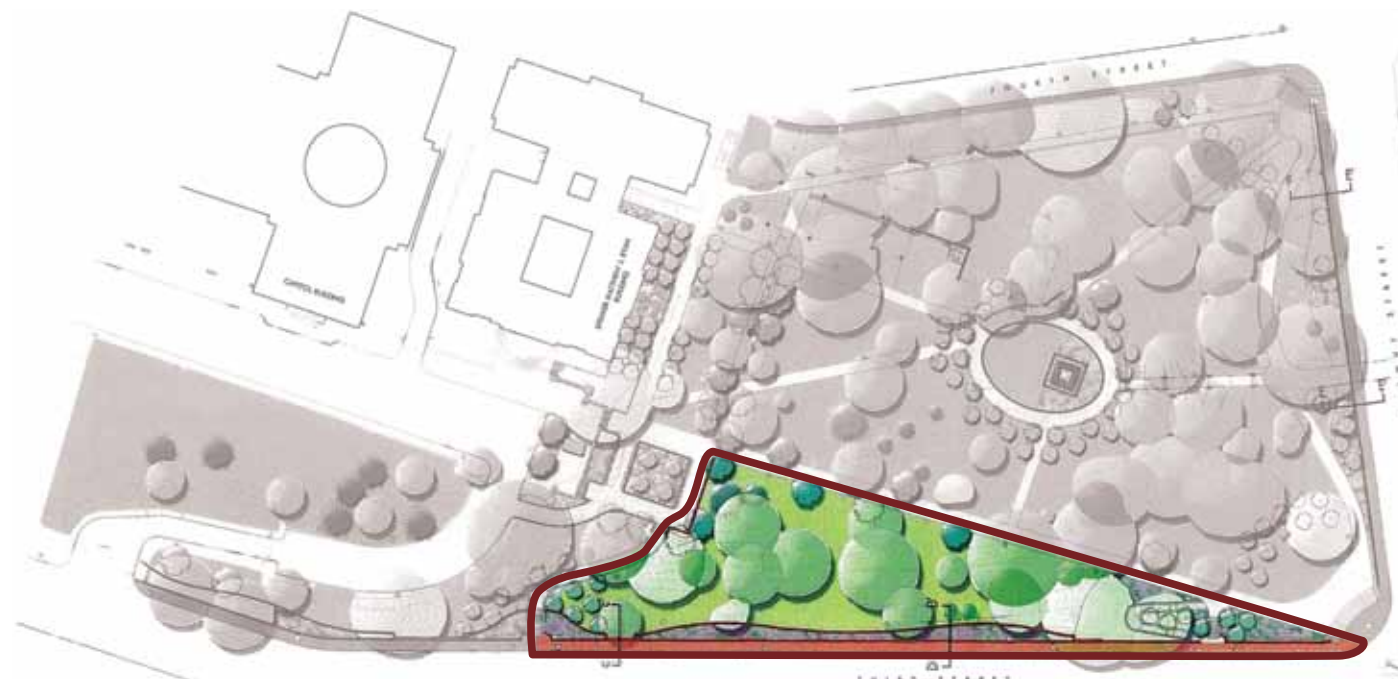
Rendering from the South Capitol Park Master Plan - Phase 2 outlined in Red

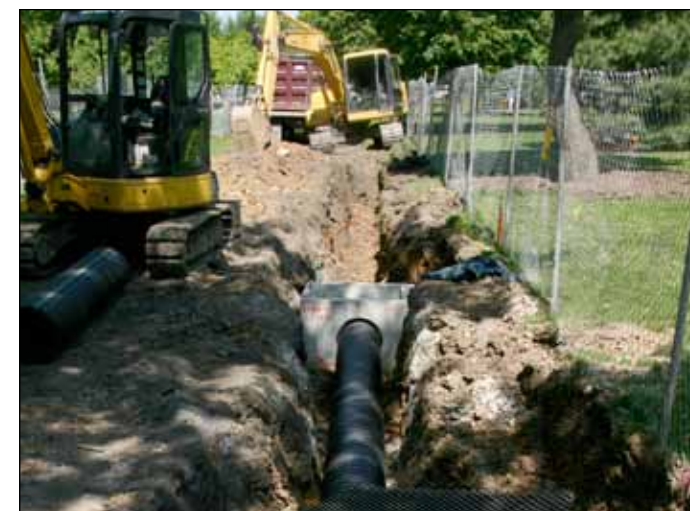
Catch basins connected by 15" pipe along interior park path

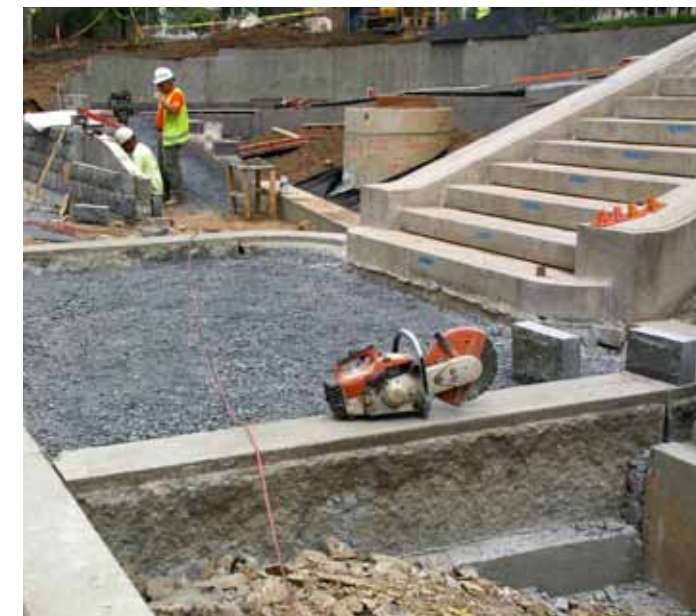
Partially reconstructed steps, footer, gravel bed for new sidewalk and granite curb Third Street

Phase II involved the installation of new concrete footings and the reinstallation of the original granite stair elements located at the south end of Third Street near Locust Street, which provides access into the South Capitol Park. Initially, the existing granite steps were surveyed to document the condition and exact location of each piece for reconstruction during the reinstallation of the steps. Each granite stair element was then photographed and labeled to identify the locations and orientation of each piece in that location. The steps were then disassembled and stored on site and the existing handrails were also removed and discarded. As the old footer of the steps began to be demolished, a second concrete footer was uncovered beneath the first. Both footers were subsequently demolished. New compact fill was then laid and a new concrete footer was constructed. The steps subsequently received a new concrete foundation and walls, reinstalled granite cheek walls and treads, new granite veneer walls and new handrails with a bronze cap to match the existing. At the base of the steps, brick pavers over a concrete sub-walk were installed, along with reinstalled granite pavers bands.

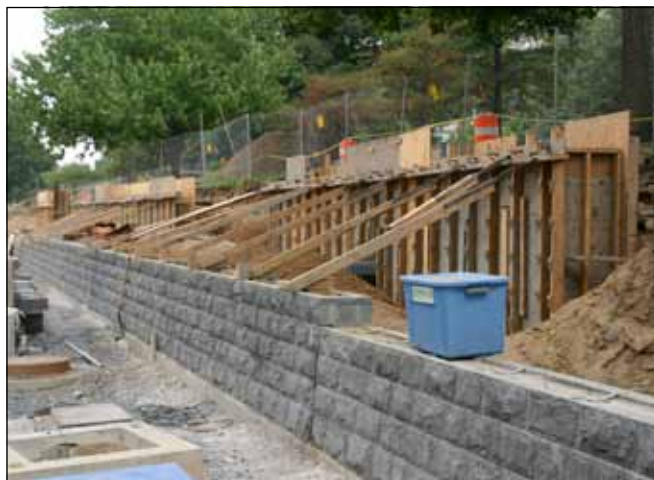
Western retaining wall with granite veneer and eastern retaining wall with poured concrete forms

In conjunction with the new sidewalk and storm water management along the east side of Third Street, the parallel area to the east was excavated and a new concrete footer and retaining wall was constructed. A second, oscillating retaining wall was installed to the east. The purpose of both walls was to mitigate future stormwater drainage issues such as erosion and excessive run-off and to protect the roots of the existing mature trees. The first step was the excavation of the existing bank to the east of Third Street. Structural fill was then laid and the forms and rebar for the concrete footings were constructed. A batter was installed along each wall to facilitate

drainage. The retaining wall then received a granite veneer and a granite coping. In the area between the two walls, soil was laid and tilled and the area was subsequently planted.

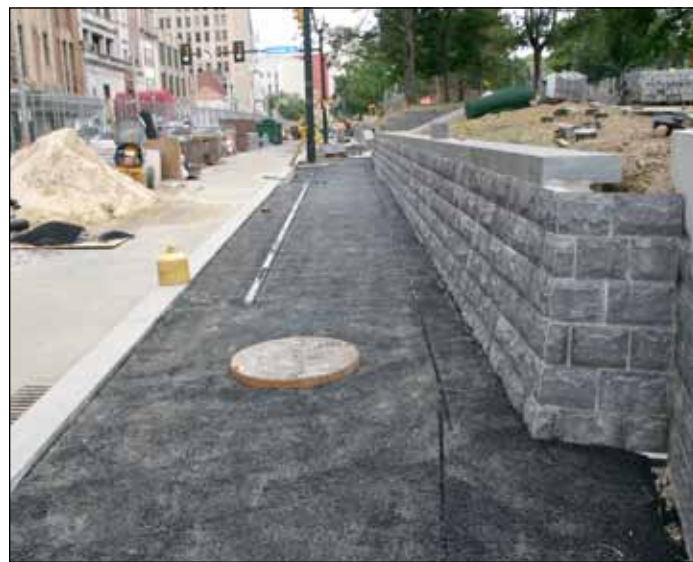
Sidewalk with asphalt bed and granite curb along Third Street

The sidewalk, including the concrete and granite curbs, along Third Street was initially removed. The area was then graded, staked and superfluous soil was removed. Installation began with a concrete sub base, which was poured to provide a foundation for the brick paver installation. An asphalt setting bed was then installed, along with slot drains, which paralleled the curb. Lastly, brick pavers were laid in a herringbone pattern in the field with a running bond brick border. As the existing granite curbs on the east side of Third Street was determined to be inline and well anchored, it was decided that the curbs could remain in place as was done in Phase 1 of the project. This required the proposed ADA curb access points be cut and ground into the existing granite curbs in lieu of setting the curbs in place at predetermined slopes and elevations. This technique was completed successfully on the southern access point but could not work on the northern access point due to pre-existing damage to the granite curb. The curb was subsequently removed and replaced with granite selected and provided by the Capitol Preservation Committee. The new granite was set to an elevation and then cut and ground to accommodate the conditions and access requirements.

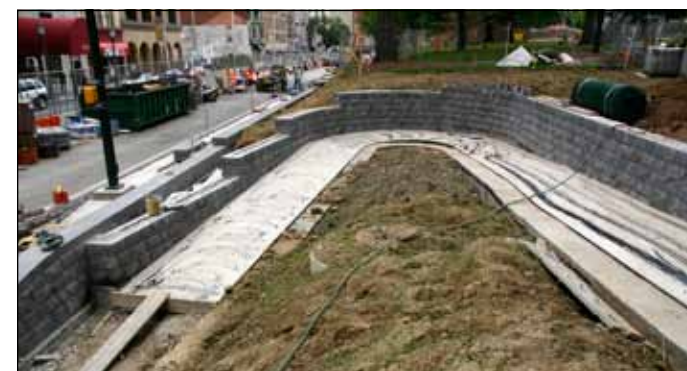
Handicap ramp with poured concrete base, retaining wall and granite facing

In order to facilitate handicap access from the Third Street sidewalk to the interior of the South Capitol Park, a U-shaped handicap ramp was installed at the south end of Third Street. To this end, the area was excavated and concrete footers were installed using concrete forms and rebar. Forms were subsequently constructed for the cheek walls, which were then installed and faced with coursed granite and smooth granite coping to match the retaining walls. For the ramp itself, a gravel bed was laid and a concrete base was poured. On top of the base is an asphalt bed, onto which the hexagonal asphalt pavers were laid. Lastly, a new handrail was installed with a bronze cap to match that of the steps.

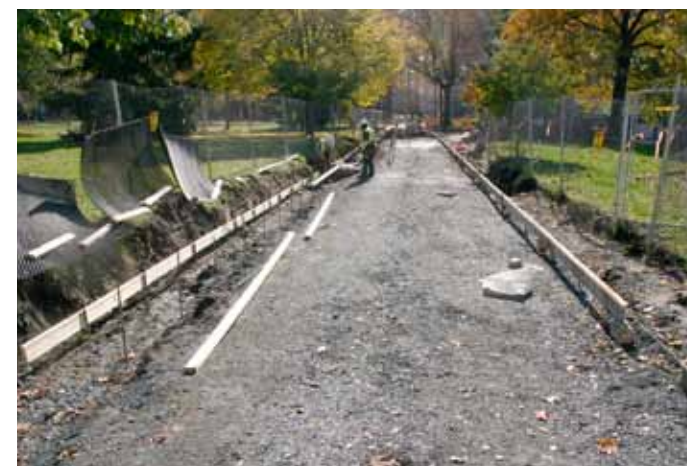
Interior park path with asphalt

Phase II of the project involved the removal and replacement of one interior park path, which runs parallel to Third Street between the corner of Third and Walnut Streets and the Ryan Building. To this end, the existing concrete walk was removed and the area was re-graded as necessary. On top of the concrete base is an

asphaltic setting bed, on top of which are new asphalt paver walks and granite cobblestone gutters with iron grates. Work was also undertaken in the area at the top of the existing steps, which was left incomplete from Phase I of the project. The area was first graded and then filled with soil. Beneath the aeration matting structural fill was laid, followed by a concrete slab, asphalt and then asphalt pavers.

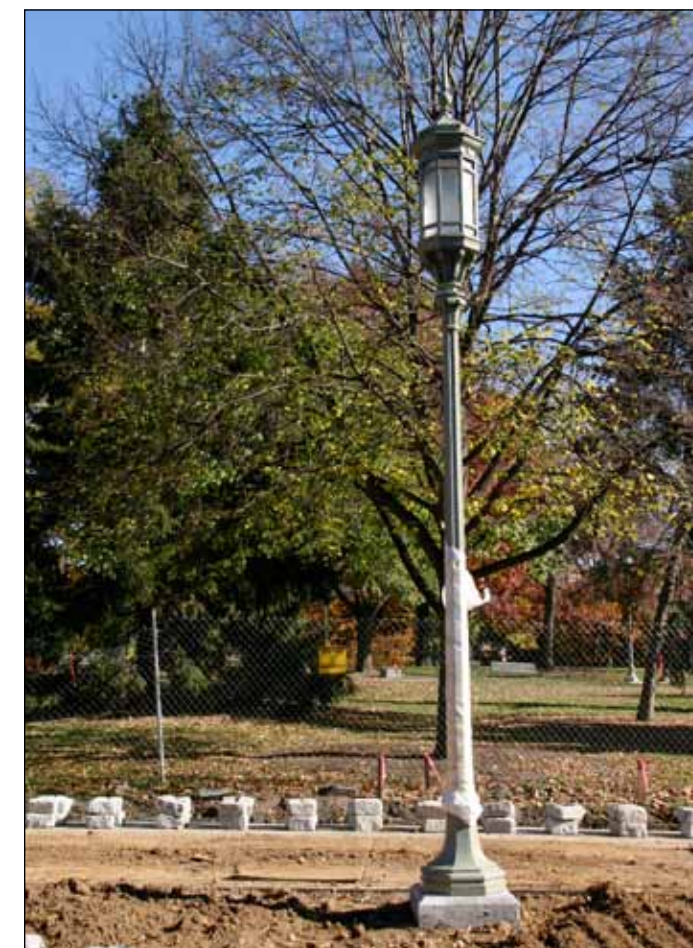
Restored light fixture along interior park path

The lighting work consisted of the removal, restoration, wiring, painting, and reinstallation or relocation of the existing fixtures. The poles and luminaries were then sent for restoration to Spring City Electrical Manufacturing Company, the original manufacturers of the lights. Once restored, the light fixtures were reinstalled in their original or relocated positions. Due to their deteriorated condition, all of the original light fixture bases were replaced with new concrete bases. Phase II called for the installation of new light fixtures, all of which match the originals in color, profile and design.

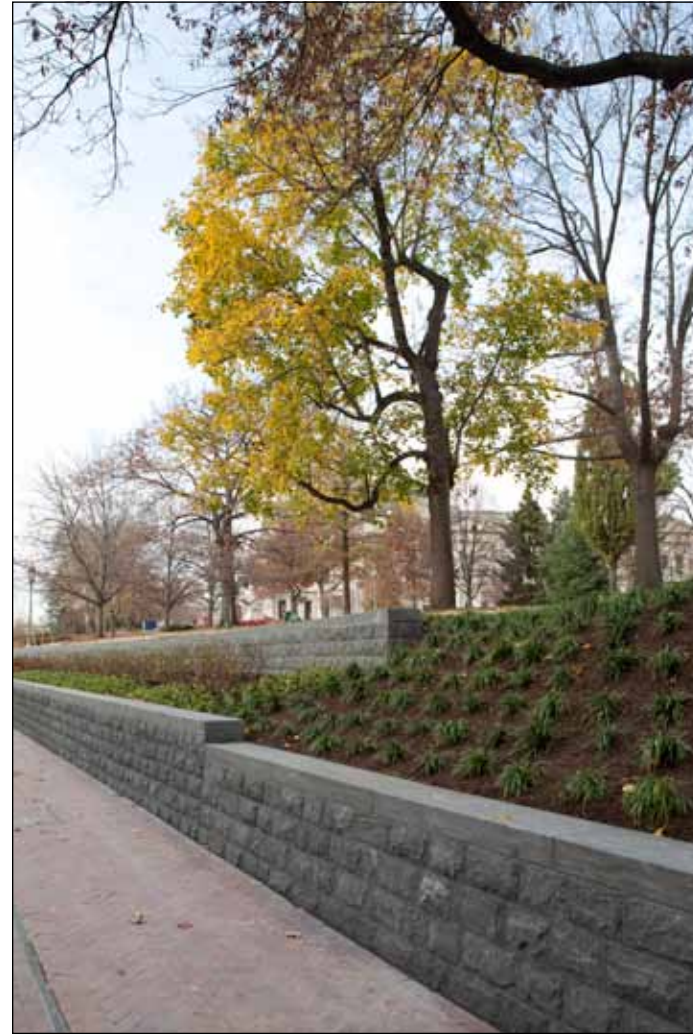
New planting between the two retaining walls

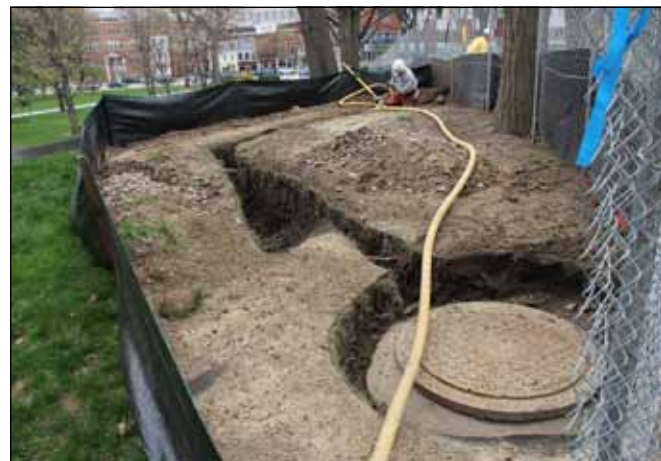
Exposed roots using SSAT excavation

TREE PROTECTION

Before any work began in the park, tree protection areas were identified and temporary fencing was installed around the perimeter of the construction area. Many trees required protection and help to control stress reduction around impacted trees. Tree protection fences were installed before any site work began. The fence remained until all of the site work was completed. On the inside of the fence, both Supersonic Air Tool (SSAT) excavation and root pruning occurred. SSAT excavation took place in areas where excavation for utilities was required but tree roots were present. Once the utility was installed, the protective material was removed and the area was backfilled with clean topsoil.

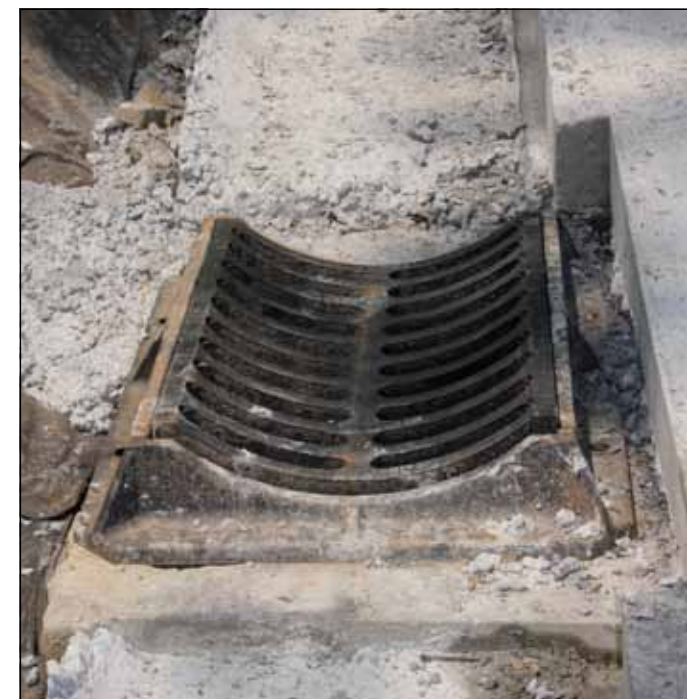
Concave inlet grate sitting on catch basin along interior park path prior to gutter installation

the installation of the new system – consisting of sixteen catch basins throughout Phase III, cast iron drains and four concrete manholes connected by 15” perforated pipe – was begun. To this end, a trench was dug and a new section of 15” perforated storm pipe was then laid and fitted into the previously installed section of pipe. The top of the pipe was then wrapped in geotextile fabric to prevent the perforated holes from becoming clogged with sediment. Stone was then installed on top of the fabric layer and then filled with a layer of the broken-up shale. Along Third Street, larger piping, as well as catch basins and drains, were utilized for water drainage because of the significant difference in the grade of the terrain. In the areas beneath the interior park paths, stone trenches, were installed at various locations. The stone trenches reduce stormwater runoff from the sidewalk and reduce the amount of stormwater runoff entering the undersized City combined storm and sanitary sewer system. Beehive inlets were installed in the mulched areas behind the retaining wall. Slot drains were also installed in the sidewalks along Third and Walnut Streets. These drains were installed to prevent water from puddling on the sidewalks and creating safety hazards for pedestrians, especially during winter months, when this standing water could freeze.

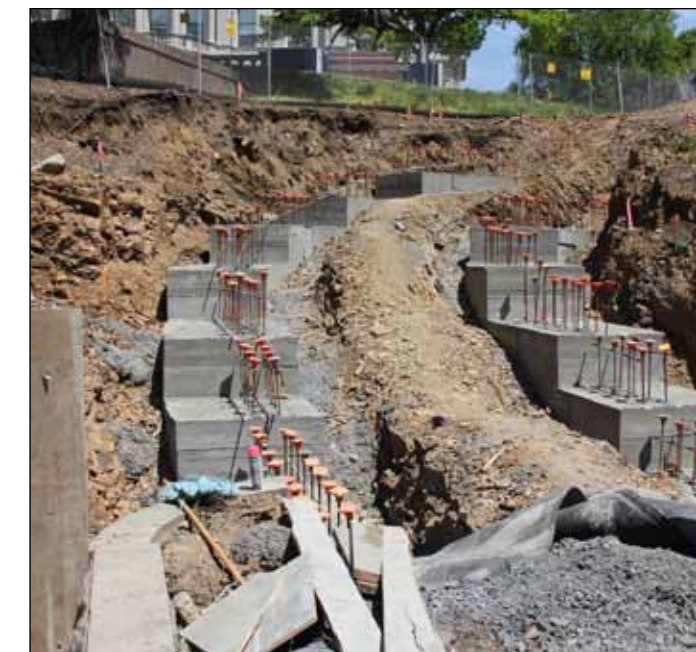
Excavated area with cheekwall footers at Pine Street steps

Phase III involved the installation of new concrete footings and the reinstallation of the original granite stair elements located at Pine and Third Streets. The steps at this location provide access into the South Capitol Park. Initially, the existing granite steps were surveyed to document the condition and exact location of each piece for reconstruction during the reinstallation of the steps. As the old footer of the steps began to be demolished, a second concrete footer was uncovered beneath the first. Both footers were subsequently demolished. New compact fill was then laid and a new concrete footer was constructed. The steps subsequently received a new concrete foundation and walls, granite facing, reinstalled granite cheek walls and treads, new coursed granite veneer walls and new metal railings. At the bottom of the stairway, the existing radius flush granite curbs were initially determined to be in good condition and would not need to be removed and replaced. Unfortunately, subsequent heavy storms undermined the footing on the northeast section of the curb. That portion was removed and reset on a new footing in the same location. New granite radius curbs were installed connecting the stair cheek wall and the new retaining wall. The existing path to the east of the stairs was also considerably altered with the installation of two sets of stairs to accommodate the change

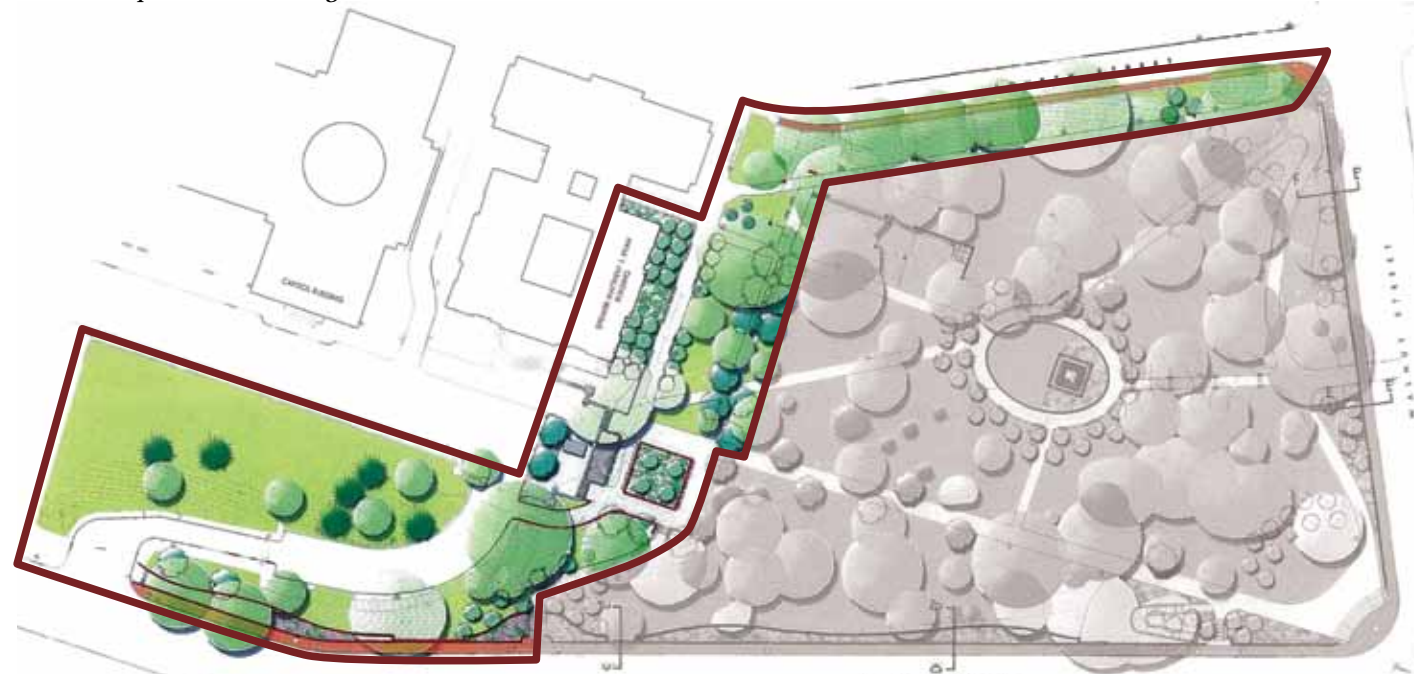
Rendering from the South Capitol Park Master Plan - Phase 3 outlined in Red

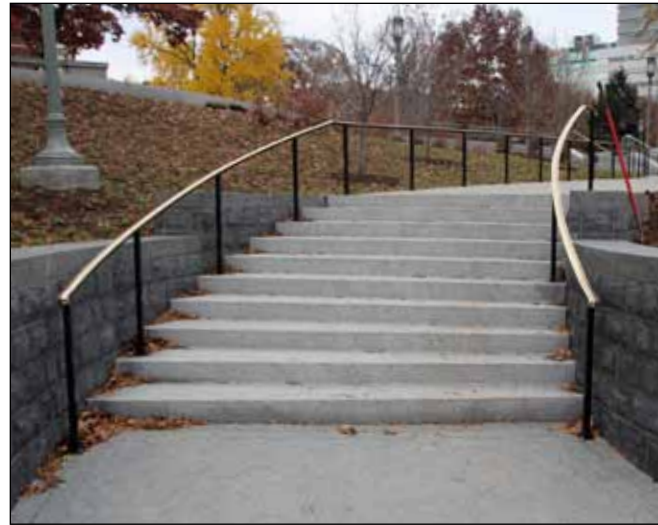
New granite steps at Pine Street

in grade. The new western stair is slightly curved and the eastern stair is straight, providing access to the re-designed Hartranft Plaza. Both stairways match those existing and consist of a concrete footer, foundation and walls, and granite facing, cheek walls and treads and metal handrails. Prior to reinstallation, the existing steps were cleaned of heavy dirt, caulking and old mortar. Once the granite was reinstalled, a more thorough cleaning was undertaken.

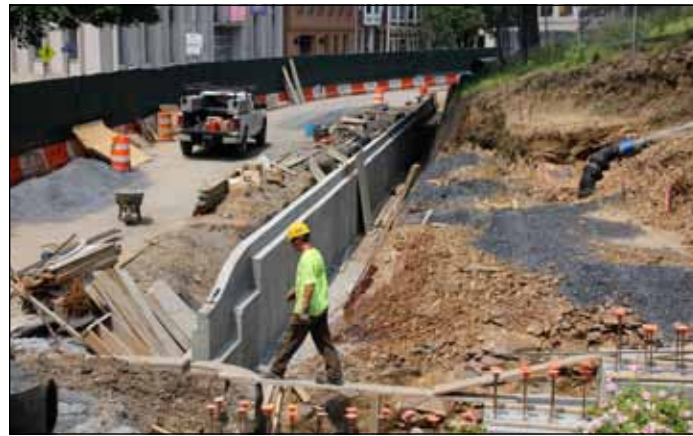
Excavated bank along Third Street with footers and concrete wall

In conjunction with the new sidewalk and storm water management, a granite veneer retaining wall was constructed parallel to the east side of Third Street. A second, oscillating retaining wall – substantially smaller than the first – was installed to its east. The purpose of both walls was to mitigate future storm water drainage issues such as erosion and excessive run-off and to protect the roots of the existing mature trees and allow for a wider sidewalk. The first step was the excavation of the existing bank to the east of 3rd Street in conjunction with the storm water excavation and the removal by dump truck. Structural fill was then laid and the forms and rebar for the concrete footings were constructed. Concrete forms for the retaining wall began to be installed as well. Once the concrete walls were constructed and had been cured, the forms were removed and a waterproofing membrane was installed on the east face of the footer, along with backfill. The retaining wall then received a coursed granite veneer and a granite coping. The granite was cleaned and, in the area between the two walls, soil was laid and tilled and the area was subsequently planted.

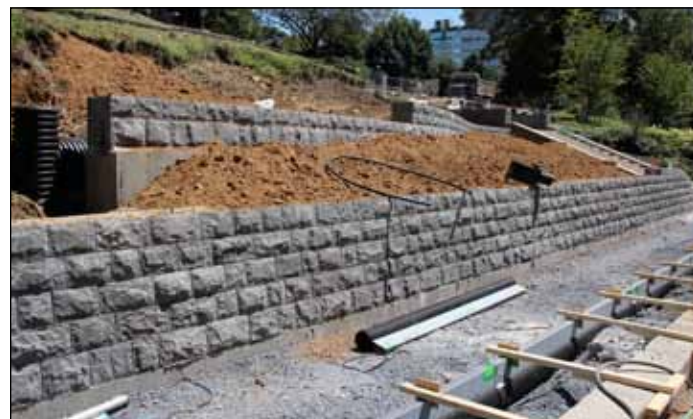
Retaining walls with installed granite facing

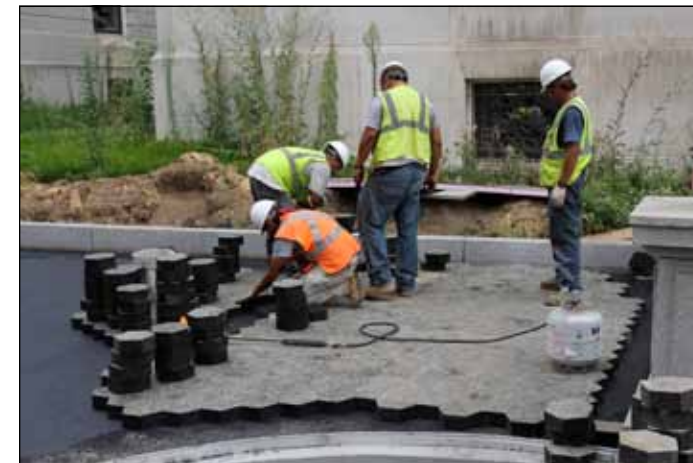
North interior park path with existing granite curb, asphaltic setting bed and partial hexagonal asphalt pavers

Phase III of the project involved the removal and replacement of two interior park paths and the addition of one historic path, as well as connecting the previously completed Phase I and II sidewalks. The existing east interior park path runs parallel to Fourth Street between the corner of Fourth and Walnut Street and the Ryan Building. The existing north interior park path runs parallel to the south side of the Ryan Building. The historic south interior park path also runs parallel to the south side of the Ryan Building, but is located to the south of the north path. Initially, the existing concrete walks on all paths were removed and the area was excavated and re-graded as necessary. On top of the base is a asphaltic setting bed, on top of which are new hexagonal asphalt pavers. On the east interior park path, granite cobblestone gutters

with iron grates were laid along the west side. On the north interior park path, the existing granite curb was removed and reinstalled.

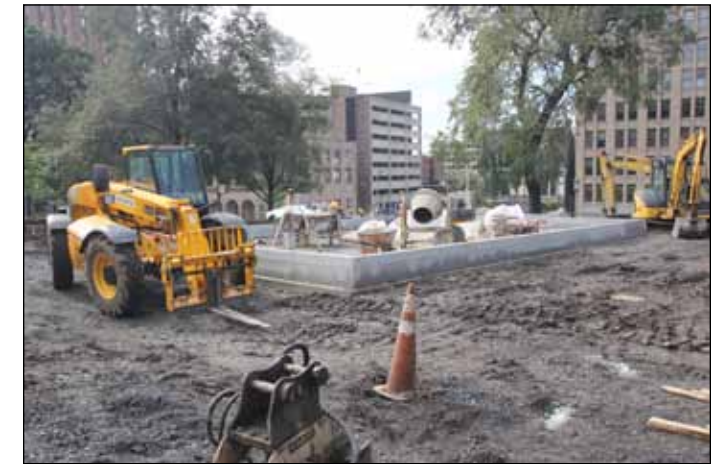
Hartranft Plaza after demolition with partially installed granite planting area

The Hartranft Plaza is located directly to the south of the Hartranft Monument; a balustrade granite wall and two short flights of granite steps separate the two areas. The initial step in the renovation of the plaza was the demolition of the concrete walks around the plaza and the driveway to the northwest of the plaza. The area was then excavated and new underground utilities were installed. Surrounding the planting area are paved walkways. New benches and trash receptacles have also been installed in this area. To the west of the plaza, a new short stairway with eight steps, granite treads and cheekwalls was also installed to accommodate the change in grade. Also on the west side of the plaza is a short, curved path that leads from the plaza stairways to the curved portion of the Pine Street stairs. As with the other interior park paths, the area was excavated and re-graded as necessary. On top of the base is an asphaltic setting bed, on top of which are new hexagonal asphalt pavers. Along the north side of the path is a metal railing. The existing driveway was widened by 12'0" to accommodate larger vehicles and repaved bordered by new granite curbing. The new driveway incorporated hand-tooled joints to mirror the existing parking deck.

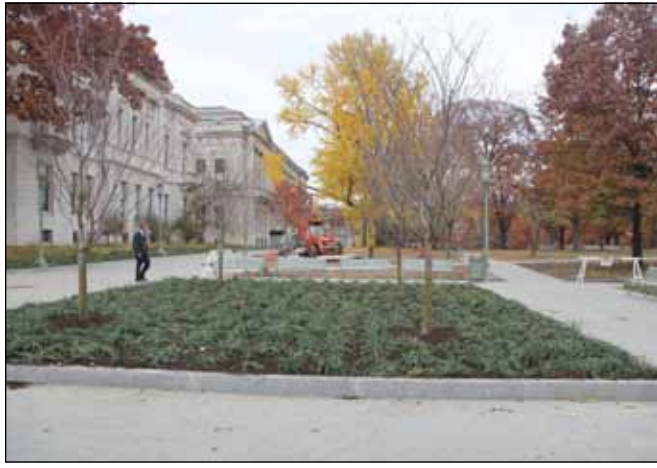
Hartranft Plaza with installed asphalt pavers and landscaping

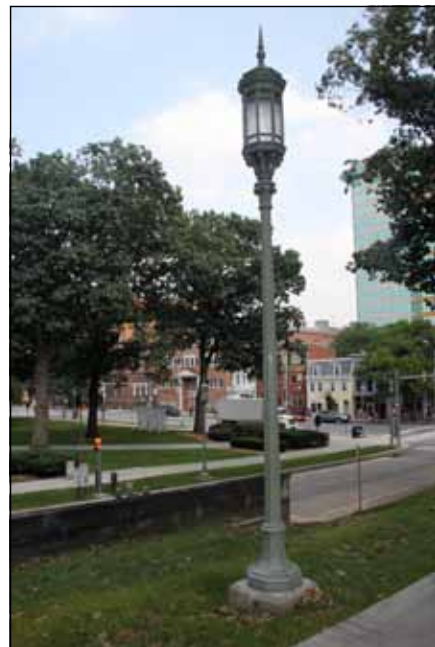
Restored light fixture along east interior park path

The lighting work consisted of the removal, restoration, rewiring, repainting and reinstallation or relocation of the existing fixtures. The poles and luminaries were then sent for restoration to Spring City Electrical Manufacturing Company, the original manufacturers of the lights. Once restored, the light fixtures were reinstalled in their original or relocated positions. Due to their deteriorated condition, all of the original light fixture bases were replaced with new concrete bases. Phase III called for the installation of three new light fixtures. The new fixtures matched the originals in color, profile and design.

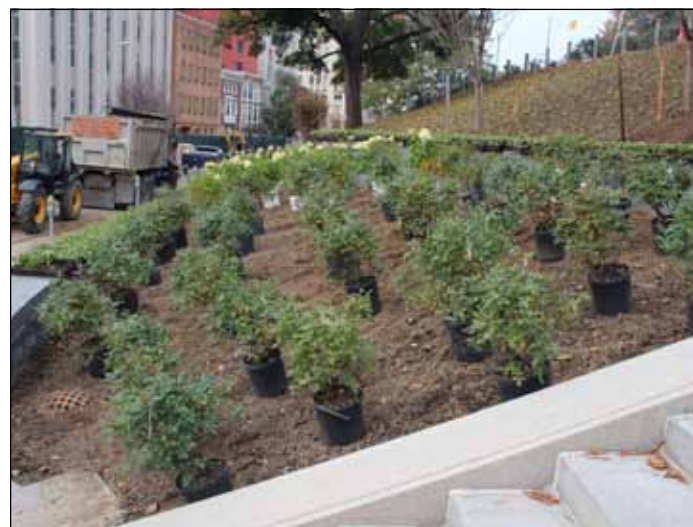
Planting area to the north of the Locust Street steps

The South Capitol Park contains numerous varieties of existing trees, including Red Oak, Red Maple, Norway Maple Gold Raintree, Red Bud, Kobus Magnolia, London Planetree, Flowering Cherry and Weeping Birch. The center of Hartranft Plaza contains a new planting area with four Yoshino Cherry, 624 Liriope and 1,000 daffodils. To the north of the plaza and in a planter in front of the Hartranft statue balustrade are twenty-five Pink Knockout Rose and twenty-six Hamlin Fountain Grass. The area to the northwest of the plaza contains 8,400 Pachysandra, 6,250 daffodils, 909 Liriope, ten Fairy Rose, seven Yoshino Cherry trees, fifty-five English Spreading Yew trees, sixty-two Possumhaw Virburnum, one Red Oak tree, five Japanese Dogwood, thirty-one Limelight Hydrangea, thirty-four Pink Knockout Rose, three Flowering Dogwood, twenty-five Oakleaf hydrangea, two London Planetrees and one Red Maple tree. The area to the east of the plaza is primarily planted with grasses and has a planting bed along the south elevation of the Ryan Building. The planting bed contains 480 Liriope. To the south of the bed, six Red Maple trees and three Japanese Dogwood trees have been planted. The remainder is planted with grass. At the south end is a planting area with six Flowering Dogwood, 4,560 Pachysandra and 630 daffodils. The area of the swale behind the Fourth Street wall contains 1,400 Liriope, seven Possumhaw Virburnum and nine Limelight Hydrangea. These plantings provide additional stability for the soils located in that area.

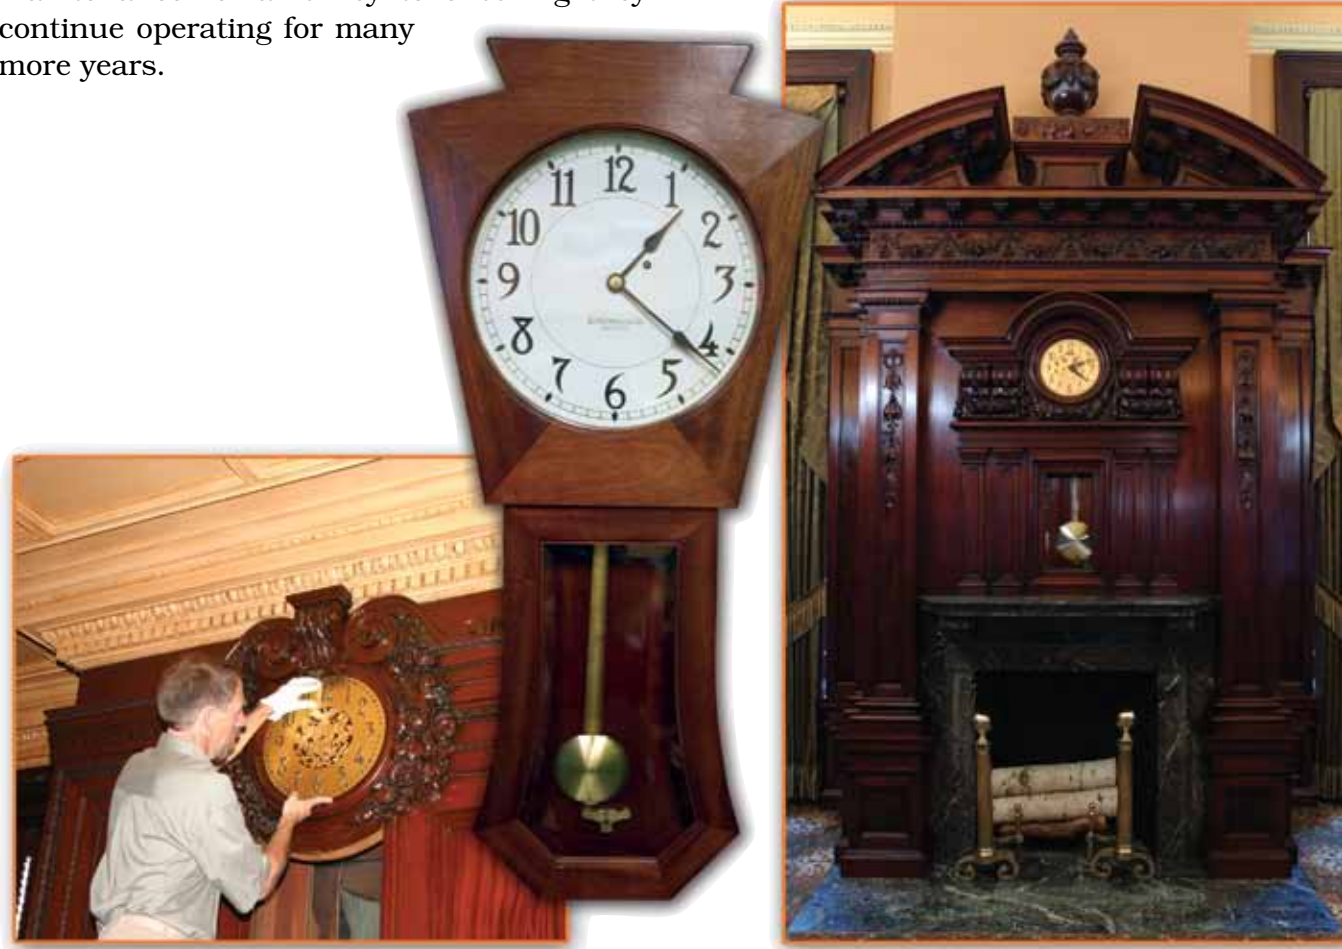
The Capitol Preservation Committee is responsible for the regular maintenance of more than 280 original historic clocks, which are still located throughout the Capitol and associated buildings of the Capitol complex.

The clock project began in 1993 with the objective to restore and maintain the clocks' wood finishes and inner mechanisms. In addition, the Committee wanted to collect and maintain historic documentation along with an inventory of each clock. By developing an electronic database, detailed information was compiled, including clock descriptions, construction materials, conditions, location, and an ongoing maintenance history.

Following restoration, each clock was put on a cyclical maintenance program. The Committee's clock conservator oils the inner mechanisms of each clock every three years, however, this will be changing to a four year cycle. After six years, the clocks are given a thorough check-up and cleaned inside and out. While the majority of Capitol clocks have now been restored, ongoing preservation maintenance remains key to ensuring they continue operating for many more years.
