PENNSYLVANIA CAPITOL PRESERVATION COMMITTEE
ROOM 630 MAIN CAPITOL BUILDING
P.O. Box 202231
HARRISBURG, PA 17120
717-783-6484 • FAX: 717-772-0742
[HTTP://CPC.LEG.STATE.PA.US](http://CPC.LEG.STATE.PA.US)

2003 ANNUAL PROJECT REPORT

Preserving a Palace of Art

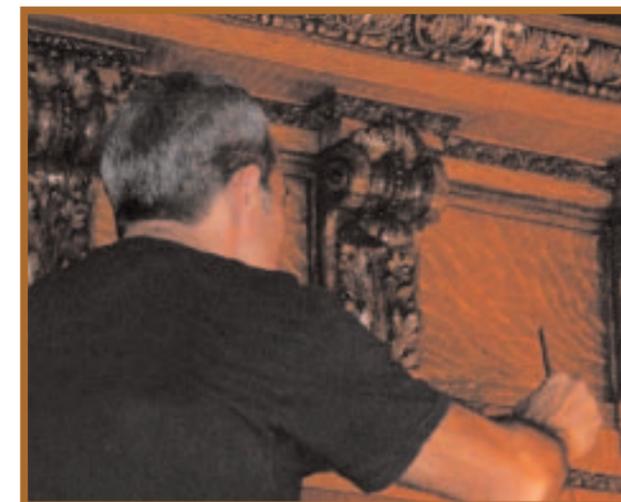
WOODWORK RESTORATION

Missing or broken composite elements were replaced by casting new pieces that were faux finished to match the original work.

Following the cleaning, dutchman repairs were made to several locations within the paneling where voids had been created when various utilities were installed over the years, but had since been abandoned. The dutchman repairs were toned to match the original color, and the woodwork was waxed and polished for a deep finish.

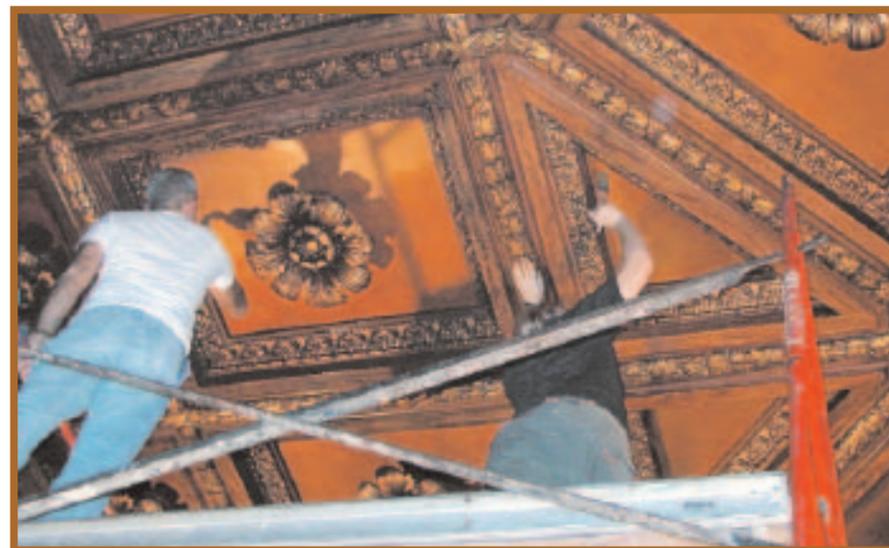
CONSERVATION OF ORIGINAL FINISHES

Prior to conservation, the ceiling of the Governor's Reception Room, like the rest of the room, appeared very dark and dirty. The Committee documented that large areas of the faux wood grain, which previously had been over-painted, were now flaking off and some sections were showing signs of water damage. The faux wood elements were cleaned with a solution of liquid soap and distilled water, which was applied with cotton. Any flaking or discolored areas were lightly sanded, and all loose plaster was removed from the water-damaged areas followed by a spackling and sanding process. Since this cleaning campaign removed the dirt from the ceiling, the old over-painted areas were now a dark contrast. To correct this, the darker areas were repaired and faux finished to match the cleaned ceiling.

Ninety percent of the original polychrome and gold leaf finishes of the decorative cove ceiling in the Governor's Reception Room was found to be original, requiring only mild cleaning. The canvas of the aluminum leafed fields surrounding the rosettes was in stable condition and required no repairs, though some areas did have paint loss and required inpainting.

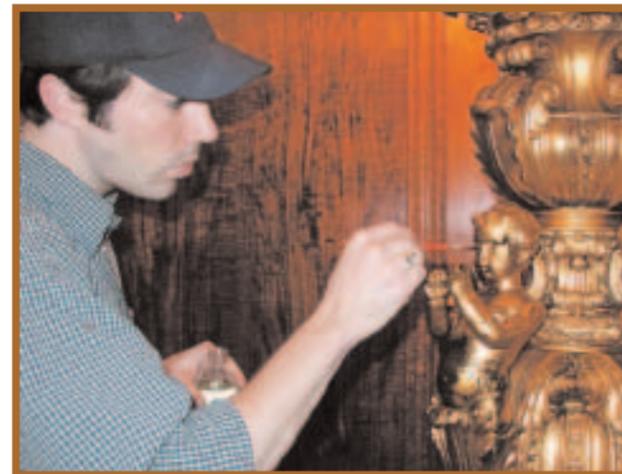
LIGHT STANDARD INPAINTING

plated light standards located in each corner of the room all contained areas where the original finish had been completely worn away, revealing the darkened base metal. Some of the more pronounced areas were the mouths, bellies, and hands of the cherubs, the acanthus leaf decoration, and the claw feet on the standards' bases.

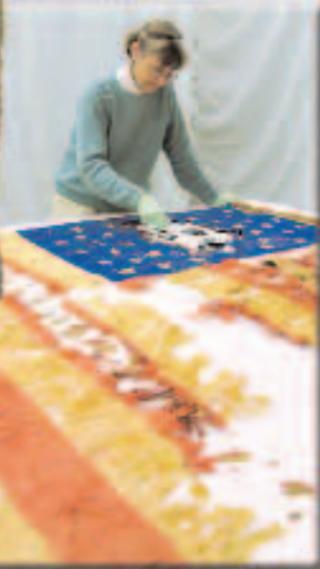
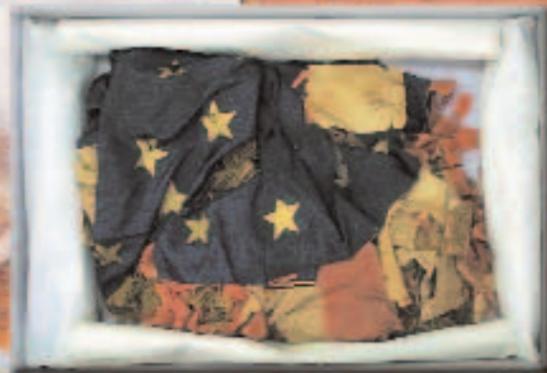
1ST PA RIFLES FLAG BEFORE CONSERVATION TREATMENT (LEFT); AFTER INITIAL CONSERVATION TREATMENT (ABOVE)

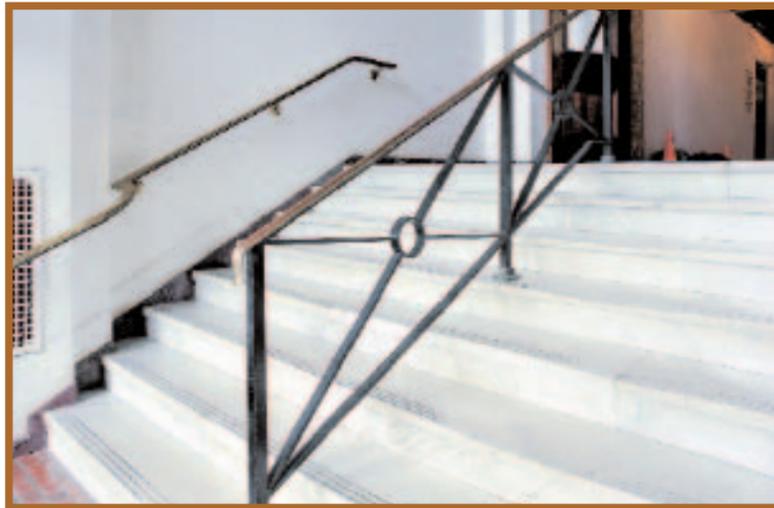
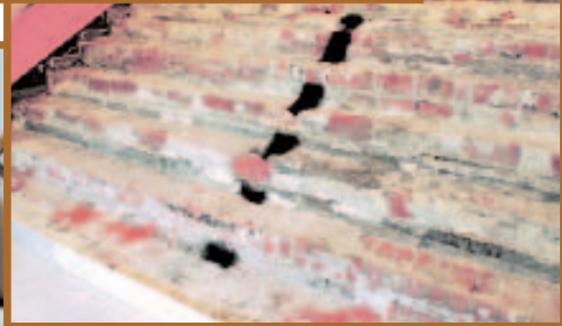
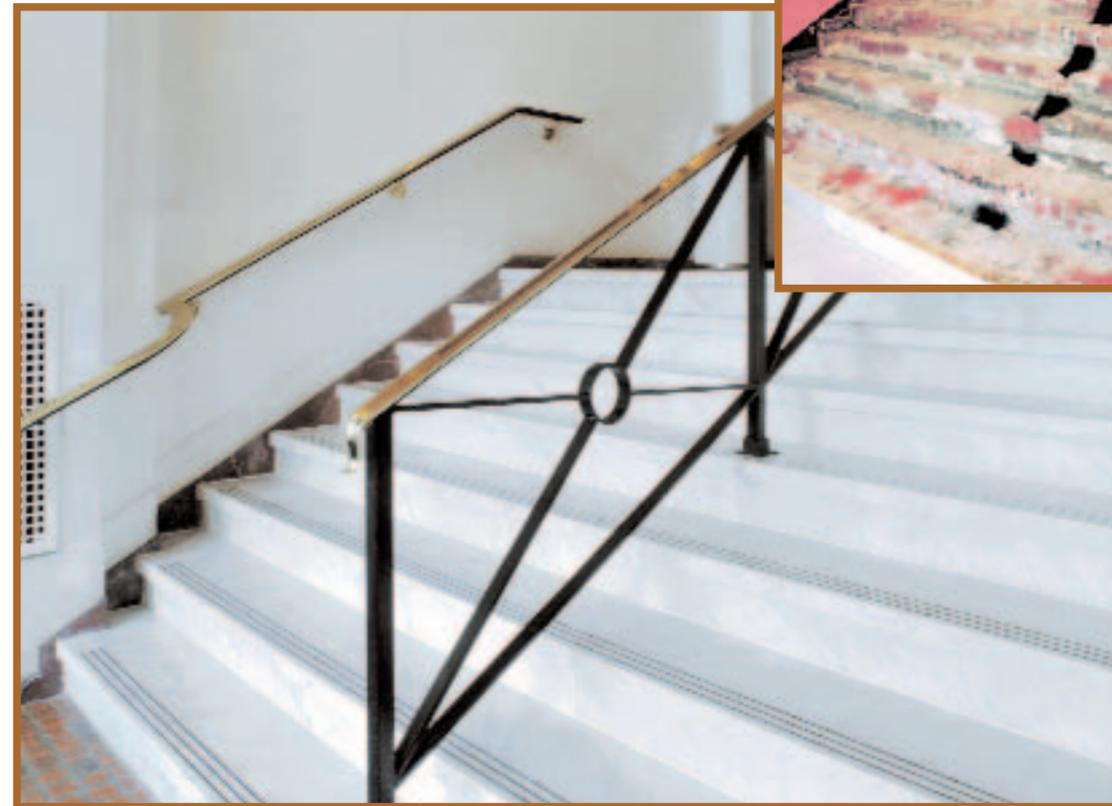
STEPS SHOWN BEFORE (TOP) DURING (MIDDLE) AND AFTER (BOTTOM) REPAIRS

Just before the end of summer 2003, the Committee undertook a project to replace the marble steps and risers located at the Capitol's south entrance. After many decades of use, the steps were considered a hazard by the state safety inspectors because of their uneven and "dished" treads. More than twenty years ago, a portion of the original steps had been replaced due to breakage and since then the steps' unevenness has only worsened.

White Carrara marble, which was used in 1906, was procured to match the original steps and wainscoting in the entry vestibule. The replacement of the steps occurred during the legislative summer recess and once the old steps were removed, new treads and risers were installed. Non-slip abrasive inserts were applied to the marble treads. Simultaneously, the brass handrails were removed for refinishing and the handrail carriages

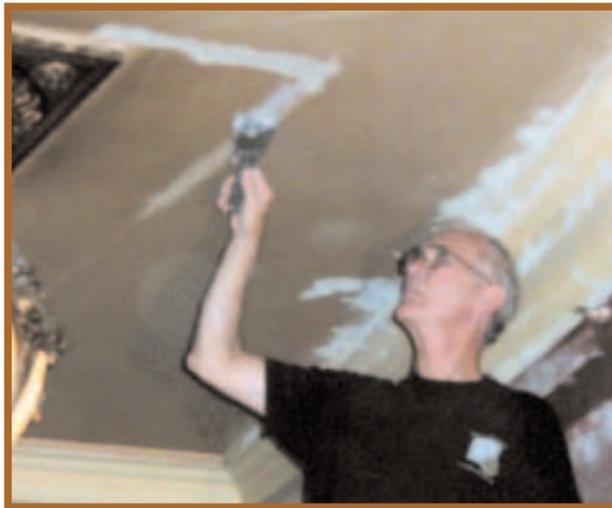
REPAIRING CEILING AND CORNICE

The conditions on the entresol floor center wing consisted of red painted walls with white marble wainscot, and an off-white ceiling that appeared to have no decoration. The cornices, capitals, and bases were painted white and gold and there were several large cracks in the ceiling near the central doorway leading to the rotunda.

Repairs were made to the cracked areas by in-filling chipped plaster with spackling compound and sealing small cracks with vinyl spackling as needed. In some cases the

cracks resided beneath the previously painted-over canvas and created a visible impression on the canvassed walls. Larger repair areas required the removal of the canvas from the walls followed by clearing away loose and unstable plaster. A bonding agent was applied to these surfaces in order to seal the old plaster and improve adhesion of the new plaster to the original plaster substrate.

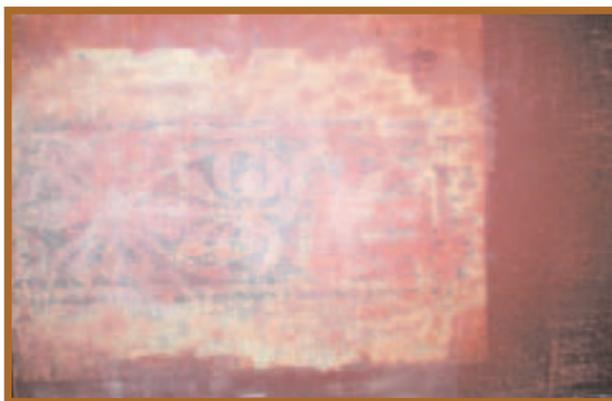
EXPOSURE WINDOW OF ORIGINAL STENCIL

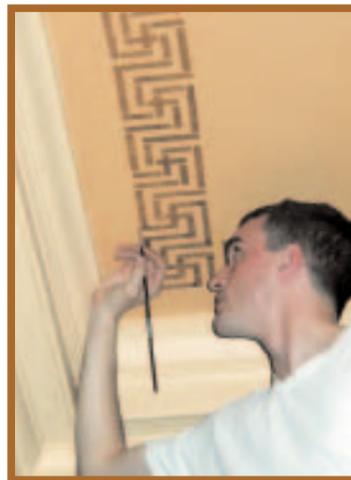
INPAINTING OF STENCIL GAPS

Extensive analytical investigation was conducted to uncover the original color schemes of the historic finishes. The first technique used was microscopic analysis of extracted paint samples along with chemical and/or physical de-stratification. In addition, over-paint was chemically removed in

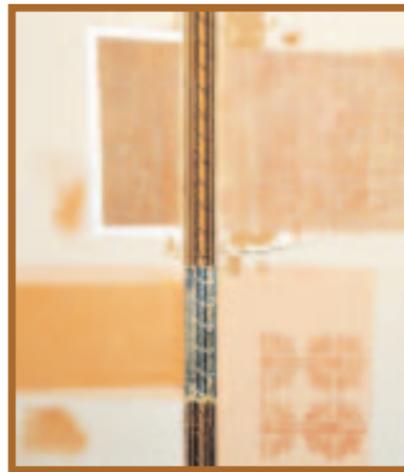
several “exposure windows” were created via chemical and/or physical de-stratification—a process that involves peeling away years of over-paint, layer by layer, from a target area to reveal the historic finish underneath. Once the data was gathered,

PAINT EXPOSURE WINDOWS

the conservator prepared a mockup panel showing the various finishes including base paints, glazes, gilding, and/or examples of stencil patterns. Documentation was also provided that details the application technique along with each progressive step needed to execute the finishes. This important process is essential in maintaining the integrity and continuity of the Capitol's historic finishes.

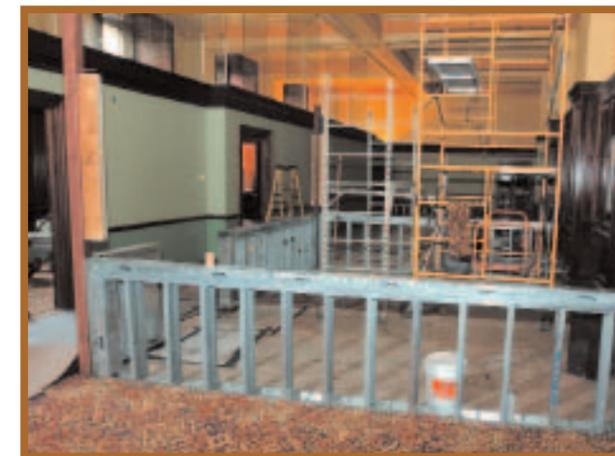
110 SUITE TELLER'S STATION DURING RESTORATION

At the entrance to the suite from the public corridor, the Treasury teller's station has been recreated on a smaller and less ornamented scale, now serving as a reception area. Using historic photographs and original blueprints, the historic preservation architect was able to design a modified version of the original plan. Next summer the Committee intends to restore the floor in the reception area to its original state. Four of the original Mercer mosaics that were recently discovered by the Committee in a storage tunnel will be returned to the floor. The remaining three-by-three quarry tiles for the floor are being manufactured by the Moravian Pottery & Tile Works in Doylestown, Pennsylvania.

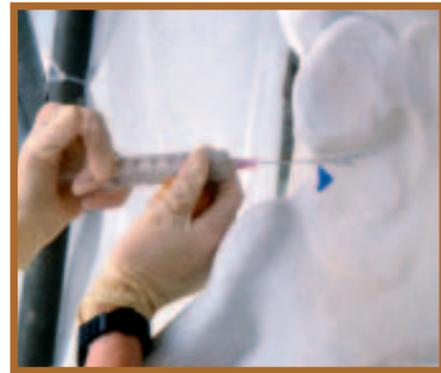
INJECTING DHL FILLS

The third year of conservation maintenance treatments for the statuary groups required a thorough inspection of all dispersed hydrated lime (DHL) fills, and mortar joints executed during the previous treatment years (2001 and 2002). The inspection was

made to determine the proficiency and quality of the joints and fills, and concluded that ninety per cent of the mortar joints and eighty per cent of the DHL fills had remained intact. The small percentage of failure can be traced to application, expansion, or stress conditions inherent in the statuary's construction and are considered within a normal range. All failed areas were documented and retreated during the course of this year's project.

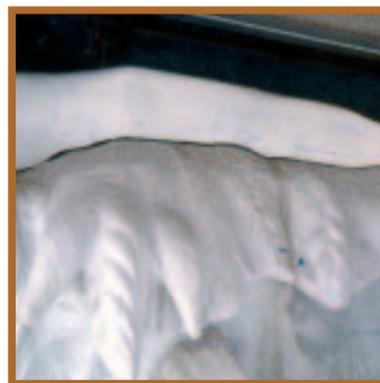
MID-TREATMENT: PERMANENT FIBERGLASS CAP INSTALLATION

A temporary soft mortar cap, which had been installed last year on top of the statuary's north group relief panel, was removed and replaced with a permanent fiberglass cap. The fiberglass cap was designed to include a ventilation system that adequately allows air to flow through the enclosed area without water

penetration. This will keep the interior section of the monument dry, helping to reduce harmful freeze/thaw effects upon the monument.

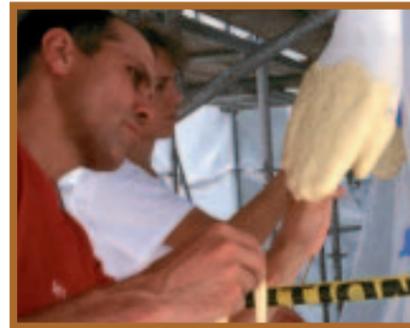
PREPARING SILICONE RUBBER MOLD

During the 2003 maintenance campaign, several silicone rubber molds were taken on the north statuary group so that in the future selected damaged carved elements could be replaced. The molds will later be used to produce plaster models for which new marble elements will be carved. The elements that were cast include previously damaged and repaired fingers, thumbs, hands, and in one case, an entire forearm.

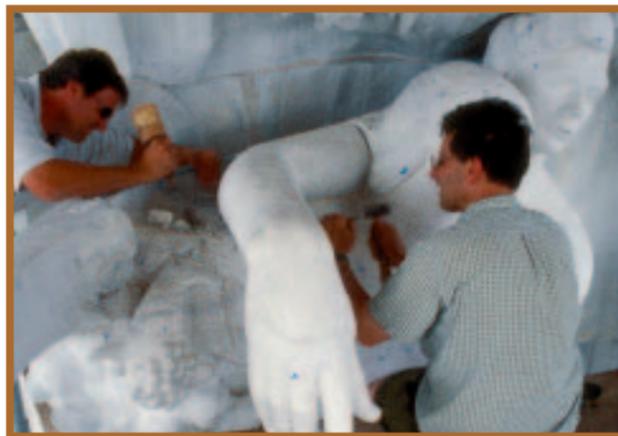
REMOVING UNSTABLE MATERIAL FROM LEFT ARM

panel of the north statuary group, which was discovered and temporarily repaired during the 2002 maintenance campaign. This process required the removal of the left arm from the male figure in this group. Once the unstable material was removed, the conservator discovered that the marble on which the large arm rested had substantially deteriorated, and that two large cracks had also formed in the marble block.

Structural engineers assessed the damage relating to the group's stability and devised a solution of cross pinning the weak section to a more solid area within the marble block using stainless steel anchors. This was accomplished by placing one anchor positioned to run at a forty-five-degree angle downward and perpendicular to the east building wall, extending the second anchor horizontally from a location below the arm at an acute angle to the same wall.

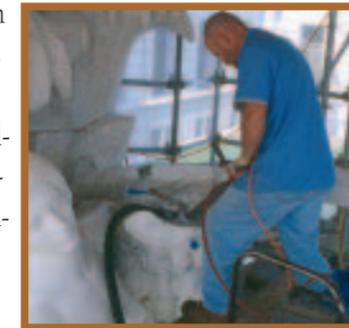
CORE DRILLING ANCHOR HOLES

Holes were core drilled to a depth of fifty inches to provide complete embedment of anchors, each of which were forty-eight inches in length. Extreme care was taken to assure that the holes were drilled according to the structural engineer's plans to avoid damaging the carvings. The procedure successfully joined the stone slabs back together, and once the pins were positioned, a new marble saddle was carved to replace the deteriorated section. Annual maintenance plays an important role in preserving the Barnard statuary for future generations.

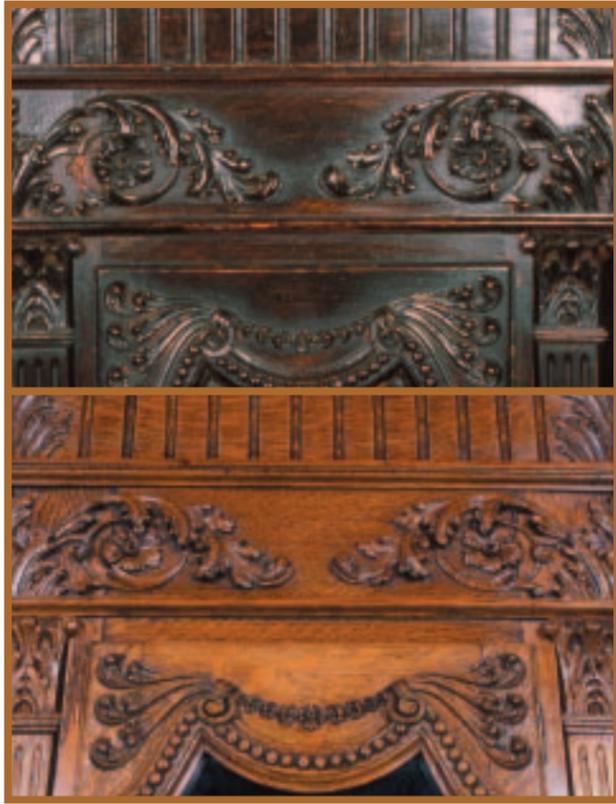
CLOSE-UP OF CLOCK BEFORE AND AFTER CONSERVATION TREATMENT

The clock’s conservation treatment included photographic documentation of its former condition followed by repairs to the broken glue joints, which had become loose over time. The elaborate carving, size, and poor condition of the oak case’s surface required the removal of the shellac over-finish, while preserving the original finish—an extremely meticulous and time-consuming process. The final color of the stain after cleaning matches the quartered oak finish on the wainscot of the reception room.

Restoration of the clock movement required complete dismantling, inspection, and cleaning of all components. Worn, missing, or non-original parts, such as taper pins, pivots, and suspension springs were replaced as necessary. All brass parts were cleaned, stripped of discolored and deteriorated lacquer, then polished and re-lacquered. The elaborate decorative steel hands were stripped of their black over-paint, then re-blued (a treatment used to prevent corrosion of the steel hands) and re-lacquered. The results from the clock restoration are remarkable and serve to enhance the beauty of the newly restored Governor’s Reception Room.

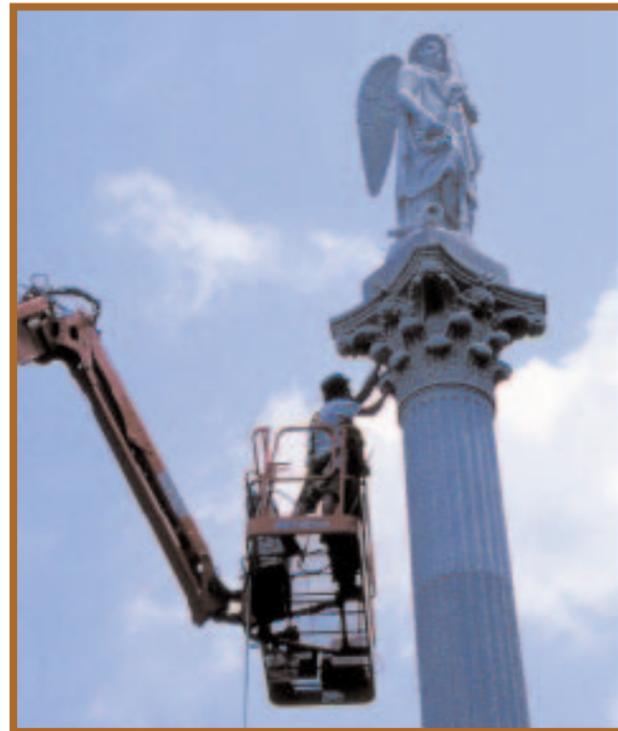
The second year conservation maintenance to the Mexican War Monument included an in-depth inspection of the entire monument using an aerial lift that rose up to one hundred thirty five feet. The purpose of the investigation was to assess the treatment that was performed during the initial work, which was executed during the summer of 2002.

The results of the investigation revealed that stone strengthener previously applied to the weathered marble surfaces showed strengthening properties to the stone. The pinning procedures executed on the capital of the

PERFORMING INSPECTION

monument are performing well with no visible adverse effects to the stone. In addition, all mortar joints are intact and show no signs of failure.

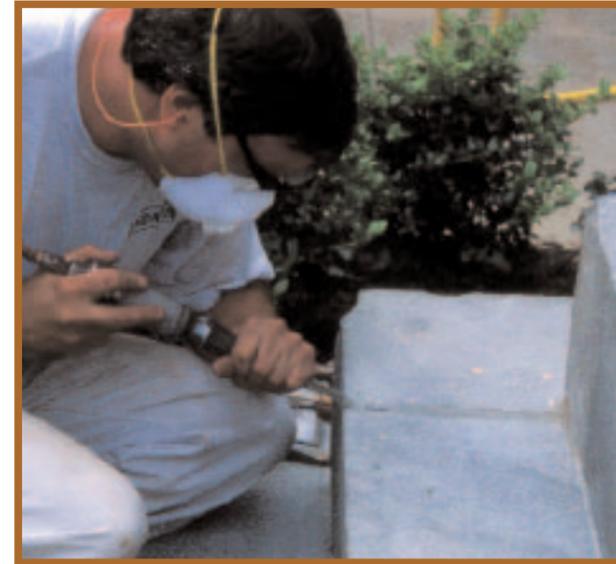
REPOINTING STEPS

During this year’s maintenance campaign, the granite steps were repointed and six stone dutchmen were added to several corners to prevent water from entering the monument at these jointed areas. During our inspection we also discovered that approximately five percent of the Dispersed Hydrated Lime (DHL) fills, which were applied to minute fractures throughout the monument, had failed. This failure, which typically occurs on flat surface areas hardest hit by continual rainfall, causes deterioration and were replaced by new lime injection procedures.

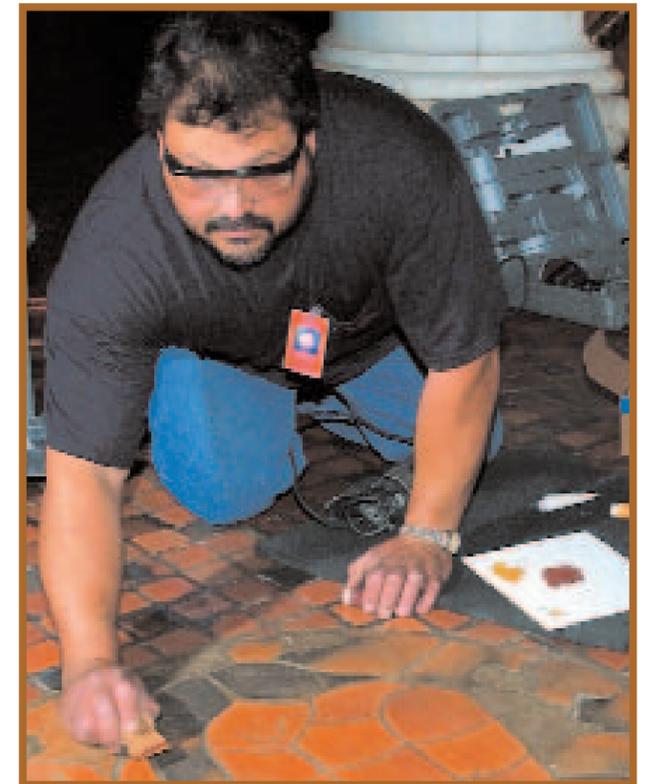
Repairs this year generally consisted of loose mortar joints, cracked tiles, and damage from direct impact. Mortar joint repairs consisted of raking the joint free of damaged mortar, thoroughly cleaning the area, and then re-grouting. Loose tile and fragments within the mosaics were carefully removed, repaired, and then placed back into the floor. Any tile loss that occurred within a decorative mosaic was repaired by filling the loss with an epoxy treatment, which required tinting the material in the field to match the color of the existing loss.

CONSERVATION REPAIR TO MOSAIC

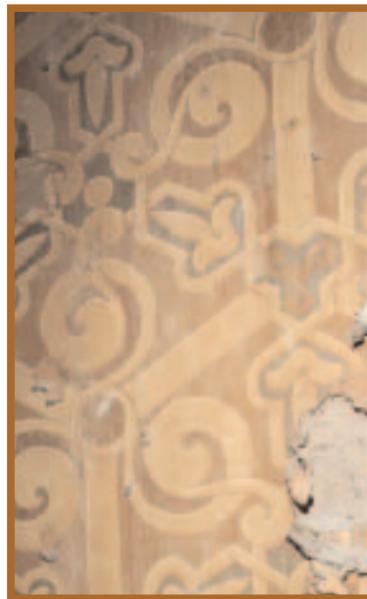
WALLPAPER FROM COBB CAPITOL

During the demolition phase for the 110 Suite restoration project, the Committee made several interesting discoveries. Located in the suite behind several wood pilasters and sections of paneled wainscoting were wallpaper remnants from the Cobb Capitol (1898-1902). When Architect Joseph Huston designed the present Capitol, he incorporated the Cobb

Capitol into the building's construction. This original decoration of the Cobb Capitol has been encased in the current Huston Capitol for nearly 100 years untouched. These remnants were photographed for documentation purposes, but otherwise were left undisturbed, thus preserving them as part of the Capitol's history.
