PENNSYLVANIA CAPITOL PRESERVATION COMMITTEE

2018 Annual Report
Preserving a Palace of Art

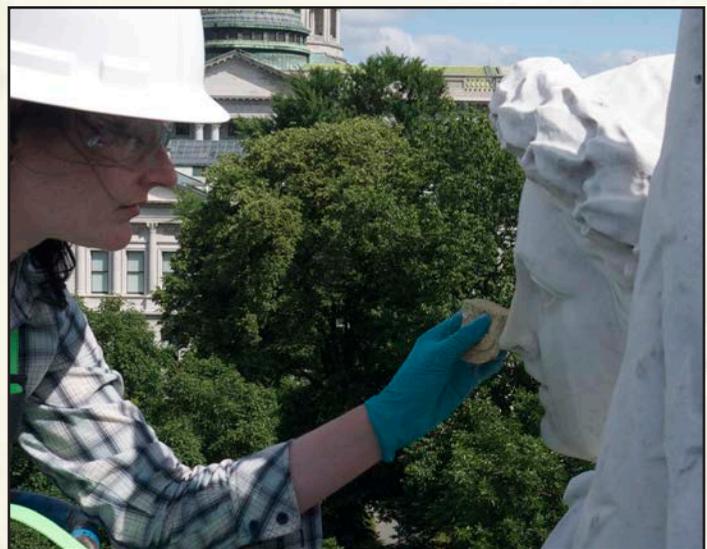
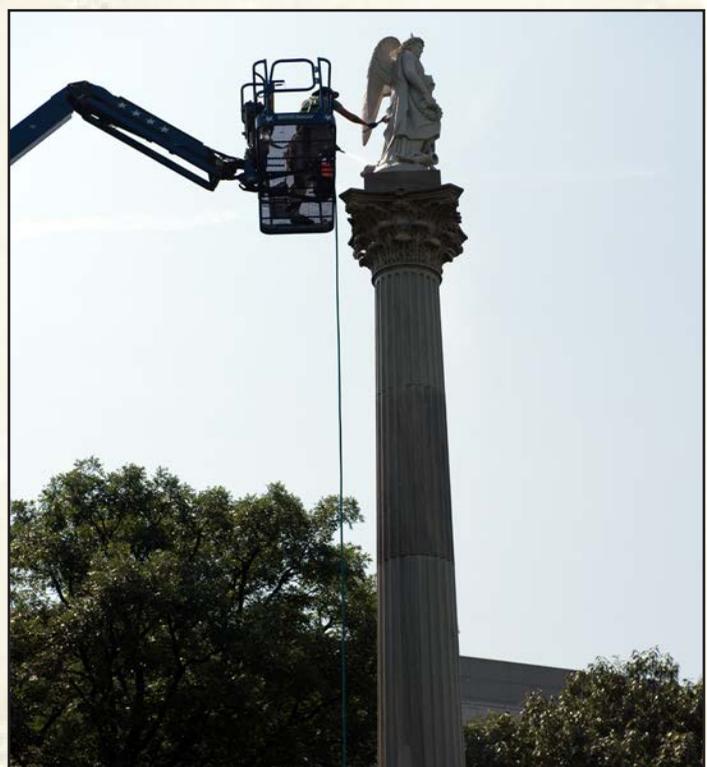
Initial examination of the Mexican War monument showed only slight loss to material which was loosened by freeze/thaw cycles. Areas which had washed out were filled with new grout which was injected into the cracks. Overfill of the Jahn mortar (for cracks larger than 1/8" in width) was immediately sponged from the surface.

For micro cracks and fissures less than 1/8" in width a DHL (dispersed hydrated lime) putty was introduced and left slightly proud from the surface. Both the Jahn and DHL mixtures were tinted to match the color of the existing monument. Overall, many of the previous campaigns of introducing fill remained intact, indicating that the Committee's conservation program has been successful in protecting the monument. Most of 2018's treatment was conducted at the capital, cavetto, and inscription areas of the statue.

Additional areas of treatment removed soiling and biological growth using a D/2 Biological Solution. The shelter coat from 2016 was largely intact and required only re-application on the eagles' wingtips. Areas of mortar loss and spalling were addressed in a fashion similar to the process for filling of the cracks and fissures, as well as surface deterioration on the acanthus leaves. Other

areas of the monument such as Dutchman repairs, eagles, anchors, and weather caps showed no appreciable deterioration in 2018. Lastly, the stepped granite base of the monument was washed with a Triton-X-100 detergent and rinsed, as well as the U.S. Coastal Survey Monument located at the base of the monument. The cyclical treatment of the Capitol's exterior monuments ensures that they are preserved and prevents future expensive campaigns of restoration.

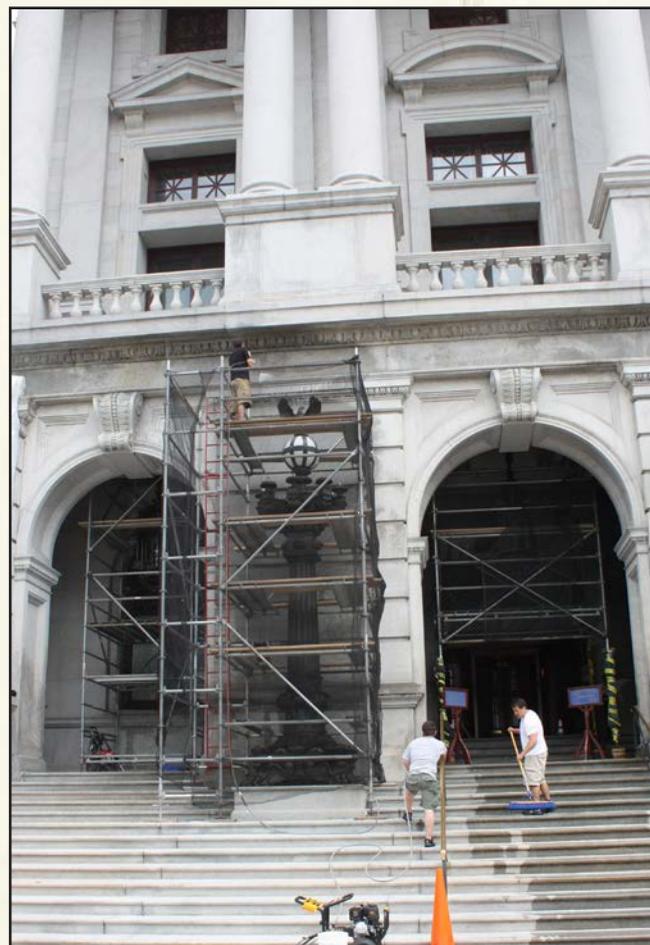
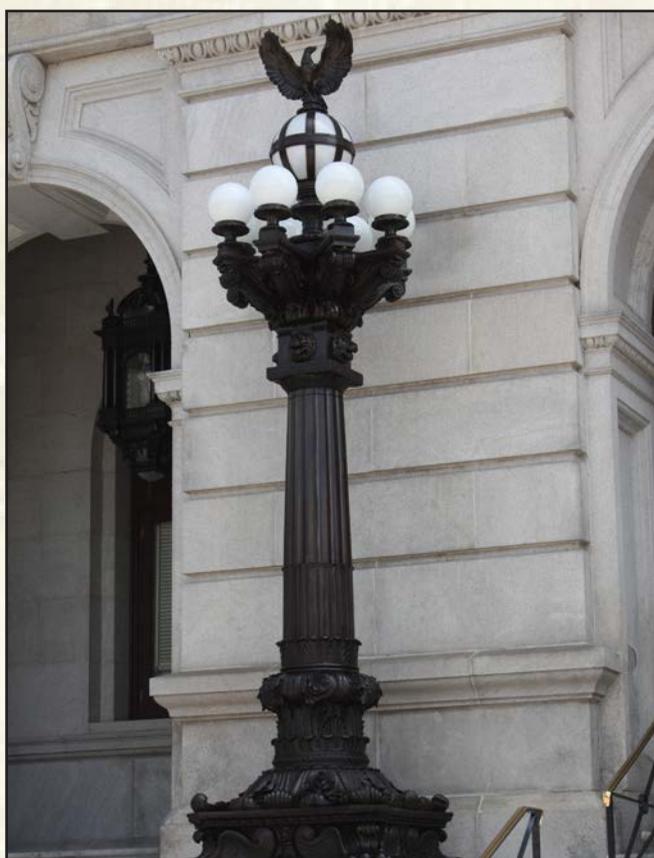
In 2017 the Committee completed year three of the Bronze Conservation of Exterior Fixtures and Doors. This project serves to mitigate the effects of harmful weathering, salts, freeze/thaw cycle and biological growth. All bronze surfaces including lanterns and torchieres, north, south and center bronze doors and assemblies, north and south Security gates as well as fixed pedestal signs were addressed.

The bronze was first cleaned, brushed, and vacuumed, then wiped with cotton knit microfiber cloths using a light detergent and filtered tap water. The doors were then rinsed and dried. After cleaning, bowling alley wax was reapplied using a hot wax method to allow the wax to reflow on the bronze. Once dry and hardened, the bronze was hand-buffed.

Restoration of the fixtures and torchieres entailed removal of the glass from each fixture, after which vacuuming, washing, re-waxing and buffing was undertaken. Once complete, the clean glass was reinstalled. Additionally, the revolving entry doors at the Capitol's Main/Center entrance were cleaned, and vacuumed and the woodwork retouched and polished. Each door threshold received two applications of naval jelly to help prevent oxidation. This five-year project ensures that the Capitol's exterior bronze fixtures remain preserved and in good working order for years to come.

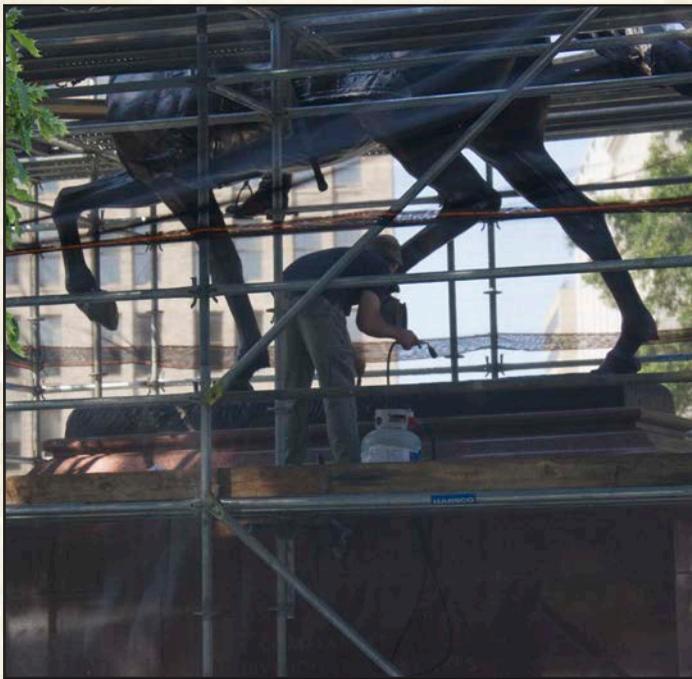
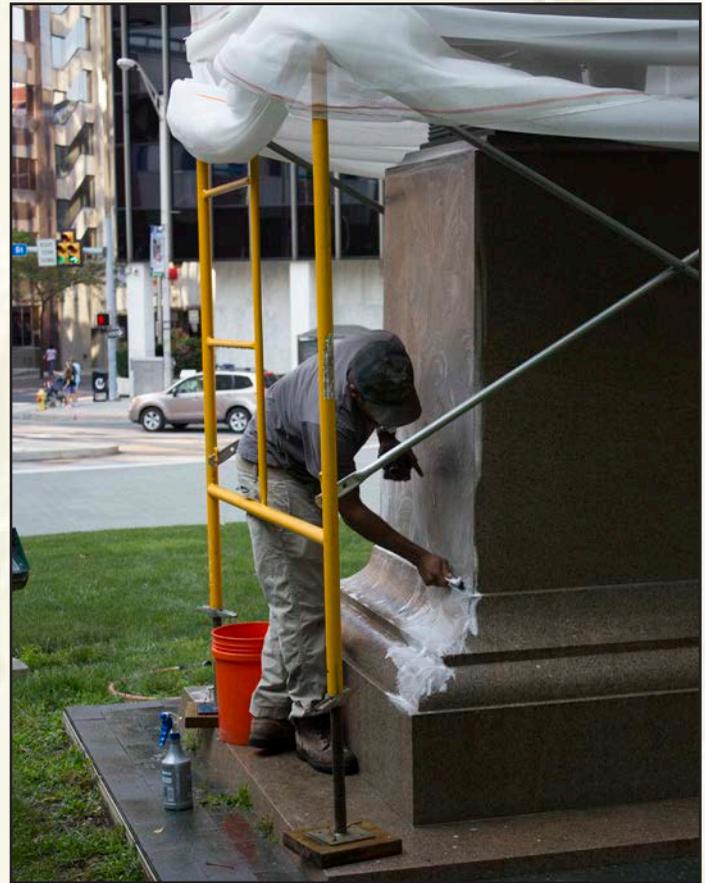
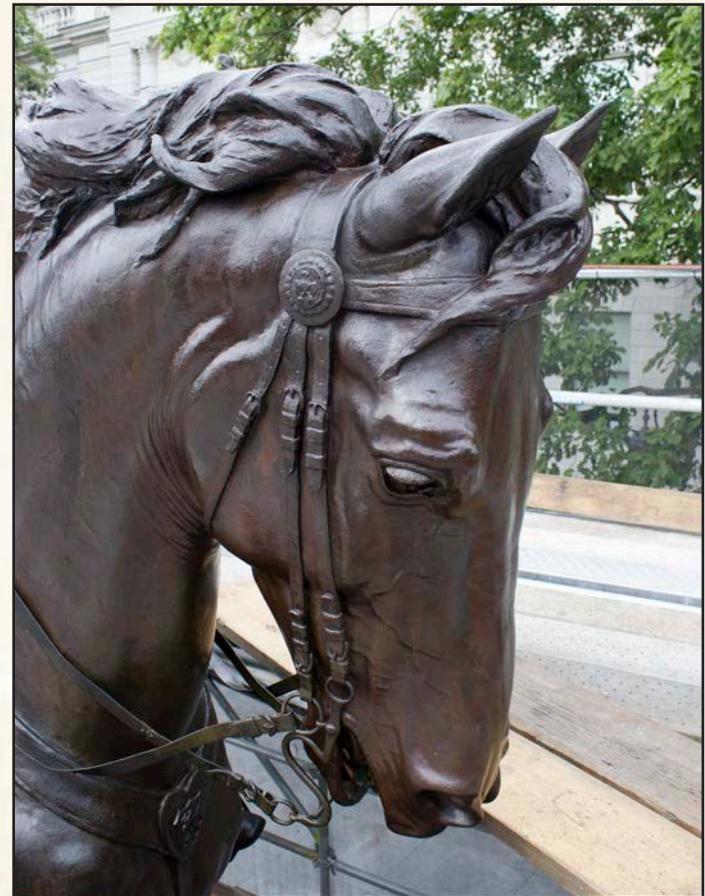
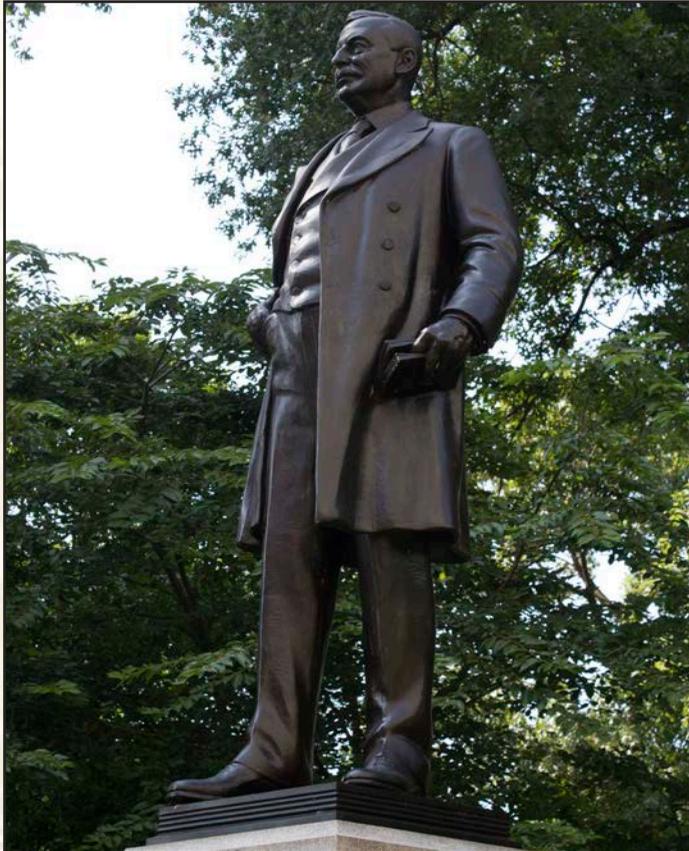
The year 2017 marked year three of the five-year project of conservation maintenance of the John F. Hartranft and Boies Penrose bronze statues in Capitol Park. The Hartranft statue was first photographed and then cleaned using brushes and vacuums. Next, wet cleaning of the metal was undertaken with filtered water and detergent, followed by a complete rinsing. The surface was then dried using cotton cloths and swabs.

The protective wax coating, which had been previously applied, was heated and reformed using torches. Small amounts of microcrystalline wax were blended into the existing wax as needed to achieve a balance of color and hardness. After application, the wax was buffed using cotton cloths.

Biological growth in the mortar joints of the granite base of the monument was removed using a stiff plastic brush. The base was then rinsed with plain filtered water and, once dry, a biocide was applied to slow future plant growth.

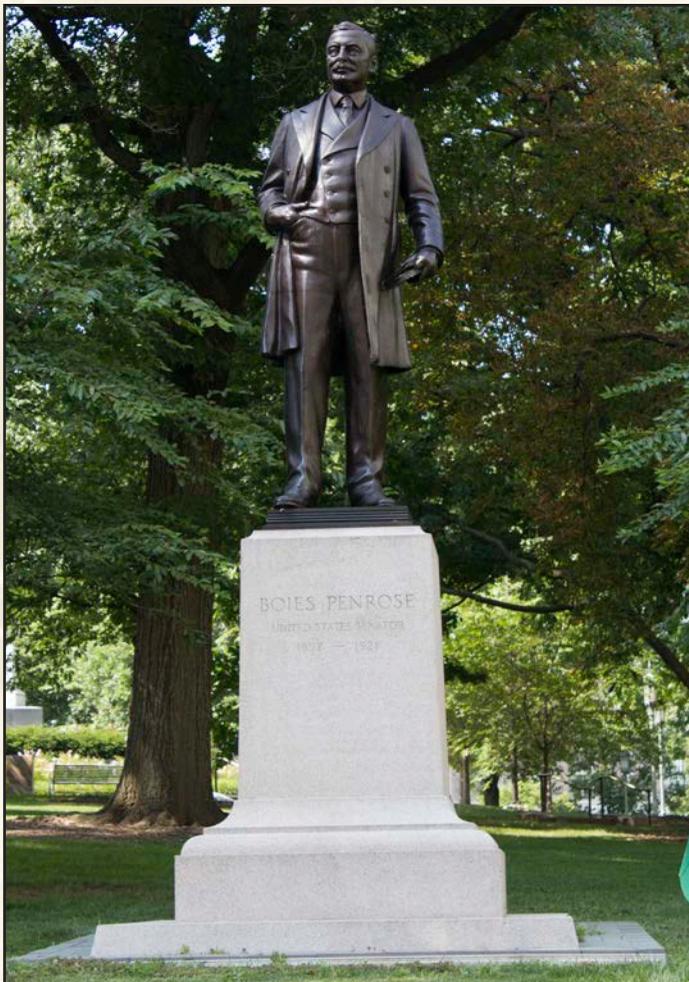
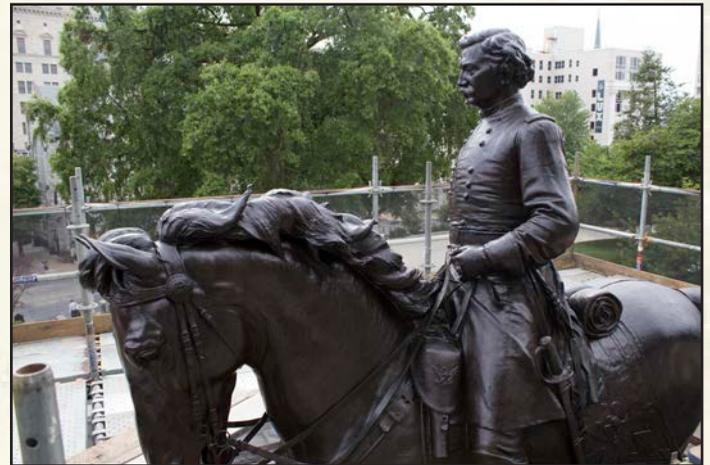
Although in good overall condition, the Penrose monument seems to attract a larger array of insect and arachnid nests. This statue, like the Hartranft, was first photographed and dry cleaned. It was then scrubbed with filtered water and mild detergent and the protective wax again heated to allow it to reflow on the bronze.

The wax was buffed with cotton cloths, and the granite base was cleaned and a biocide applied. Some loss of the patina is evident on both the Hartranft and Penrose monuments and future projects may need to address the loss of this protective coating before elements of the bronze are damaged by environmental conditions. In the short term, the cyclical application of the sacrificial wax coating achieves the same result.

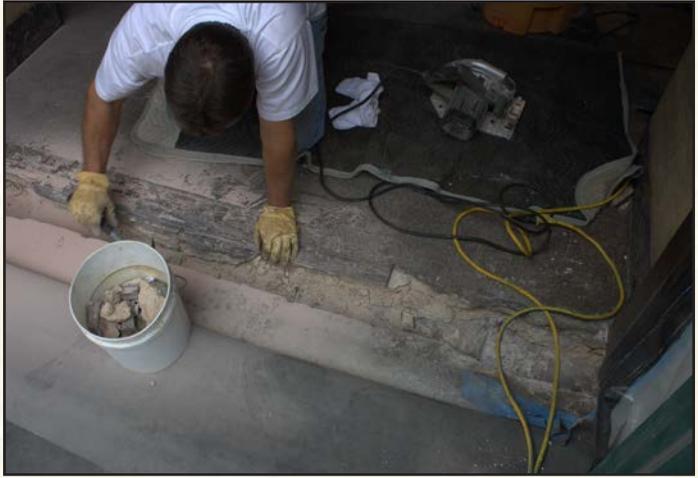
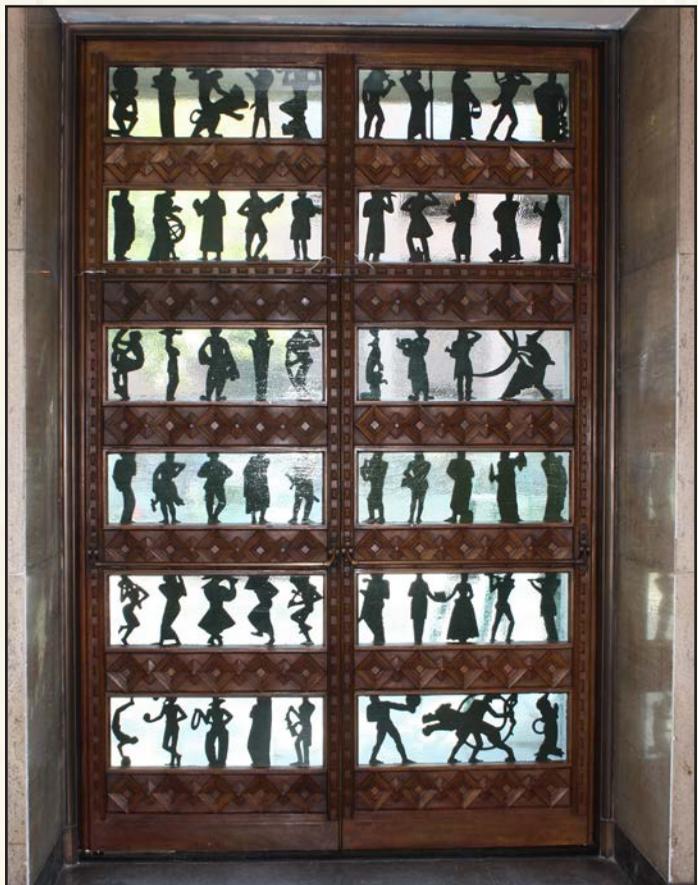
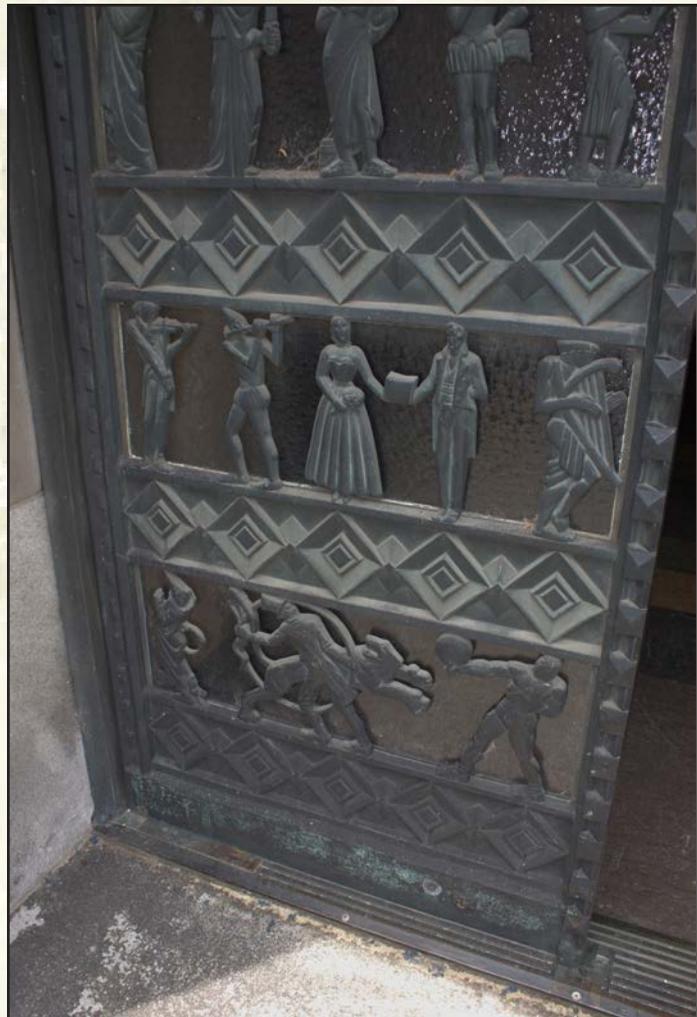
Each set of doors scheduled for maintenance was first dry cleaned and then wet cleaned and rinsed. After drying, each door was heated with a brush torch to allow the wax to reflow. Any areas of wax loss were reapplied. It was noted that the doors and thresholds seem to be suffering greatly from the application of salt during the winter, as well as blown dirt and debris accumulating on both the glass and bronze.

Normal, yearly accumulations of dirt and debris were examined as well as wear on handle areas on the most used doorways. Yearly maintenance of the Lawrie Doors ensures that the Forum Auditorium remains in top operating shape for years to come.

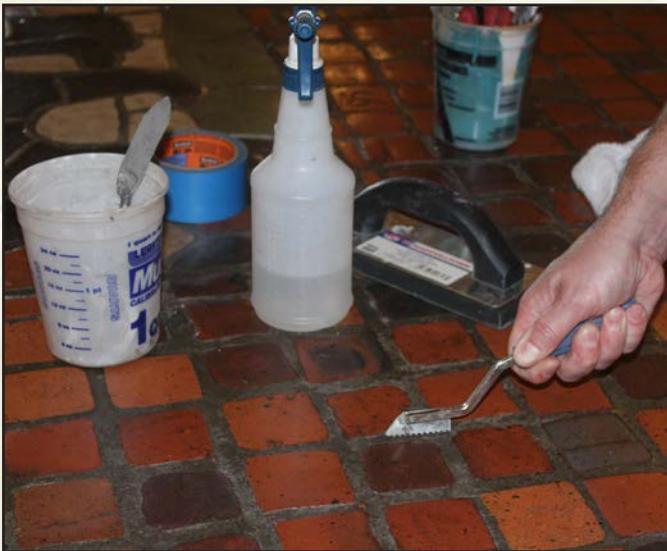
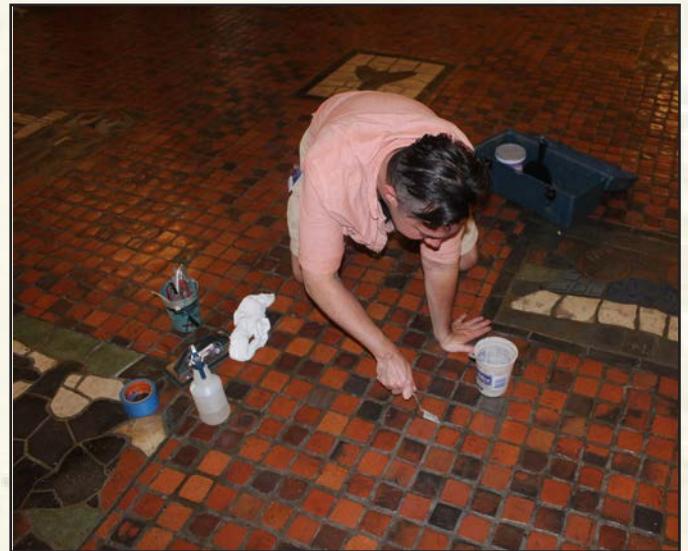
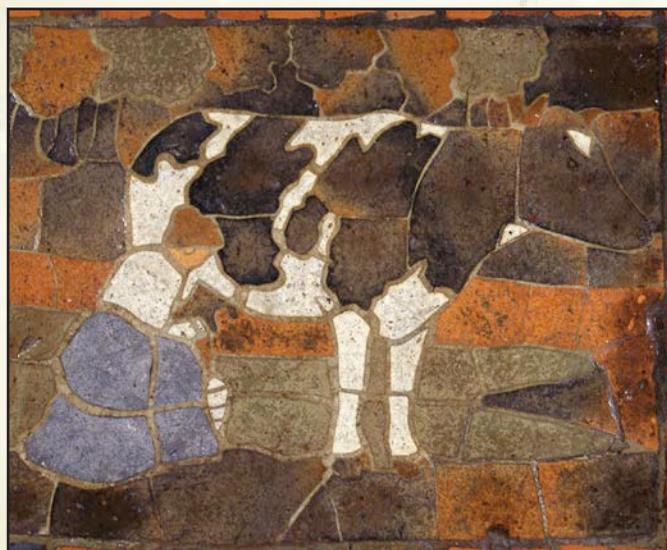
The Committee began year three of this five-year project in 2017, with continued maintenance on the Moravian tiled floor. This cyclical, specialized preservation schedule ensures there is no buildup of harmful dirt, salt, and debris on the tile and grout joints. The west entrances of the Capitol are given special attention over the winter months in an effort to reduce the adverse effects of the de-icing salt which is tracked in from the outside. The tile maintenance program also includes the marble floor outside the Lieutenant Governor's office on the second floor of the Rotunda. During bi-weekly cleanings, any new repair items are identified and addressed immediately. A survey of repairs is typically completed in the summer while the legislature is in recess. These repairs include re-grouting loose or missing joints, repairing pitted or cracked tiles, and application of protective coatings.

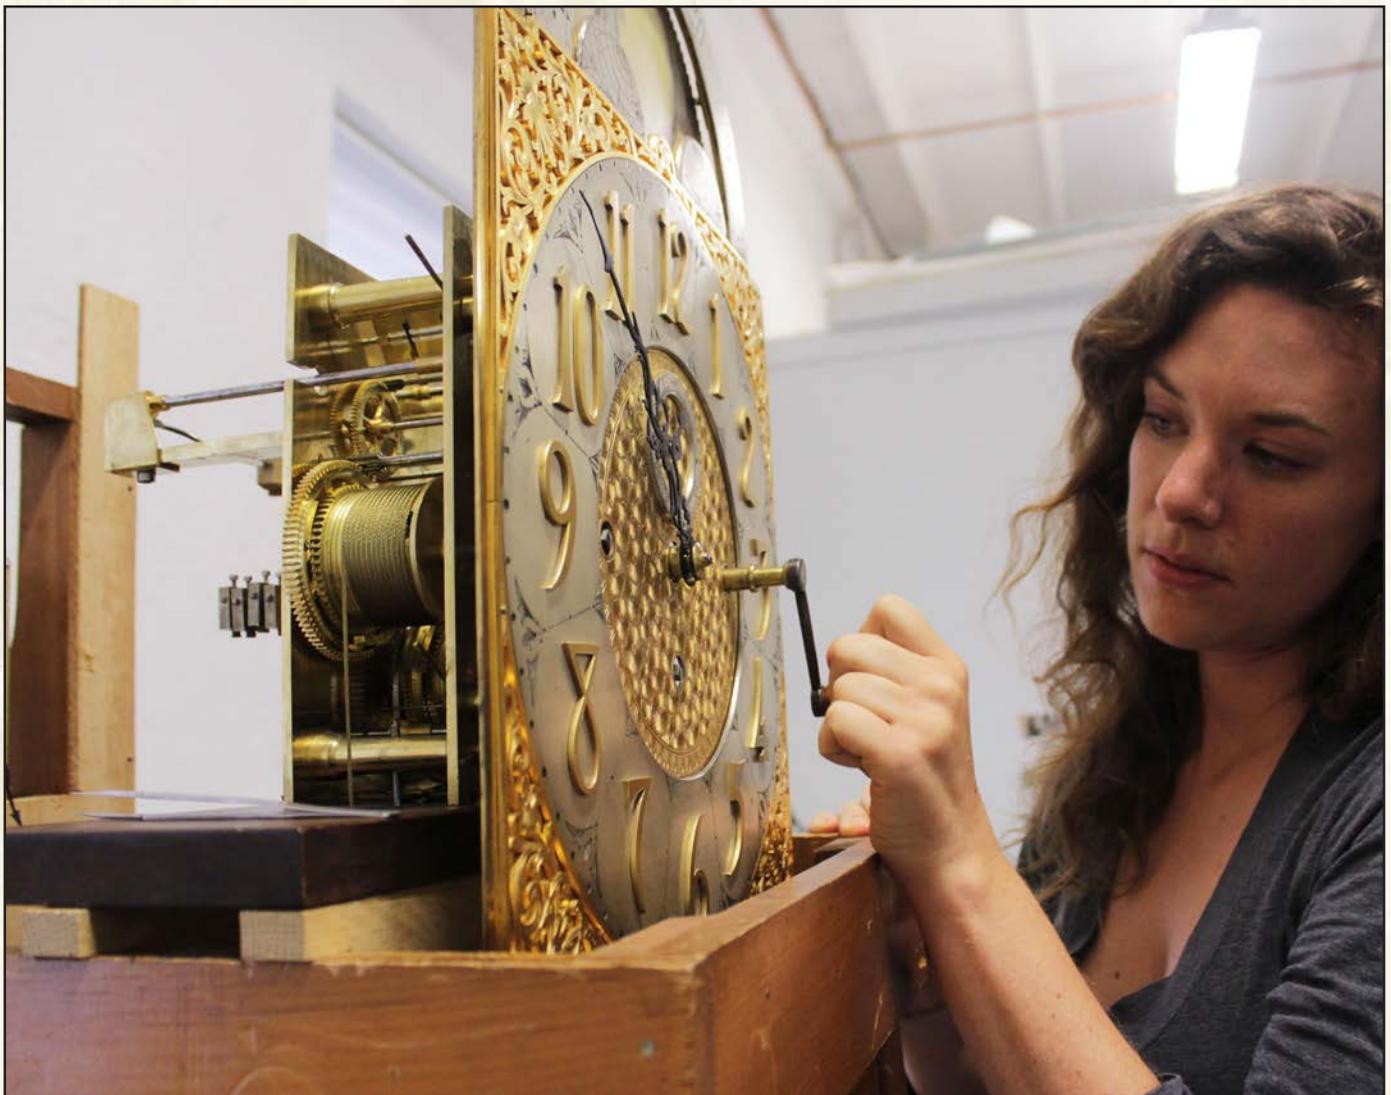
The Capitol Preservation Committee is responsible for the regular maintenance of more than 270 original Capitol clocks located throughout the Capitol and associated Complex buildings. The clock project began in 1993 with the objective to restore and maintain the clocks' wood finishes and inner mechanisms. In addition, the Committee wanted to collect and maintain historic documentation along with an inventory of each clock. By developing an electronic database, detailed information was compiled, including clock descriptions, construction materials, conditions, location, and an ongoing maintenance history. Following their restoration, each clock was put on a cyclical maintenance program. The Committee's clock conservator cleans the clocks and then they are placed on a yearly maintenance schedule wherein they are either oiled or cleaned cyclically every five years. While the majority of Capitol clocks have now been restored, ongoing preservation maintenance remains key to ensuring that they continue to operate and keep the correct time for years to come.

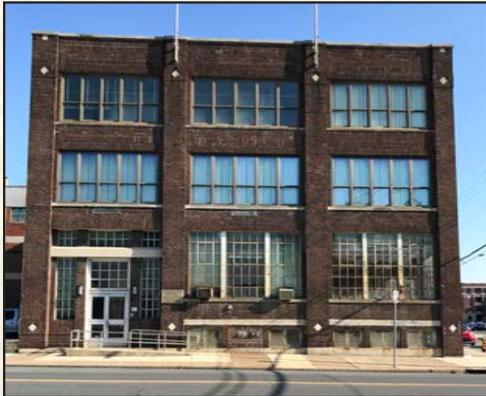
EXISTING FACILITY

The Committee is planning and designing a new facility in which to house historic Capitol artifacts, chandeliers, furniture, and other attic stock, as well as historically-significant items necessary to the Committee's restoration projects.
