# Pennsylvania Capitol Preservation Committee

2021 Annual Report

## Preserving a Palace of Art

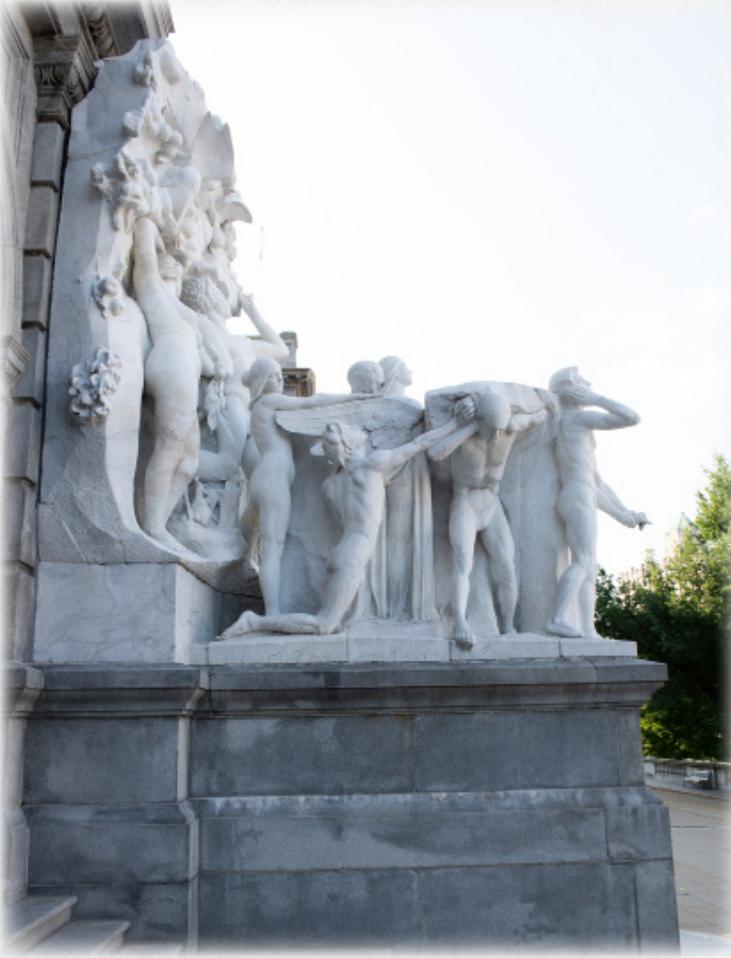
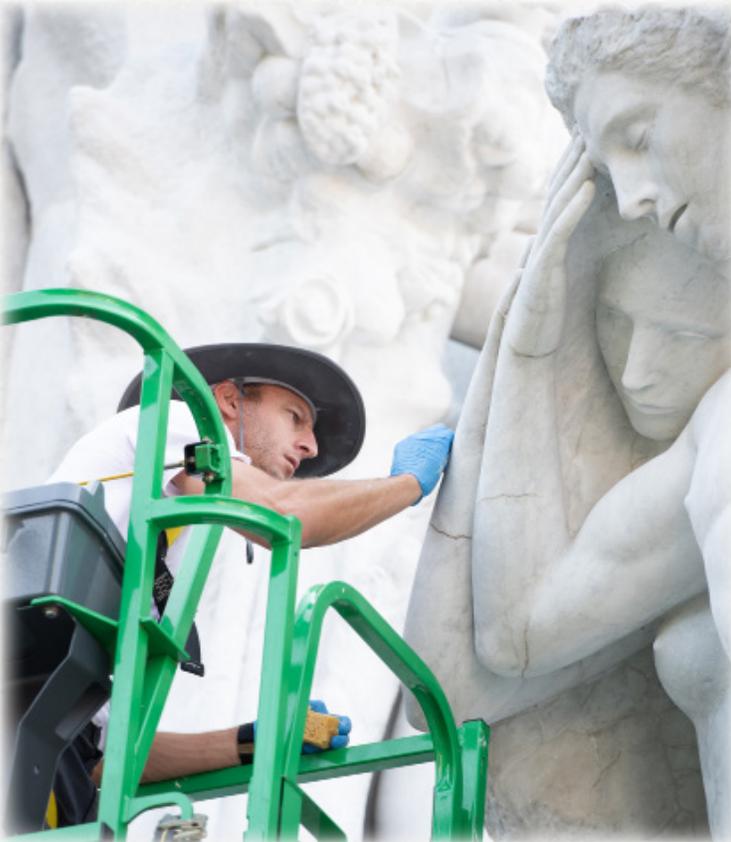
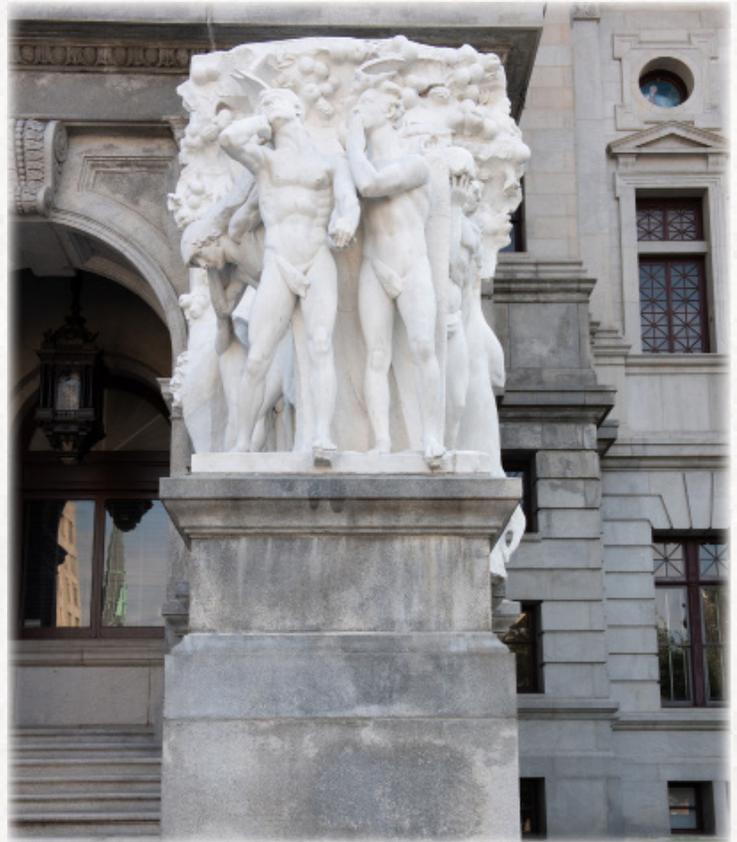
During July and August of 2021 the Committee completed biennial conservation of the Barnard statuary groups. The ornate Barnard statues, designed and installed in 1911 by George Grey Barnard and sculpted by the famed Piccirilli Brothers, were initially conserved in the early 1990s. However, due to Pennsylvania's harsh winters, the Barnard's need bi-yearly attention to keep them from cracking and spalling and preventing another costly restoration.

Conservators first document and photograph the existing conditions of the statues. Then working off man-lifts, (versus scaffolding, which was previously used), conservators wash and brush the statues with a Triton X-100 detergent with D/2 additive to remove any dirt or biological growth. After being allowed to dry, any micro-fissures are filled with dispersed hydrated lime (DHL). Areas of loss or damage to the mortar or shelter coat are repaired, and when needed reapplied. Areas of calcium accretions were also removed.

In certain areas where the marble was friable, a consolidant was applied to protect it, as well as a polyurethane sealant at the pediment base of the statues where the marble and granite meet. After treatment, the statues were again rinsed and allowed to dry. Cyclical treatment of the Barnard groups ensures that these invaluable architectural masterpieces are preserved for future generations.

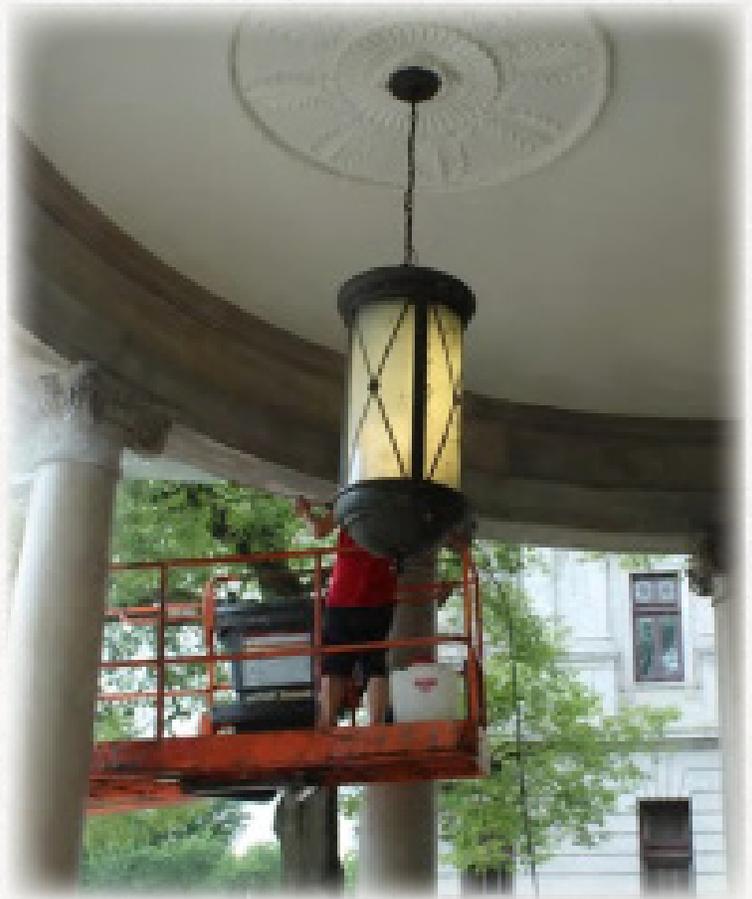
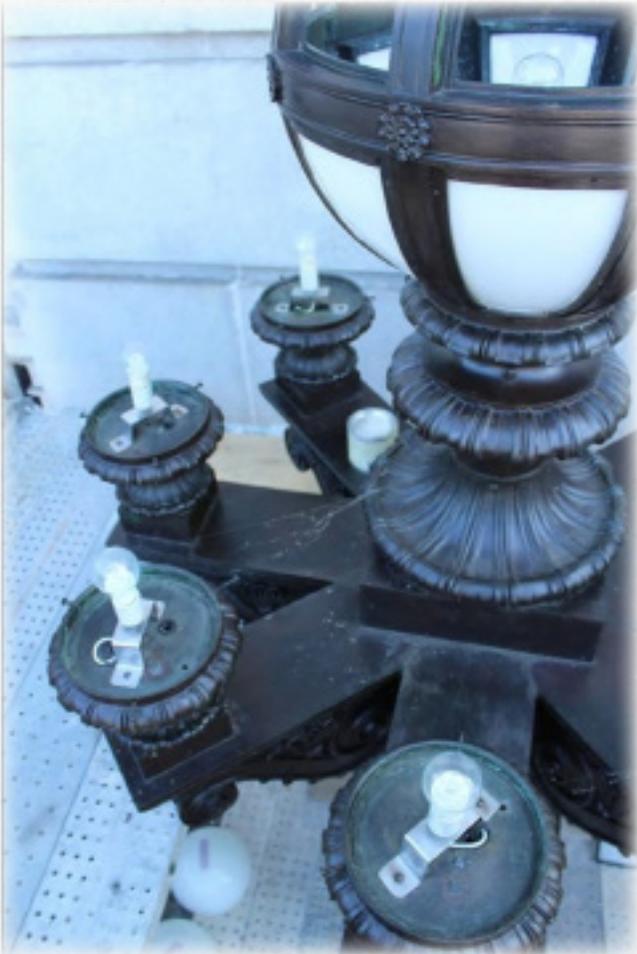
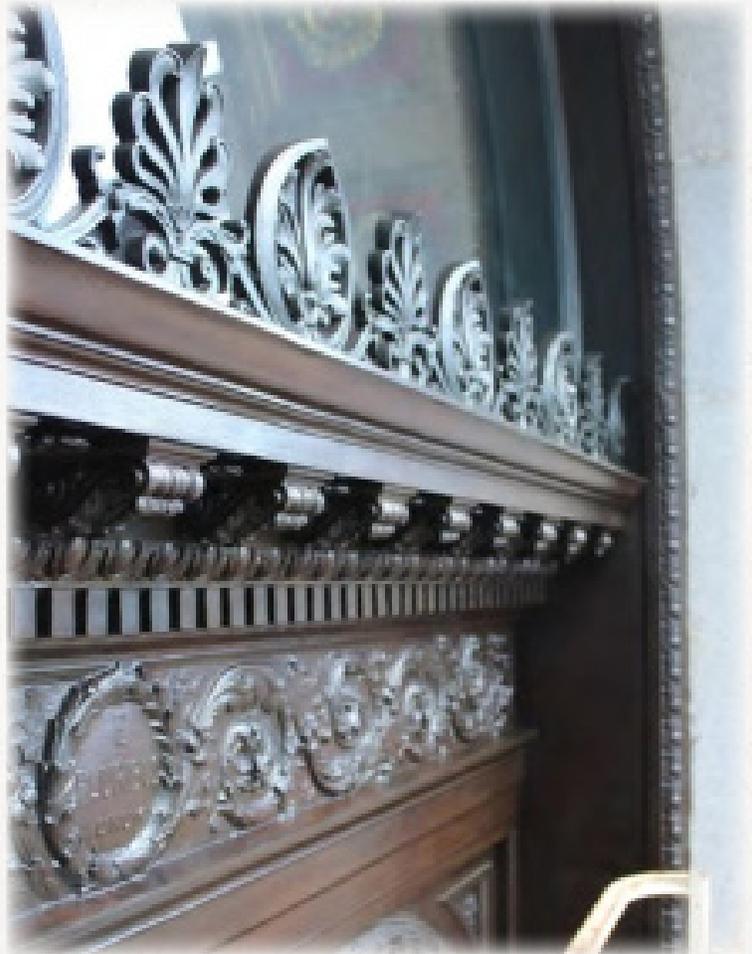
**DOORS:** Each bronze door is first dry cleaned and vacuumed and all debris, including biological growth, spider webs and bugs, is removed. The surfaces are then cleaned with a .02% solution of nonionic cleaning solution and filtered water to remove any accumulated soiling. Once rinsed and allowed to dry, the doors are waxed using a clear paste wax and a hot waxing method. The doors are heated to drive off any moisture as well as to allow the wax to flow evenly over the surface of the door. The heated wax is brushed out to remove any streaks and allowed to cool and dry before each door is hand buffed.

**CHANDELIERS & TORCHIERES:** Prior to the conservation of the bronze chandeliers, the glass components of each fixture are removed and stored during the process. The glass is cleaned separately from the fixtures prior to being reinstalled. The conservation methods for the chandeliers and torchieres, as well as the other ancillary bronze fixtures, mirrors the methods employed in conservation of the bronze doors. Once the cleaning and waxing is complete, the bulbs, lenses and glass are cleaned and reinstalled. Cyclical maintenance of the Capitol's bronze doors and fixtures removes all the salts, bugs, and biological growth that accumulate on the bronze over the course of a year and prevent future costly campaigns of restoration from deferred maintenance.

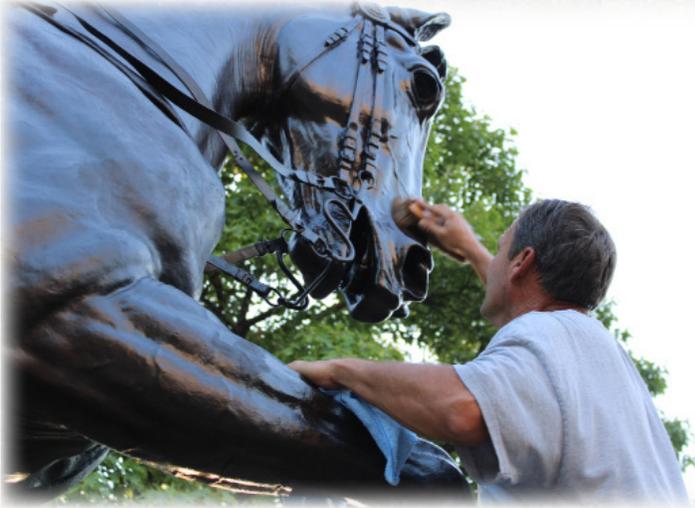
## HARTRANFT STATUE

Initial examination of the Hartranft statue in the summer of 2021 showed it to be in good condition and no areas of verdigris (detrimental oxidation) were found. The statue was initially rinsed with a pressure washer at 150 psi, using filtered water. The sculpture is washed with an Orvus solution of 2 cups Orvus to 4 gallons of water. This foamy solution is then brushed over the statue to remove webs, insects, and grime without high pressure spraying. The granite pedestal was also cleaned in the same manner. After scrubbing, the statue is then rinsed and wiped down with terry cloth towels. After cleaning, a custom wax mixture is applied to all areas and heated with a torch to allow it to flow over the statue. After the wax cools, buffing brushes and microfiber cloths are used to hand buff the statue to a high gloss.

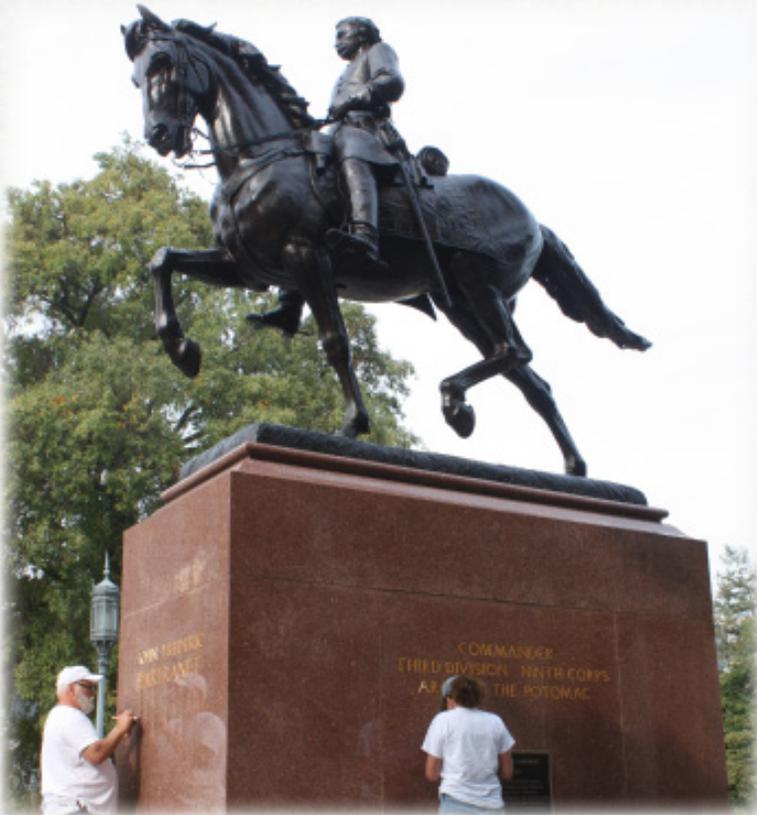
## PENROSE STATUE

The Boies Penrose statue also appeared to be in good condition upon examination. The Penrose statue was cleaned with an Orvus solution as well and hand washed and brushed to remove any yearly accumulation of bugs and biological growth. A concern with the statue is a small Dutchman installed after casting and observed in the early 2000s. The Dutchman is not changing, but the heated torch-flowed wax was not applied in this area to alleviate any thermal stress on the Dutchman. After cleaning the wax is again torch heated and re-flowed wherever needed. The statue is allowed to cool and then the wax is hand-buffed using brushes and microfiber towels.

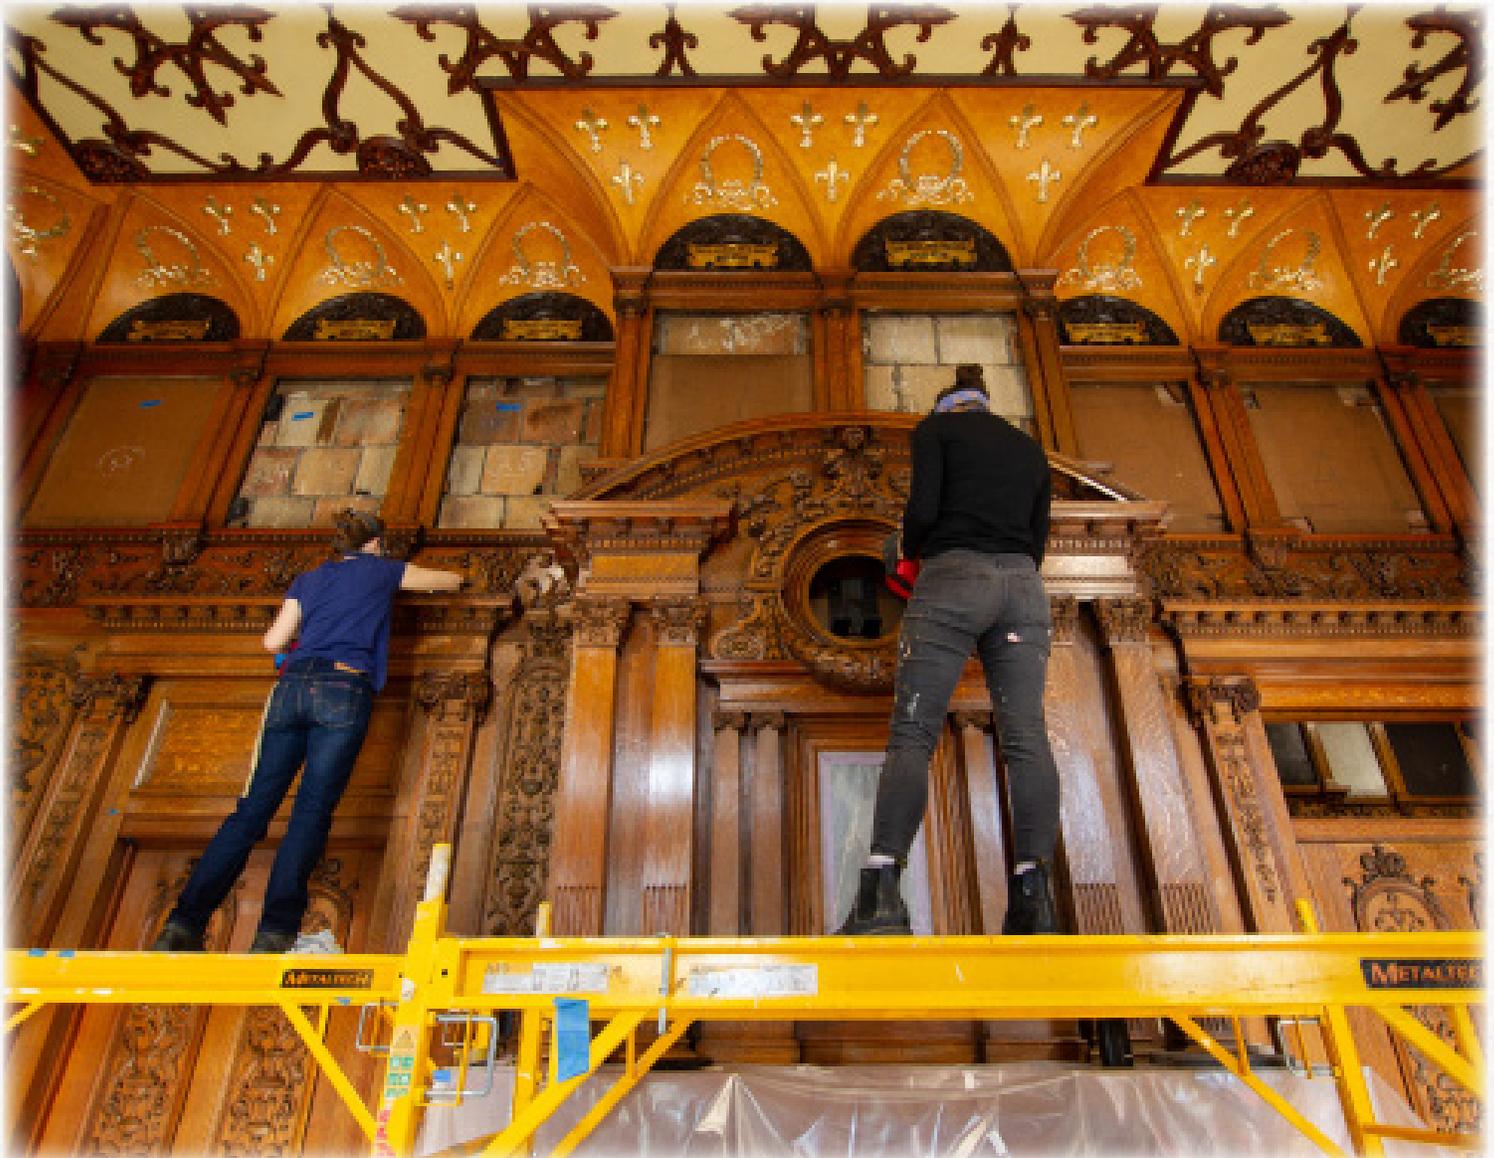
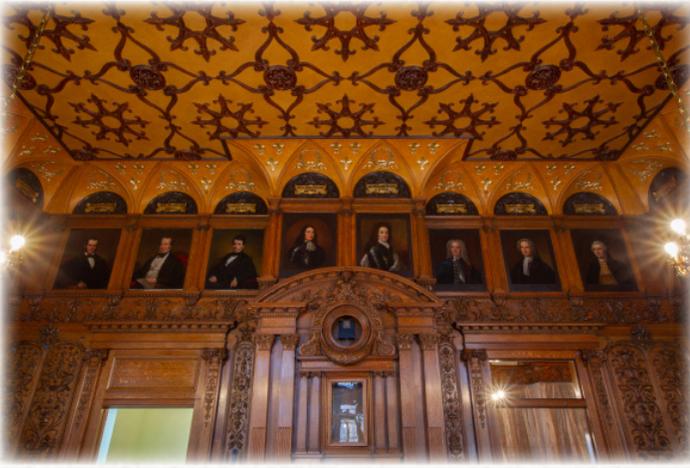
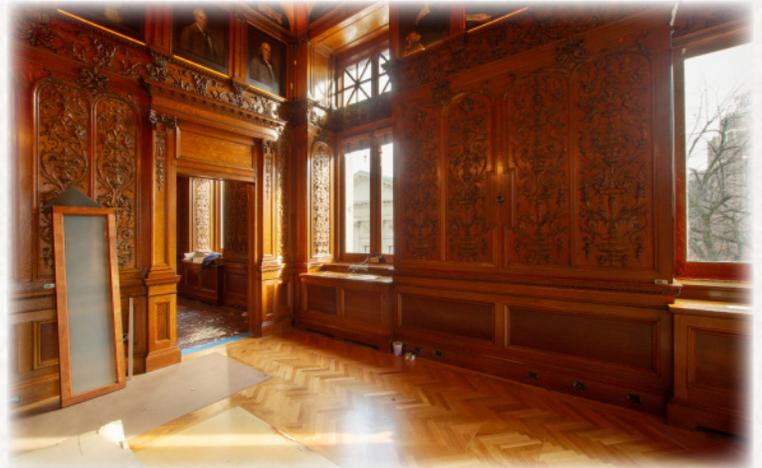
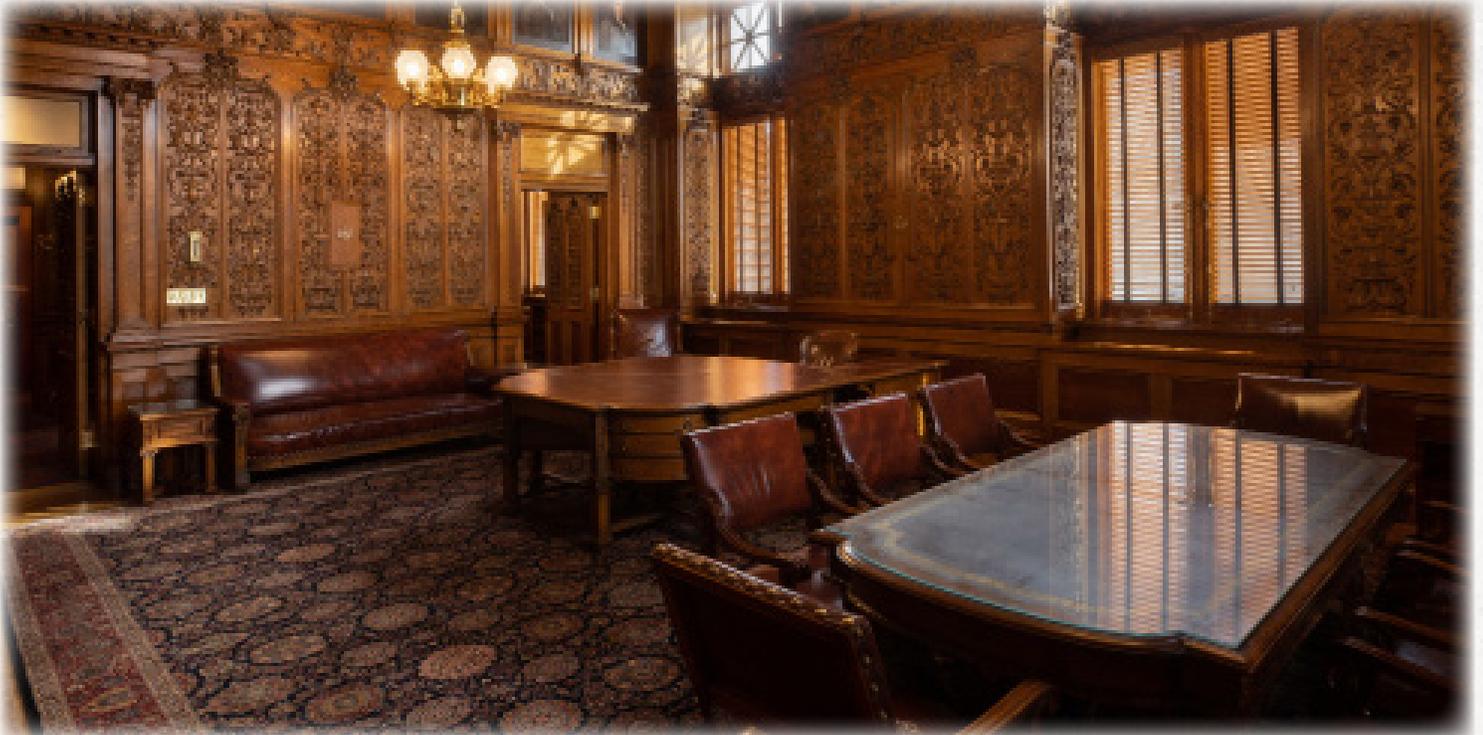
## ROOM 224 GOVERNOR'S PRIVATE OFFICE

An analysis of the Governor's private office oak woodwork was conducted in March of 2008 by Milner and Carr Conservation. Johnson and Griffith's (one of the Committee's conservators for the Governor's Suite project) was able to utilize this initial study and make further tests to determine which method would be most effective to clean and remove the darkened dry wax and restore the historic oak panels. A solution of 5-10% Green Soap and water was found to be the most effective method to remove the old, darkened finish. After removal, an application of linseed oil, shellac, and wax was applied to all panels and applied relief carvings.

Several areas of the ornamental paneling required repair or in some cases replacement of decorative elements. This was done using quartersawn white oak which was garnered from previous areas of the Governor's suite, Capitol Complex, or in some cases produced from new material. Seven large acanthus-style carvings required repair or replacement, as well as numerous smaller areas of loss.

For replacement, conservators would begin by using tracing paper to create a pattern of the original piece's profile. A scroll saw was used to rough-cut the shape of the pattern. These rough-cut pieces were then screwed into place, and hand-held tools used to reproduce the final detail of the original, matching the methods used by artisans over 116 years ago when the room was first constructed. Once completed the repaired and modified areas were custom-stained and blended to make them harmoniously match the older quarter-sawn oak original to the building's construction.

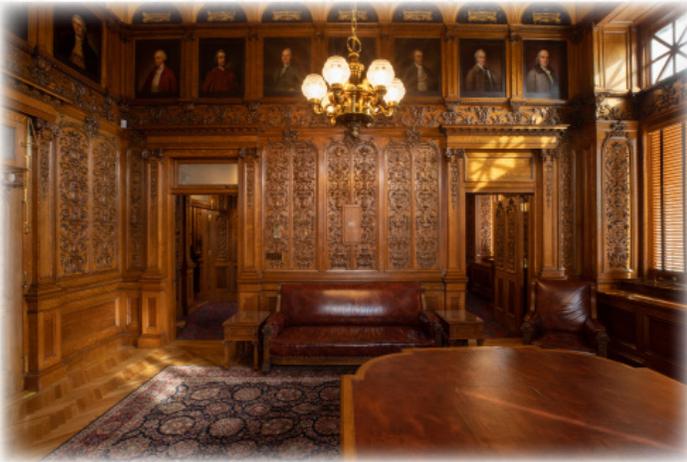
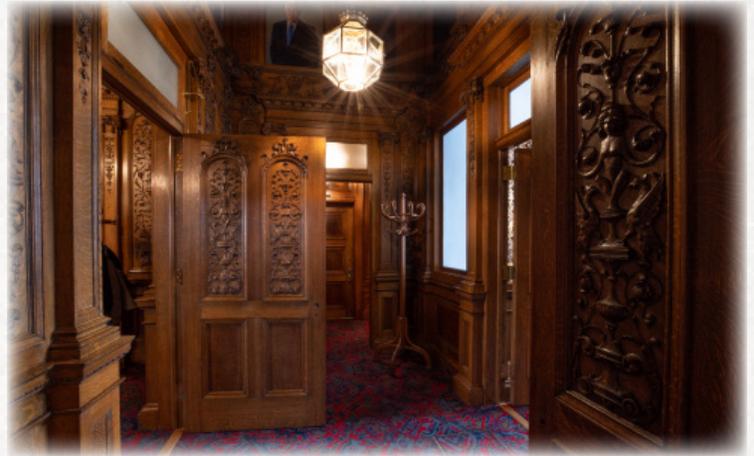
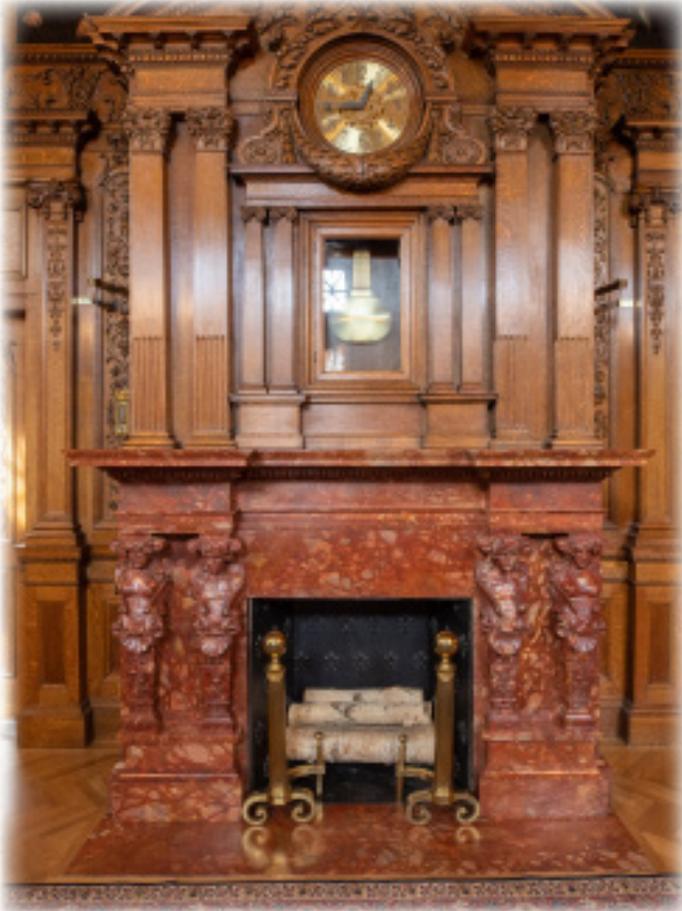
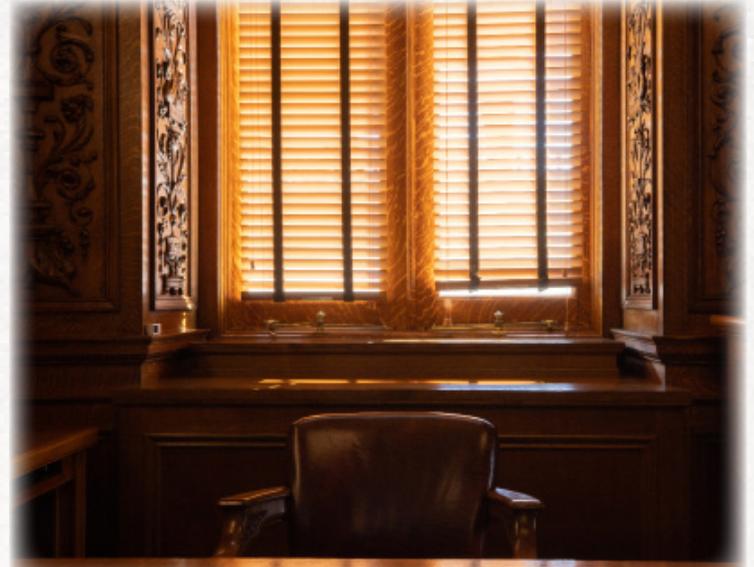
The existing floor was in such bad condition that it could not be salvaged so a decision was made to replace it with new wood parquet flooring. Once removed, two areas of damage. Two areas of damage within the concrete substrate were remediated and repaired. The substrate was then prepared and vacuumed, and a moisture barrier emplaced. The floor was then re-leveled using Ardex, a self-leveling underlayment. Next, pieces of 2' x 12" sections of quartersawn white oak were installed in a herringbone pattern and glued using a polymer adhesive. Work progressed in twenty-slat sections until the room was complete. The slats were joined with painter's tape and weighted to ensure precise alignment as installation progressed.

After installation of the flooring, the entire wood parquet floor was successively sanded with decreasing grits of sandpaper. Lastly, an oil-modified urethane stain was applied to the entire floor and allowed to dry.

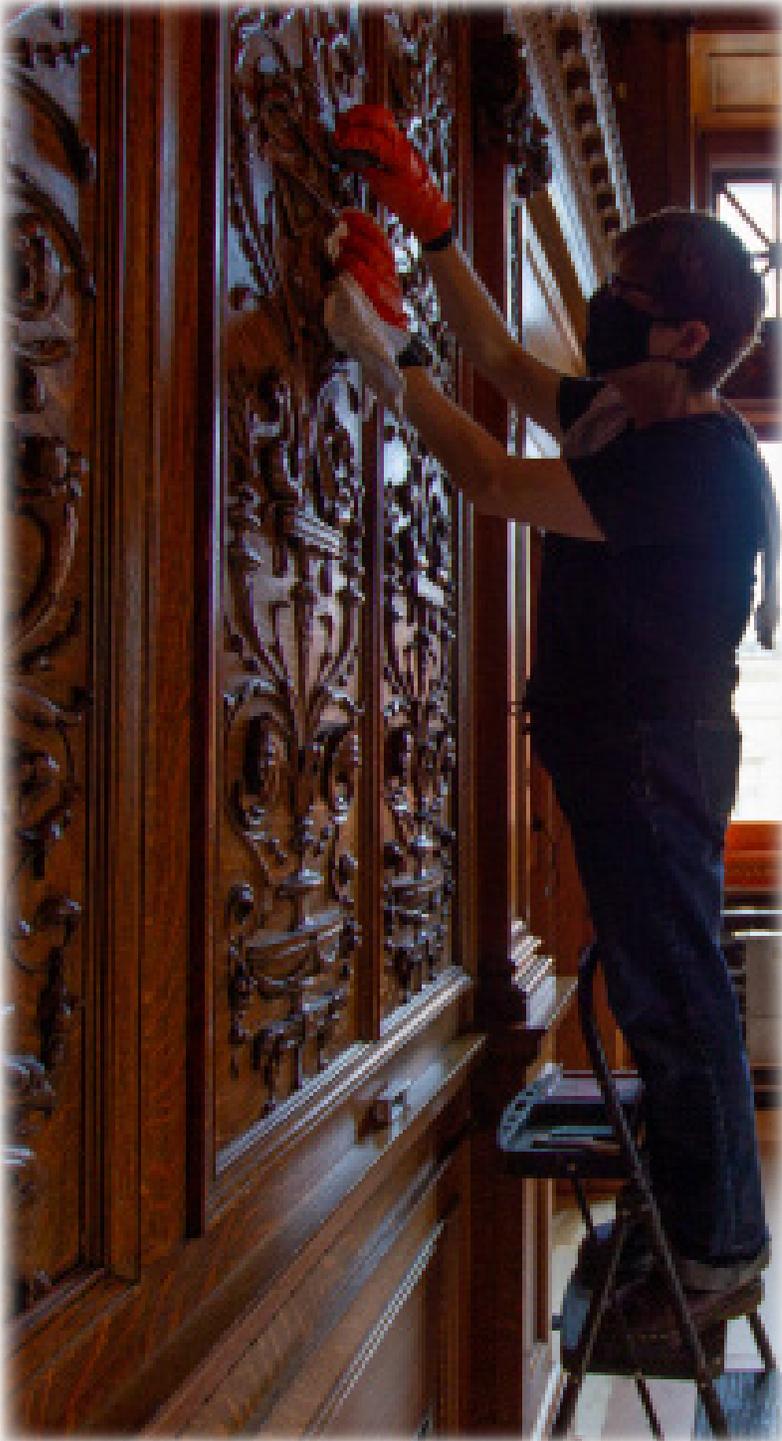
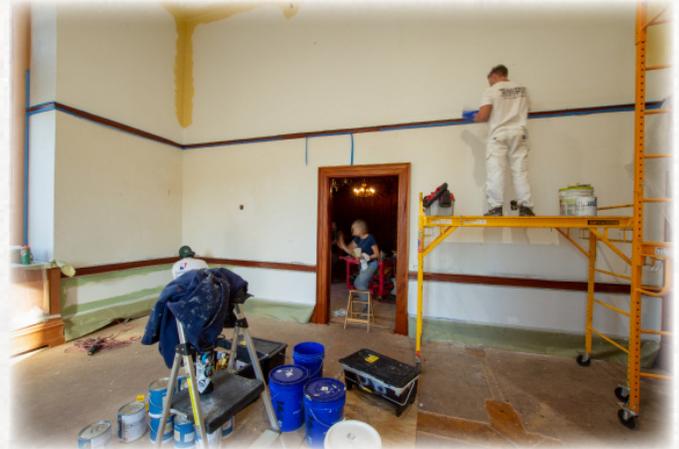
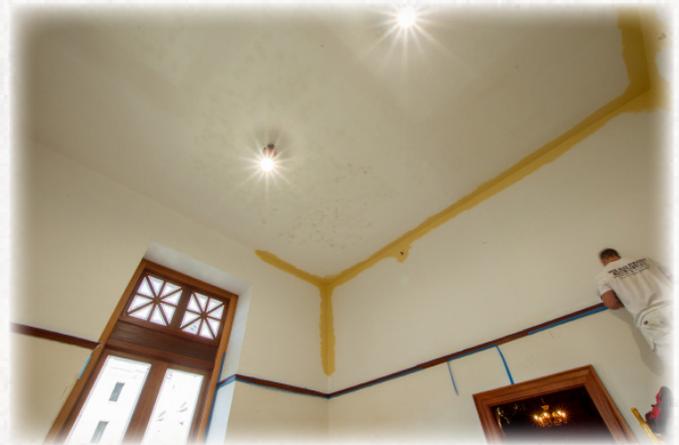
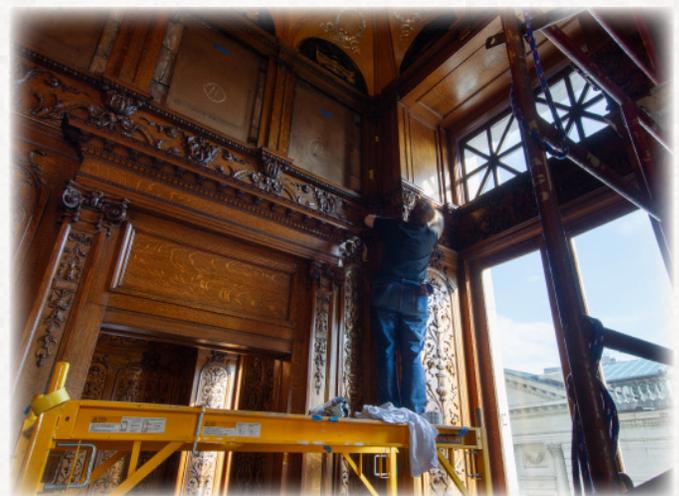
## ROOM 225 GOVERNOR'S CHIEF OF STAFF

Much of the Room 225 Governor's Chief of Staff Office restoration work mirrors that undertaken in the Governor's Private Office. The oak paneling was stripped of old finishes, repaired, and restored and the same application of linseed oil, shellac, and wax was applied. New HVAC enclosures were fabricated for the room (as they were for room 224), and the plaster strapwork ceiling was restored in a process identical to that in the private office spaces. The ceiling in Room 225 did differ in terms of colors and glazing from that present in Room 224.

Additionally, all door and transom hardware and accessories for both room entry doors were removed, restored, and reinstalled within the room. New wooden window blinds were also produced and installed. A custom Wilton Loom reproduction historic carpet in an "Arabesque" pattern was installed wall-to-wall within the room. The carpet is an Axminster-cut, yarn-dyed carpet with a pile height of .29".

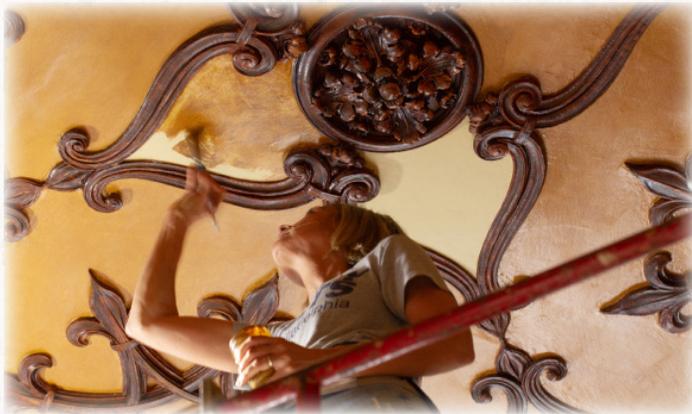
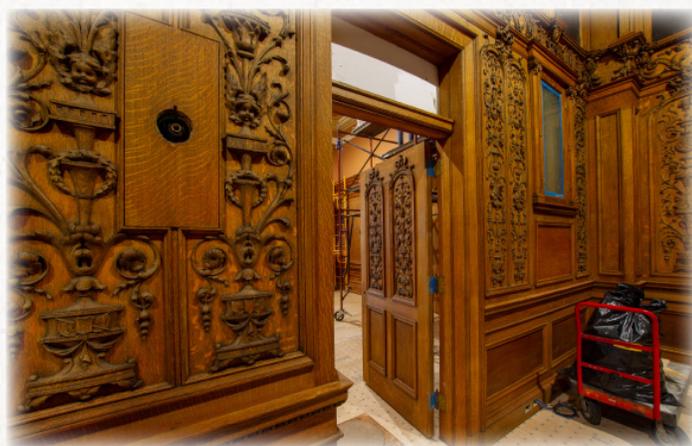
## ROOM 227 HALL

Room 227, the entry hall from the Governor's Reception Room, contains a non-ornate upper wall area of canvas over plaster and a lower area of flat white oak panels (as opposed to the carved oak panels in the more ornate areas). Repairs to the upper canvas areas were executed and the surface was primed and repainted. This area received a restored pendant light fixture salvaged from other areas of the Capitol Complex, as well as Wilton "Arabesque" carpet.
