# **Pennsylvania Capitol Preservation Committee**

**2016-2017 Annual Report**  
**Preserving a Palace of Art**

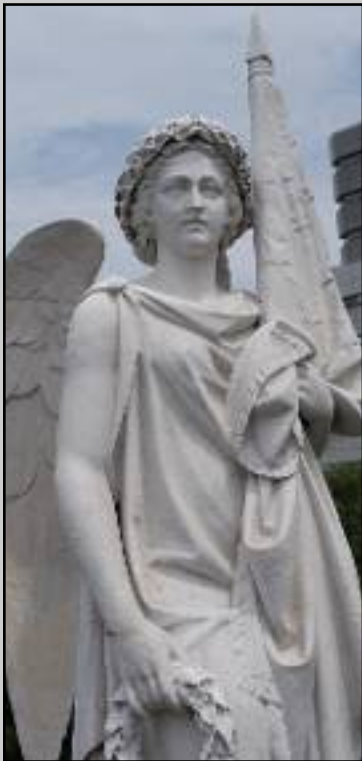
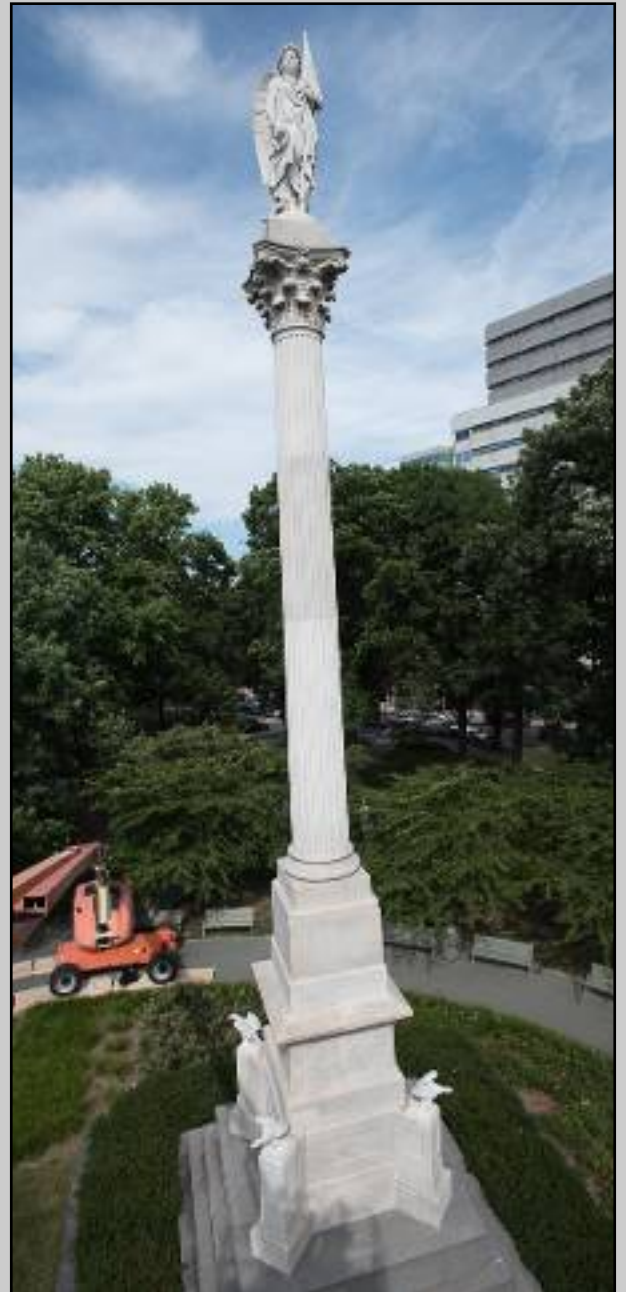
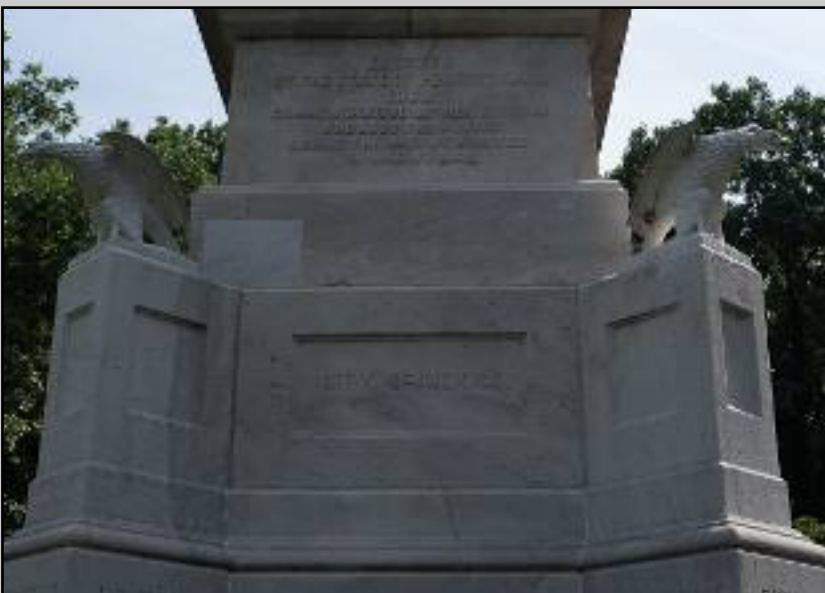
The year 2016 marked the first year of a new six-year project designed to maintain the Barnard statues and historic Mexican War monument in south Capitol Park. Year One specifically addressed issues with the Mexican War Monument such as mortar loss, micro cracks, fissures, shelter coat loss, and biological growth. Areas where previous mortar had failed were removed and re-pointed. Micro cracks were filled with dispersed hydrated lime injections and biological growth was removed. Lastly, a new shelter coat was applied to protect the monument from the elements. Sustained preservation maintenance, like that undertaken on the Mexican War Monument, will prevent costly repairs to the monuments in historic Capitol Park.

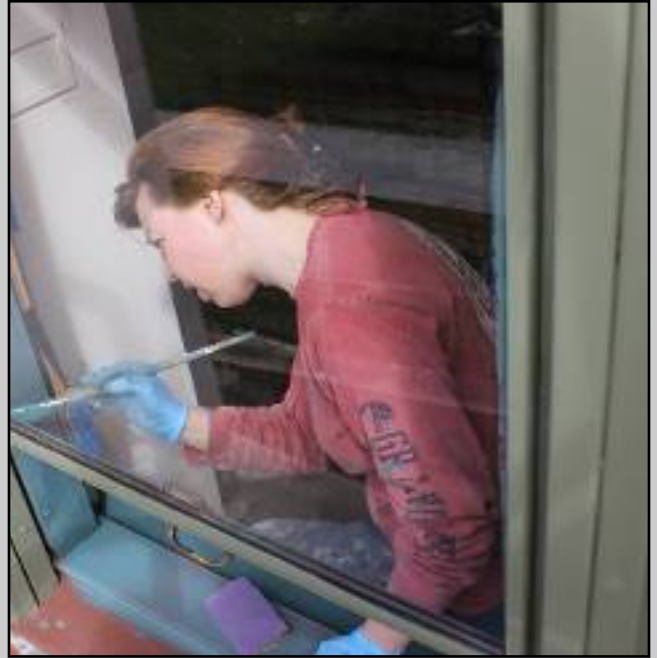
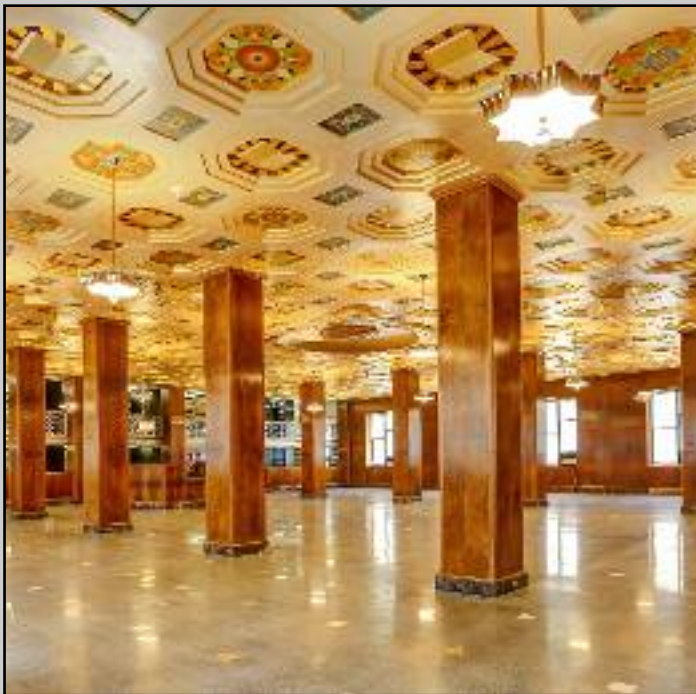
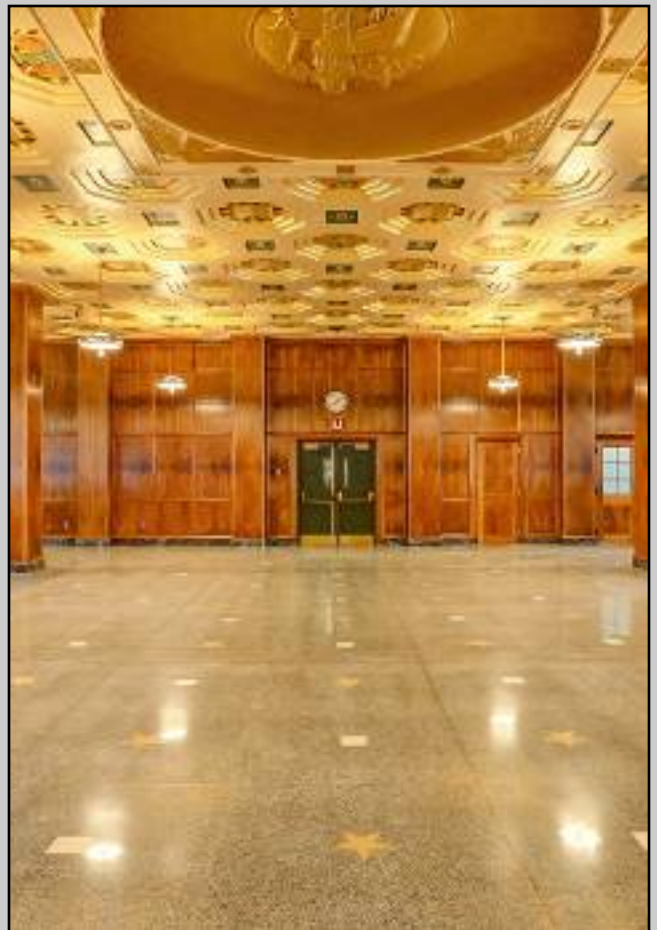
The year 2016 saw the continuation of the Committee's preservation work in the historic Law Library within the Forum Building. Work in the Law Library included full window restoration, which entailed stripping, cleaning, and prepping, counter balance repair or replacement, removal of old and failing glazing, and sealant, and finally repainting, re-installation, and re-sealing of the windows.

In addition to the windows, the Committee refinished metal bookcase end panels, the decorative metal mezzanine railing, and the terrazzo floor in the Law Library. Also included in this project was the restoration of the corridor outside the Law Library, including the decorative ceiling, repairing, cleaning, and polishing the marble walls, and refinishing the historic phone booth doors.

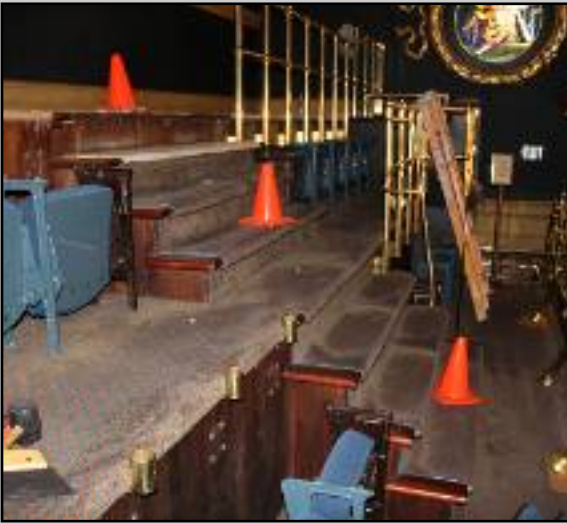
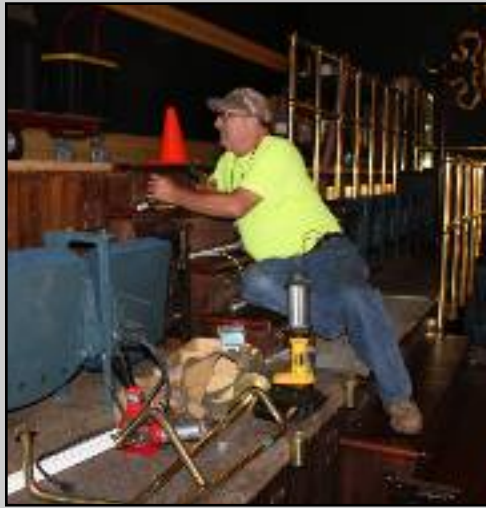
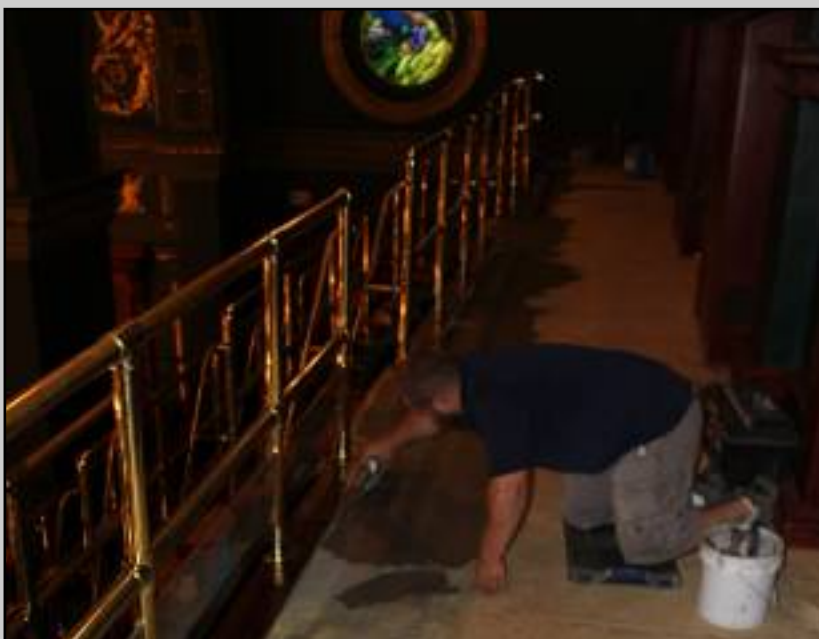
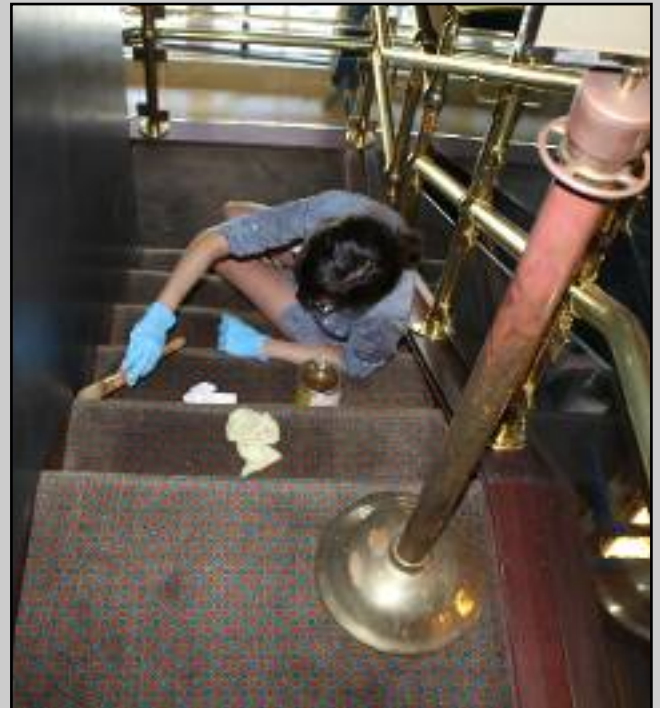
In 2015 and 2016 the Committee undertook restoration and preservation maintenance in the House and Senate Galleries. The scope of work addressed safety issues caused by loose carpet and burned out step lights, as well as maintenance of decorative finishes. New carpet on the upper landing and stairs was installed in conjunction with new LED stair lighting to eliminate tripping hazards. Decorative finish maintenance was performed on the brass railings and bronze fixtures, wood and paint finishes, and door hardware.

Due to the changing schedules of both the House of Representatives and Senate, this project spanned the summer recesses of 2015 for the Senate Gallery and 2016 for the House Gallery. Periodic restoration maintenance of the gallery areas, which are open to Capitol tours and the general public, ensures that all visitors are awed by the grandeur of the House and Senate Chambers.

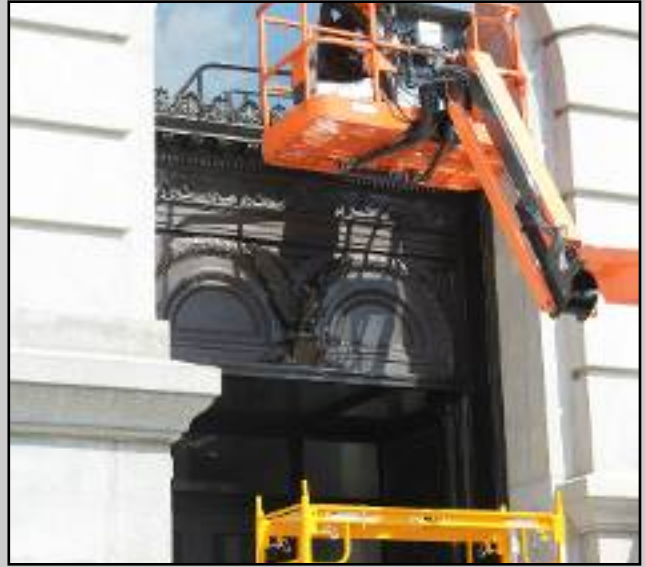
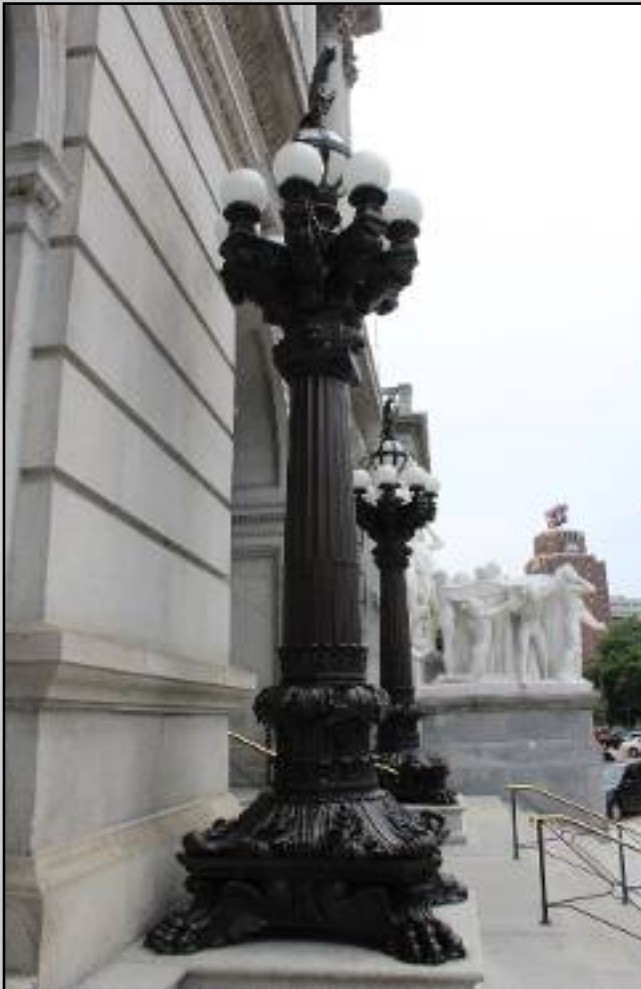
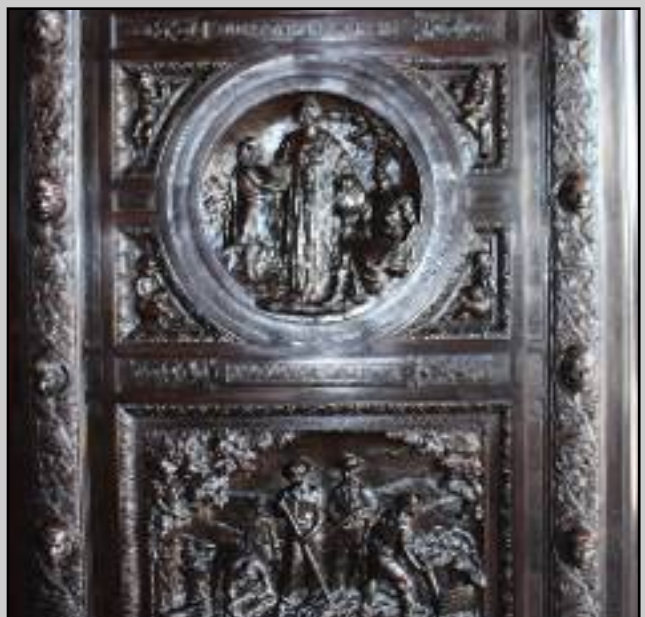
In 2016 the Capitol Preservation Committee began a new five-year project of conservation maintenance of the exterior bronze fixtures and doors at the west entrances of the Main Capitol. Each door leaf was cleaned, vacuumed, and brushed. Next they were cleaned with a solution and rinsed with filtered tap water. Then each door was air- and hand-dried.

The doors were then torch heated to eliminate excess moisture and re-flow the wax which covers the bronze. The wax was allowed to flow naturally but, where necessary, was brushed to remove any streaking. Once dry, the wax was then hand buffed to a warm sheen.

The torchieres and lanterns were also cleaned and rinsed, and the glass was removed and wrapped for protection. The bronze was again heated and, where needed, wax was reapplied over the bronze. Once cool, the wax was polished to a deep shine. Cyclical projects, such as the exterior bronze project, ensure that yearly salt, insect, and biological accretions do not cause irreparable harm to the Capitol's massive bronze doors and exterior light fixtures.

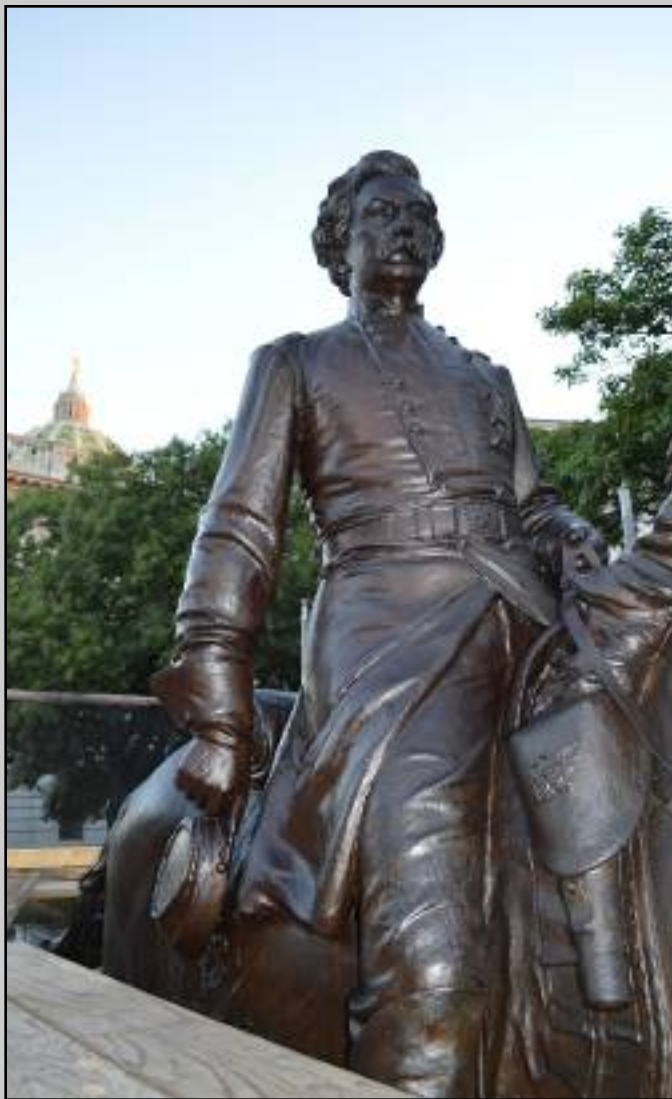
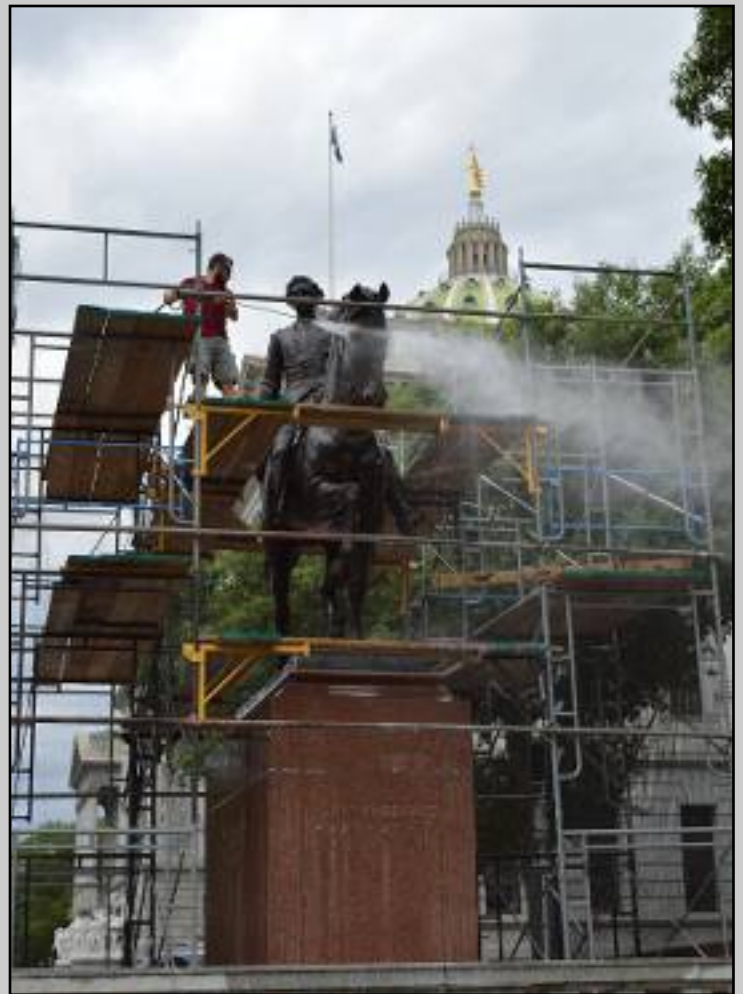
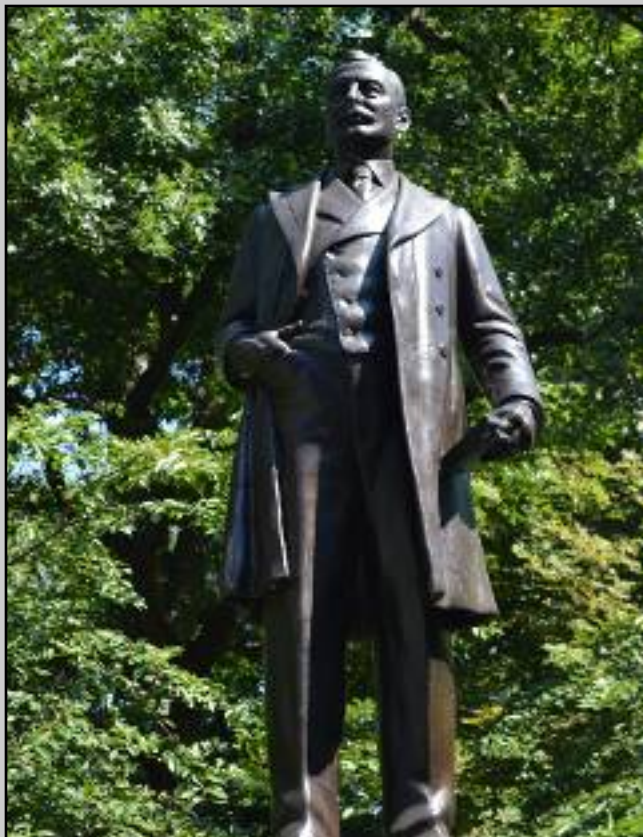
In 2016, the Capitol Preservation Committee began year one of a five-year project of conservation maintenance of the John F. Hartranft and Boies Penrose bronze statues in Capitol Park. The Hartranft statue was first photographed and then cleaned using brushes and vacuums. Next, wet cleaning of the metal was undertaken with filtered water and detergent, followed by a complete rinsing. The surface was then dried using cotton cloths and swabs.

The protective wax coating, which had been previously applied, was heated and reformed using torches. Small amounts of microcrystalline wax were blended into the existing wax as needed to achieve a balance of color and hardness. After application, the wax was buffed using cotton cloths. Biological growth in the mortar joints of the granite base of the monument was removed using a stiff plastic brush. The base was then rinsed with plain filtered water and, once dry, a biocide was applied to slow future plant growth.

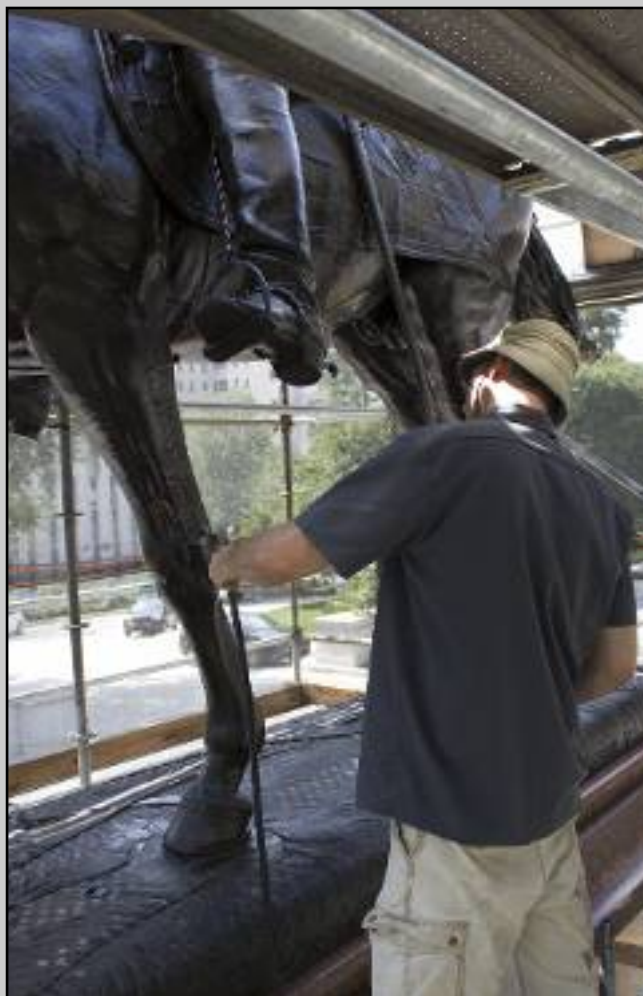
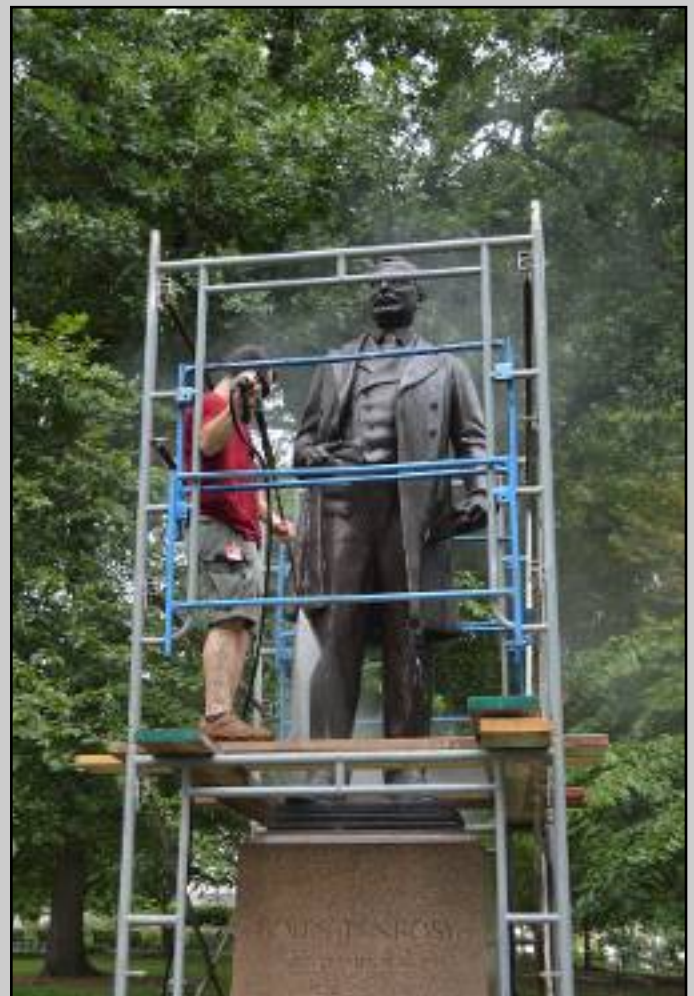
Although in good overall condition, the Penrose monument seems to attract a larger array of insect and arachnid nests. This statue, like the Hartranft, was first photographed and dry cleaned. It was then scrubbed with filtered water and mild detergent and the protective wax again heated to allow it to reflow on the bronze. The wax was buffed with cotton cloths, and the granite base was cleaned and a biocide applied. Some loss of the patina is evident on both the Hartranft and Penrose monuments and future projects may need to address the loss of this protective coating before elements of the bronze are damaged by environmental conditions. In the short term, the cyclical application of the sacrificial wax coating achieves the same result.

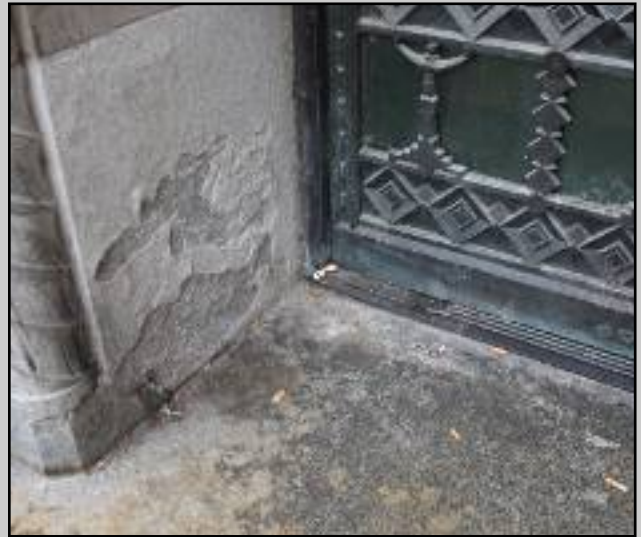
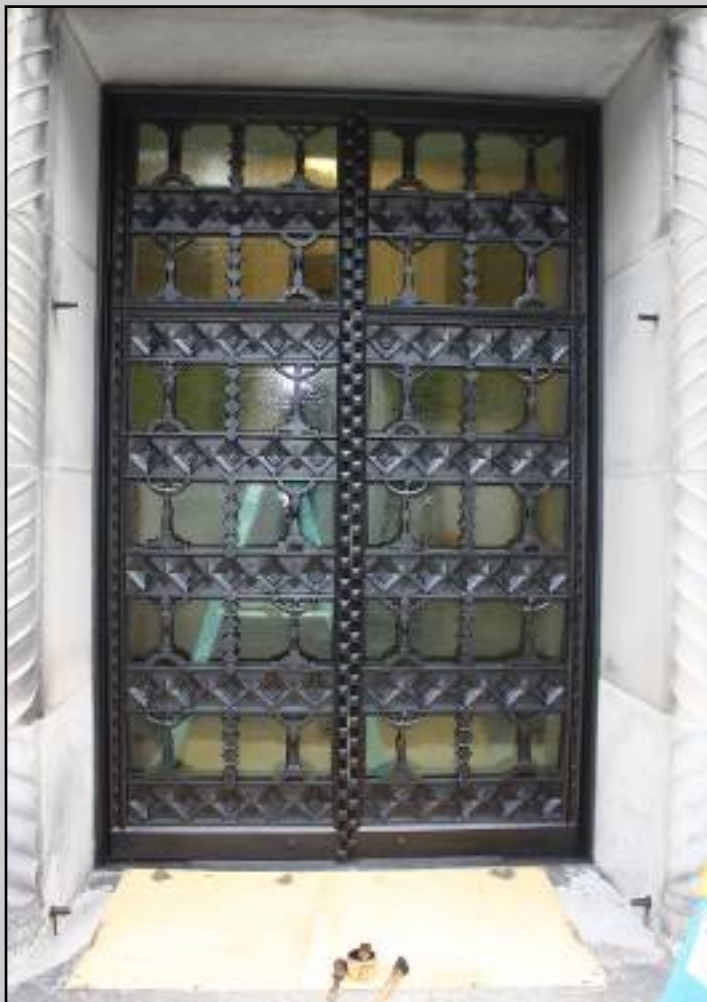
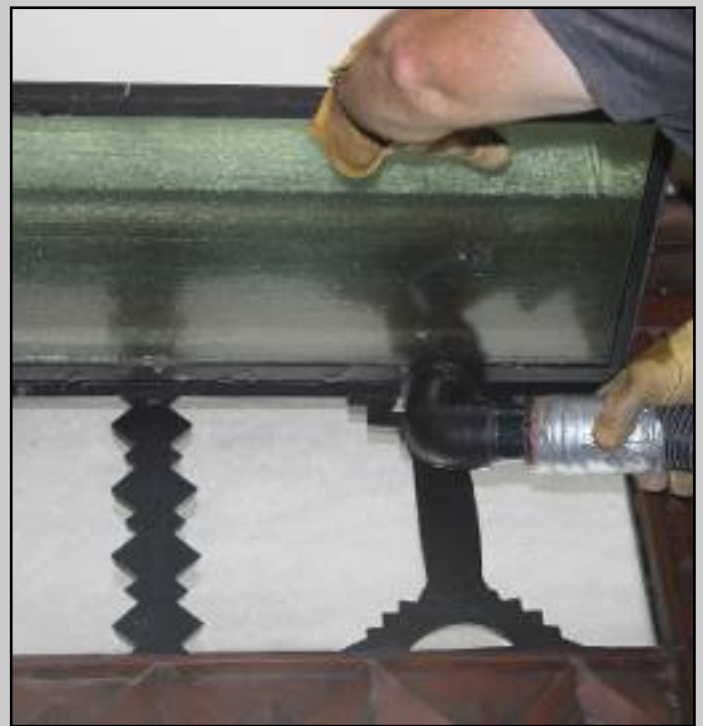
Each set of doors scheduled for maintenance was first dry cleaned and then wet cleaned and rinsed. After drying, each door was heated with a brush torch to allow the wax to reflow. Any areas of wax loss were reapplied. It was noted that the doors and thresholds seem to be suffering greatly from the application of salt during the winter, as well as blown dirt and debris accumulating on both the glass and bronze.

Normal, yearly accumulations of dirt and debris were examined as well as wear on handle areas on the most used doorways. Yearly maintenance of the Lawrie Doors ensures that the Forum Auditorium remains in top operating shape for years to come.

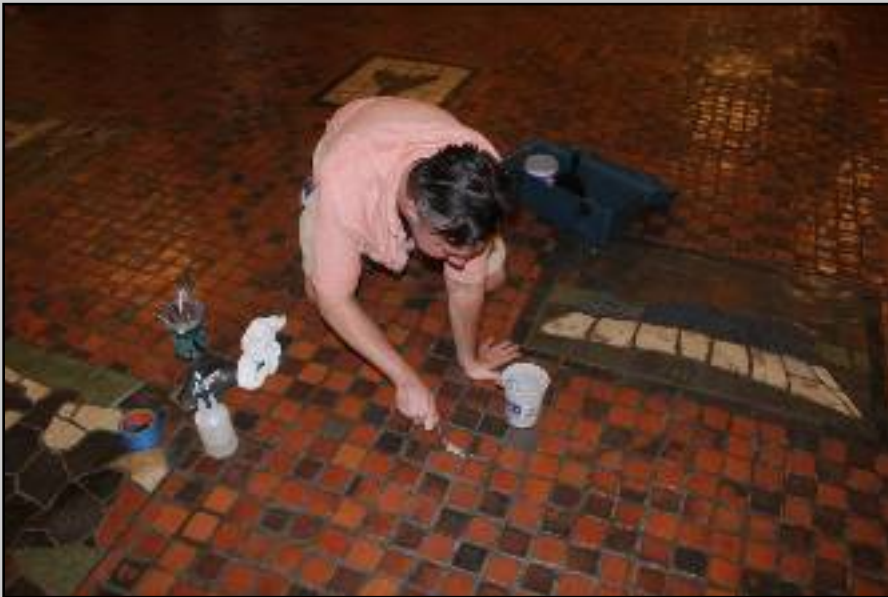
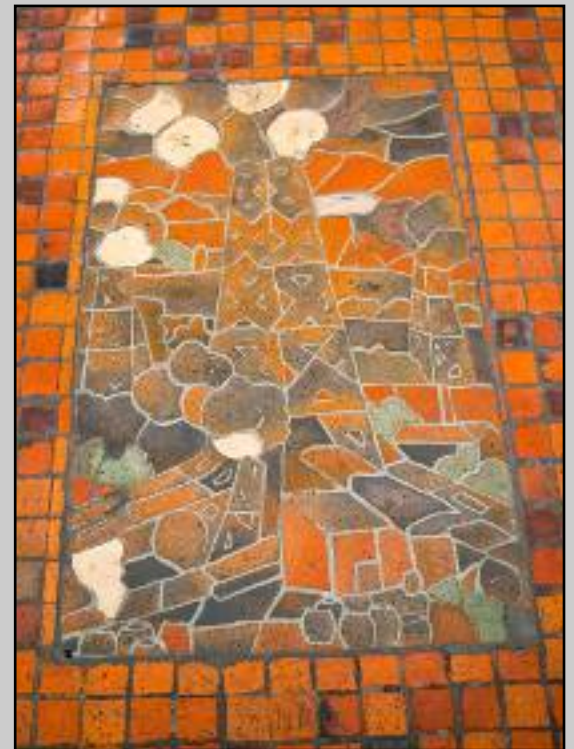
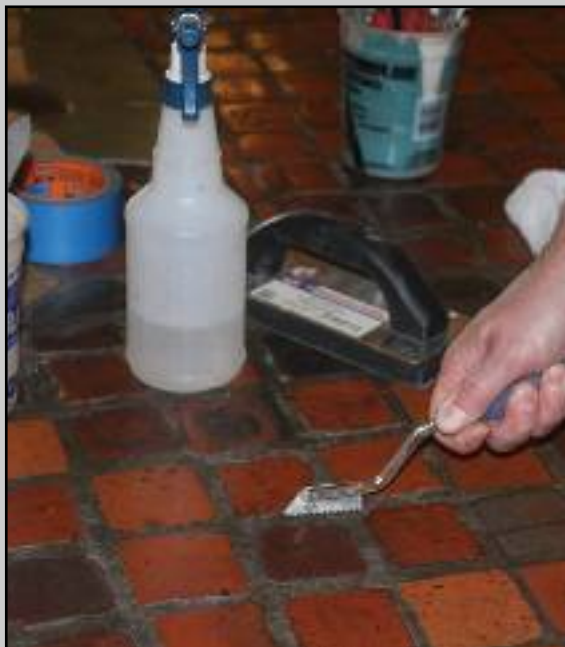
The Committee began a new five-year project in 2016 to continue maintenance on the Moravian tiled floor. This cyclical, specialized preservation schedule ensures there is no buildup of harmful dirt, salt, and debris on the tile and grout joints. The west entrances of the Capitol are given special attention over the winter months in an effort to reduce the adverse effects of the de-icing salt which is tracked in from the outside. The tile maintenance program also includes the marble floor outside the Lieutenant Governor's office on the second floor of the Rotunda. During bi-weekly cleanings, any new repair items are identified and addressed immediately. An annual survey of repairs is typically completed in the summer while the legislature is in recess. These repairs include re-grouting loose or missing joints, repairing pitted or cracked tiles, and application of protective coatings.

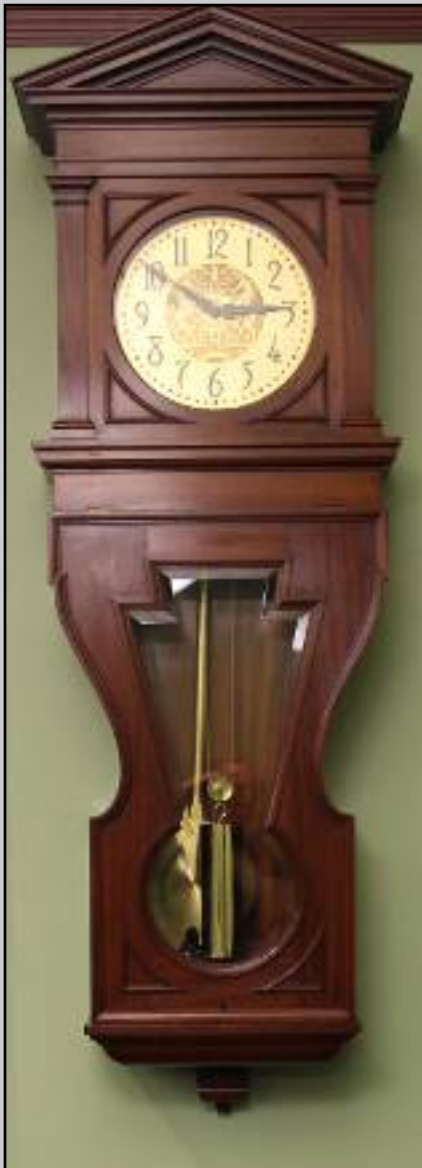
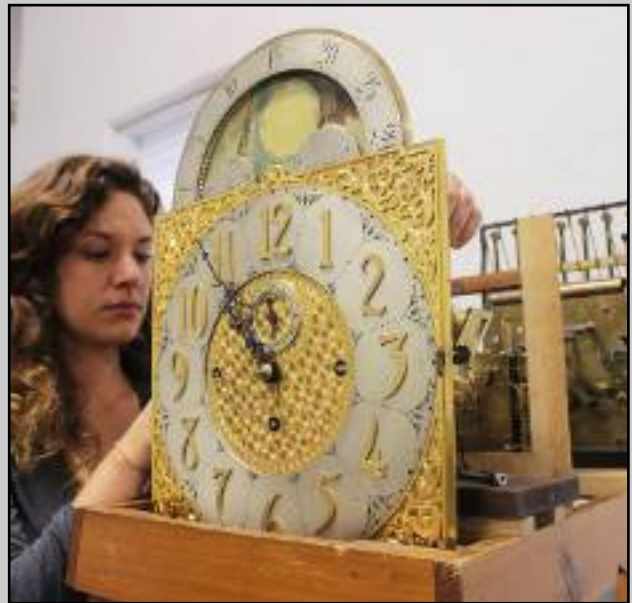
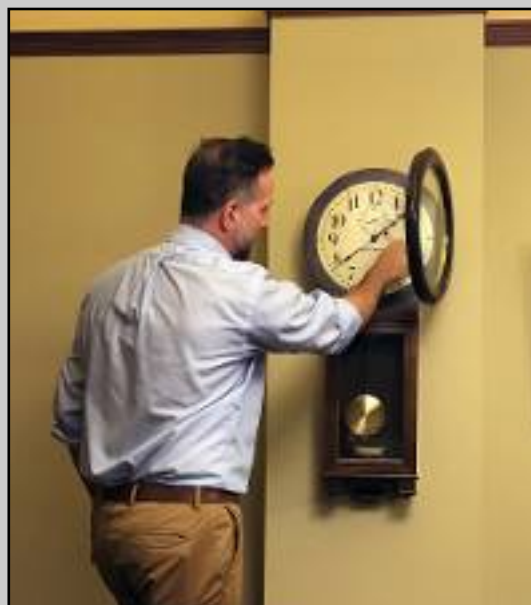
The Capitol Preservation Committee is responsible for the regular maintenance of more than 270 original Capitol clocks located throughout the Capitol and associated Complex buildings. The clock project began in 1993 with the objective to restore and maintain the clocks' wood finishes and inner mechanisms. In addition, the Committee wanted to collect and maintain historic documentation along with an inventory of each clock. By developing an electronic database, detailed information was compiled, including clock descriptions, construction materials, conditions, location, and an ongoing maintenance history. Following their restoration, each clock was put on a cyclical maintenance program. The Committee's clock conservator cleans the clocks and then they are placed on a yearly maintenance schedule wherein they are either oiled or cleaned cyclically every five years. While the majority of Capitol clocks have now been restored, ongoing preservation maintenance remains key to ensuring that they continue to operate and keep the correct time for years to come.
